moffatt & nichol
Creative People, Practical Solutions.®

FY2025 Annual Inspection and Underwater Inspection

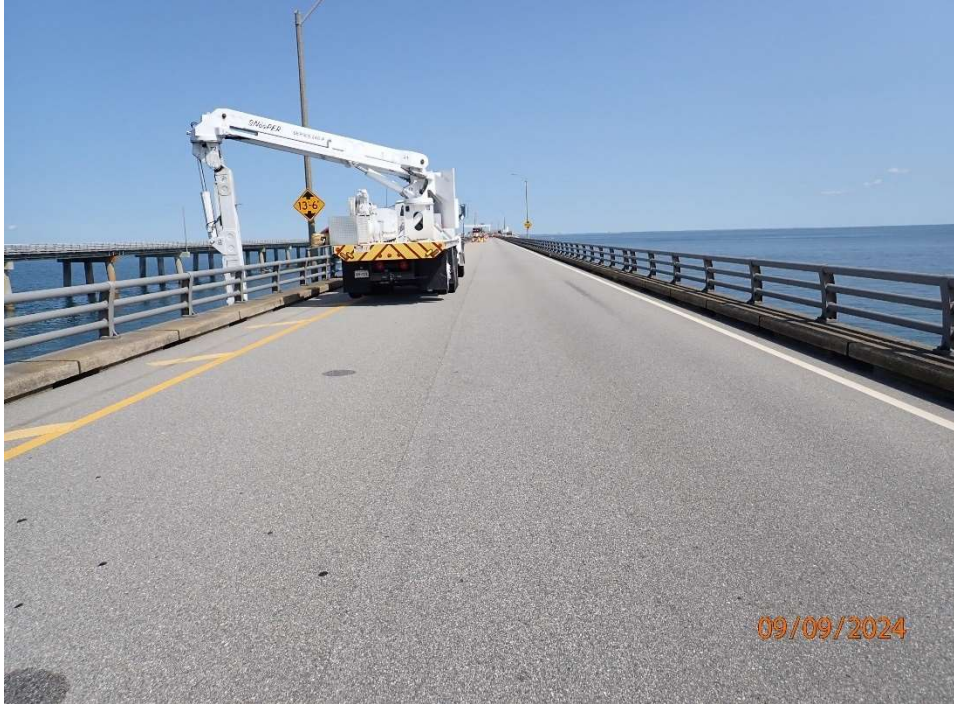
Photo 1: ASB188 Asphalt Wearing Surface – Typical good condition of wearing surface.

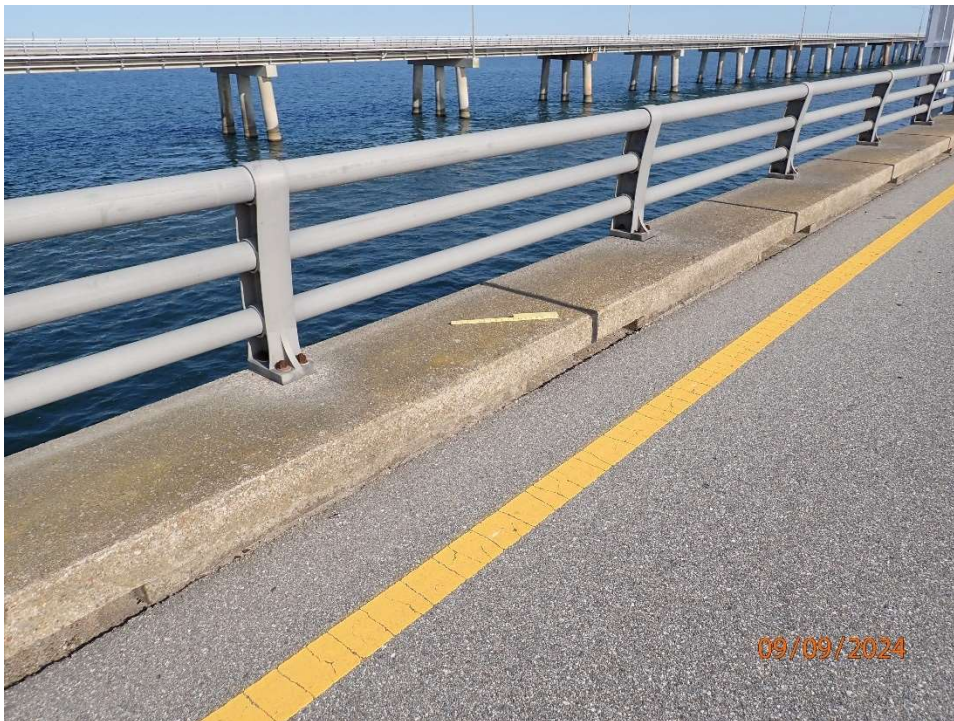
Photo 2: ANB181 Metal Bridge Railing – Typical good condition of bridge railing and curb.

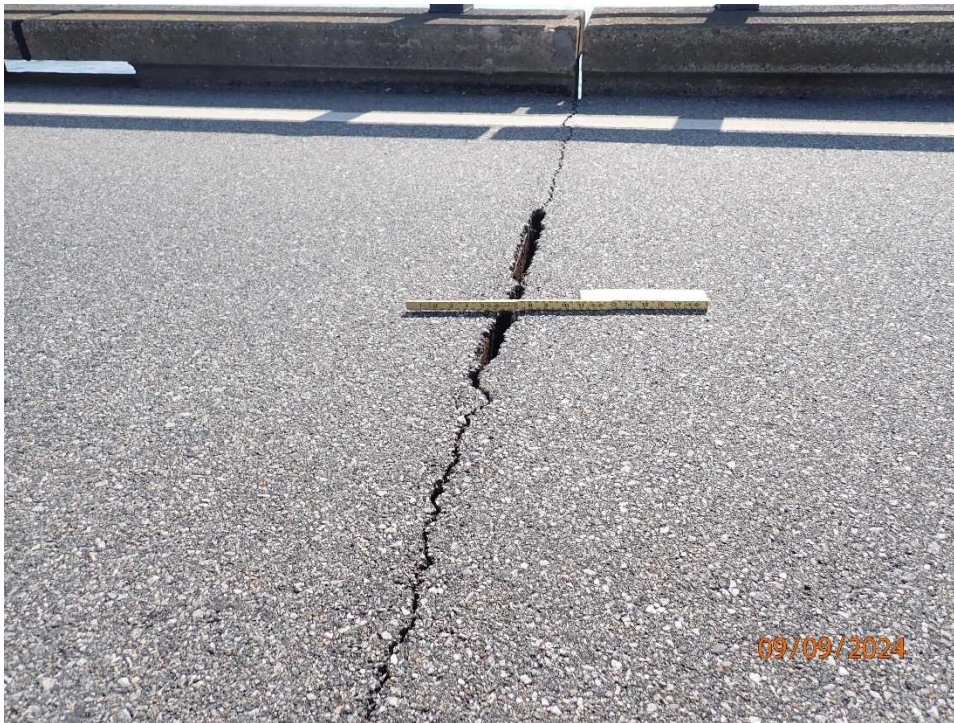
Photo 3: ANB183 Open Expansion Joint – spall 2' L x 1" w over expansion joint with $\frac{1}{4}$ " transverse crack full width (typical).

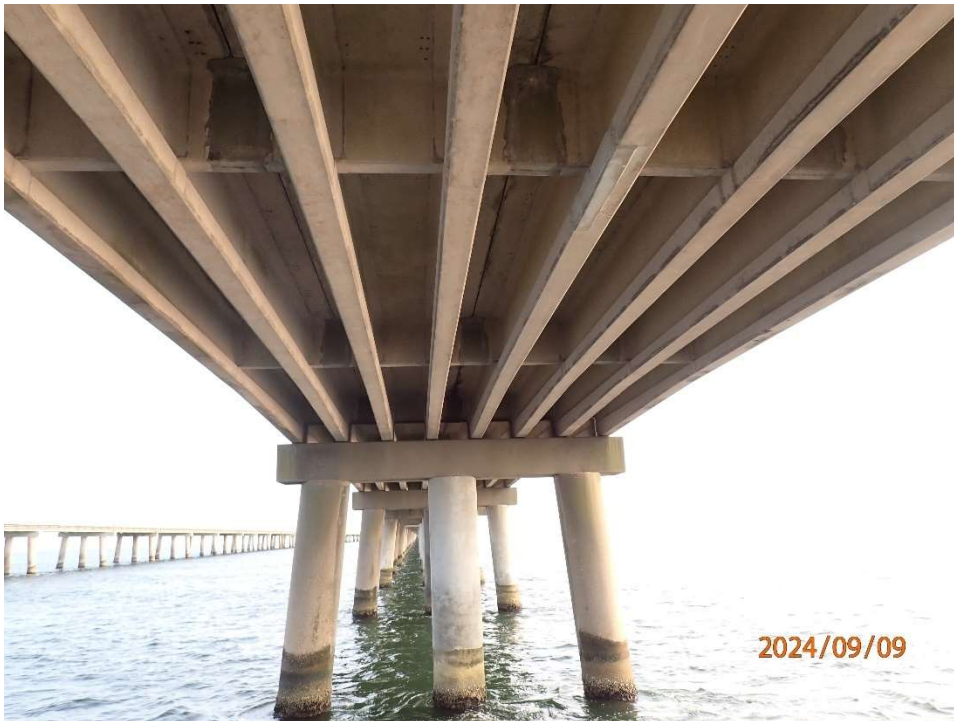
Photo 4: ANB177 – Typical Superstructure & Substructure in good condition.

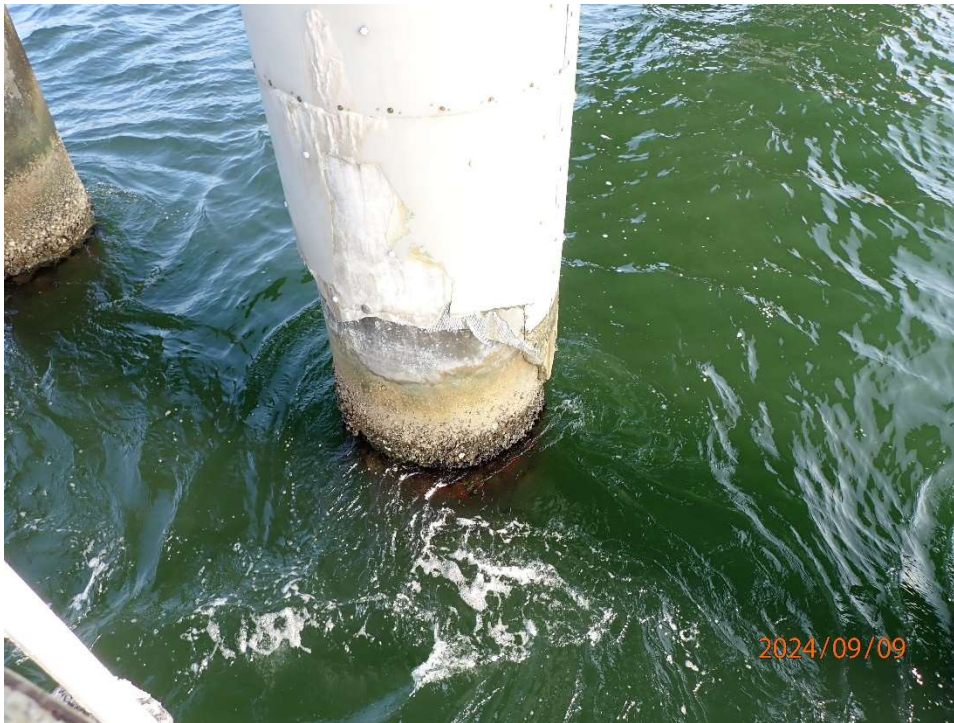
Photo 5: ANB181 – Pile B – Jacket missing full circumference bottom 8' with missing grout.

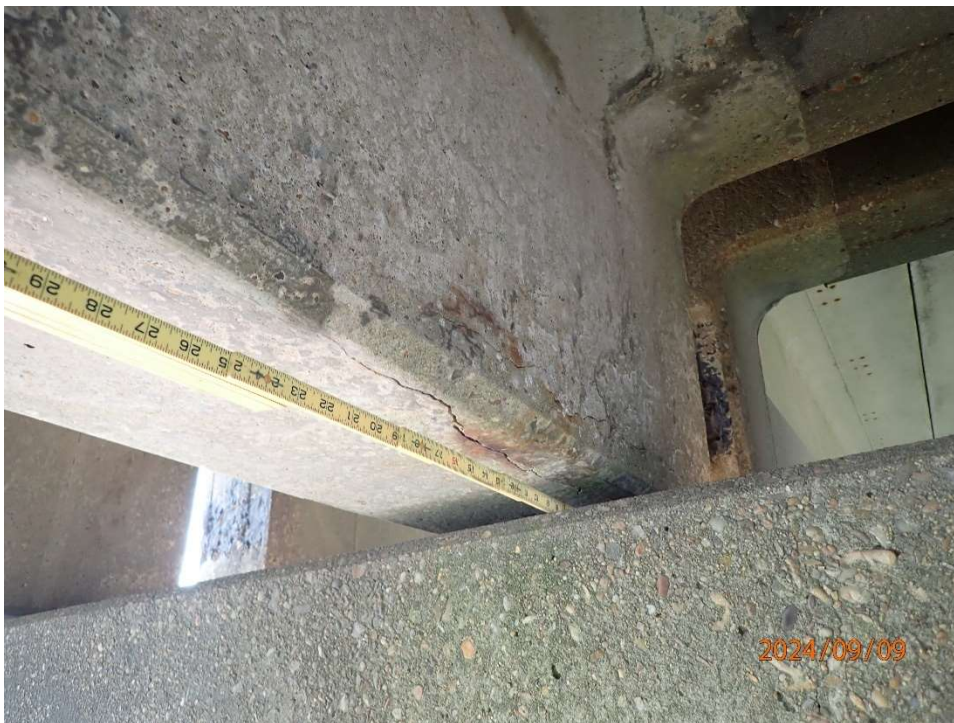
Photo 6: ANB182 – Beam 2 at Bent 183: 2' long 1/8" wide crack on underside of beam.

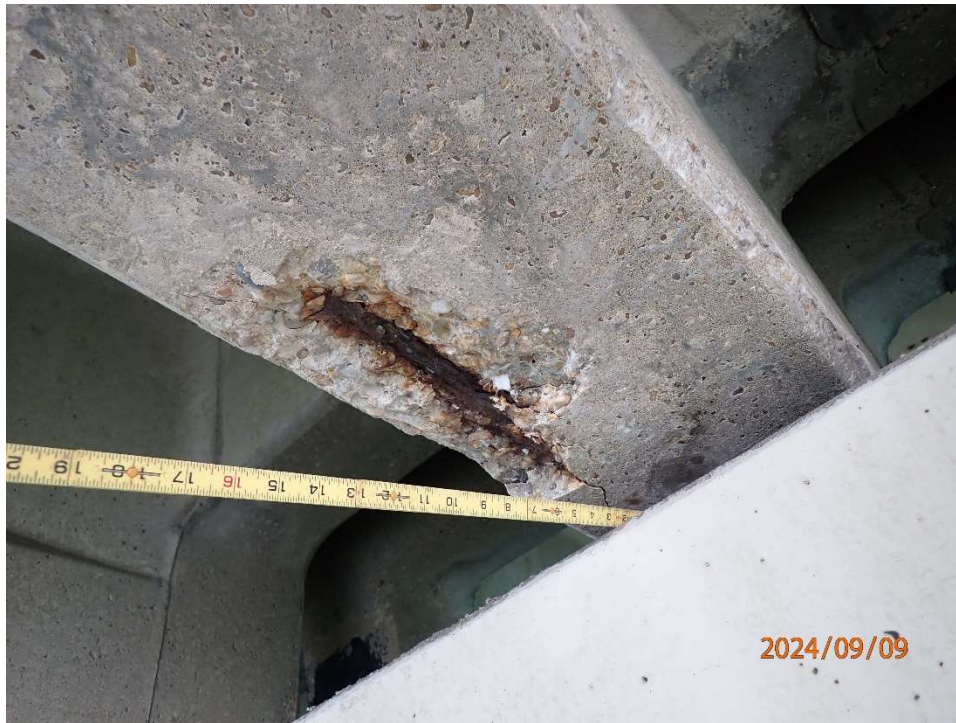
Photo 7: ANB191 – Bent 192 at Bent 5, Bay 5 spall/delam 25" L x 2" H x 8" under x 1" deep with exposed reinforcement with up to 20% section loss.

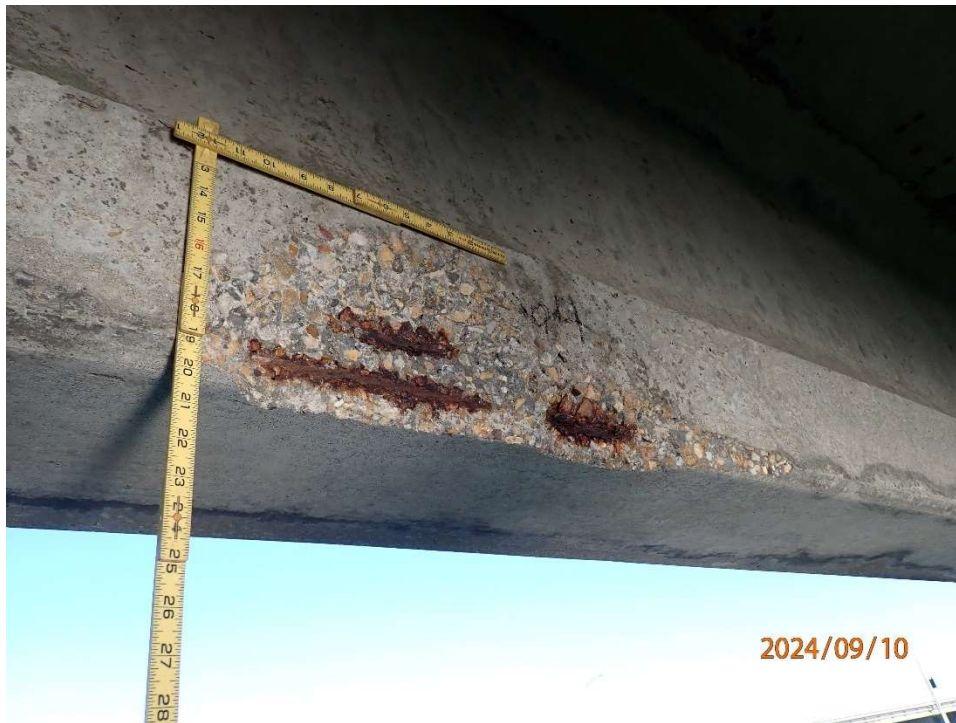
Photo 8: ANB204.5 – Beam 8, Bay 7 at 1/3 span spall 30" L x 8" H x 1" D with 2 exposed prestressing strands (L1 and L2) with up to 20% section loss.

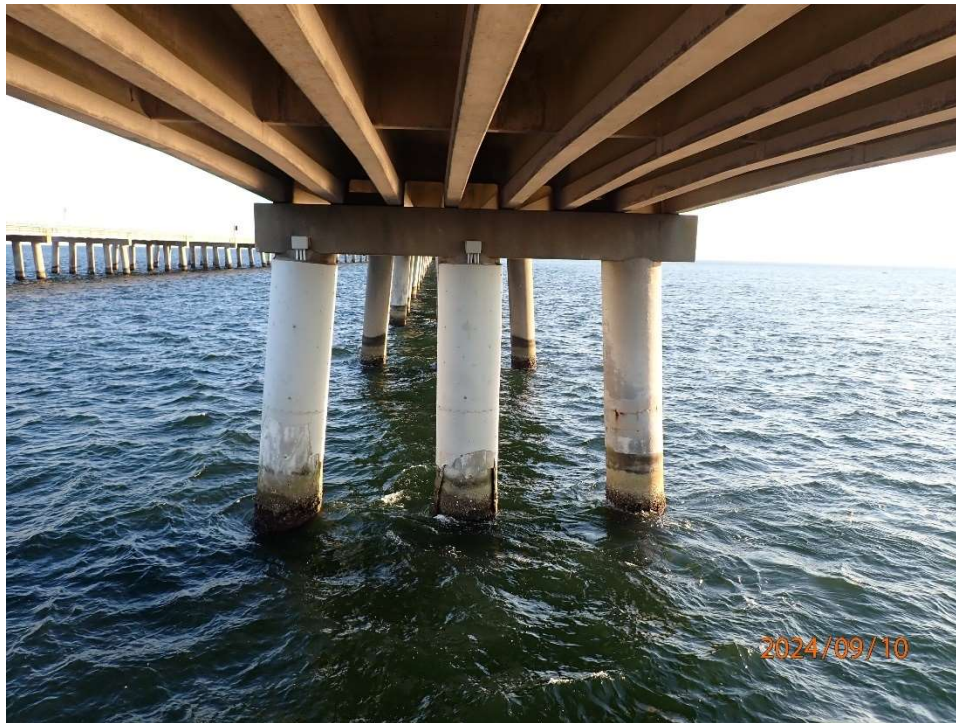
Photo 9: ANB202 – Substructure with fiberglass jackets . Jackets typically in good condition with isolated areas of jacket failure at waterline.

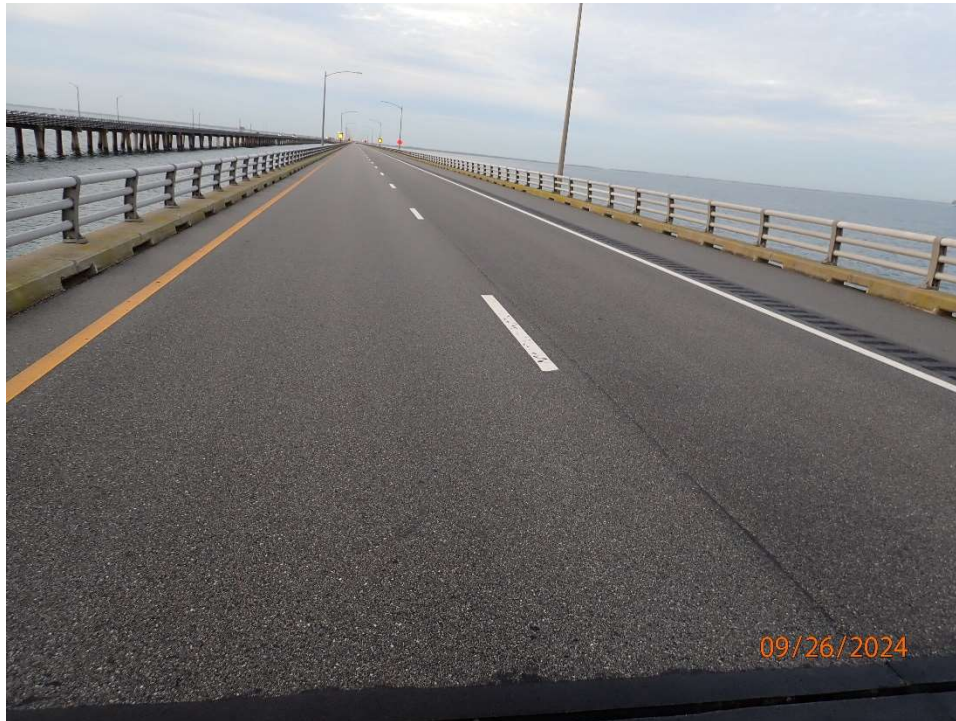
Photo 10: ASB50 Asphalt Wearing Surface – Typical Good Condition of Wearing Surface

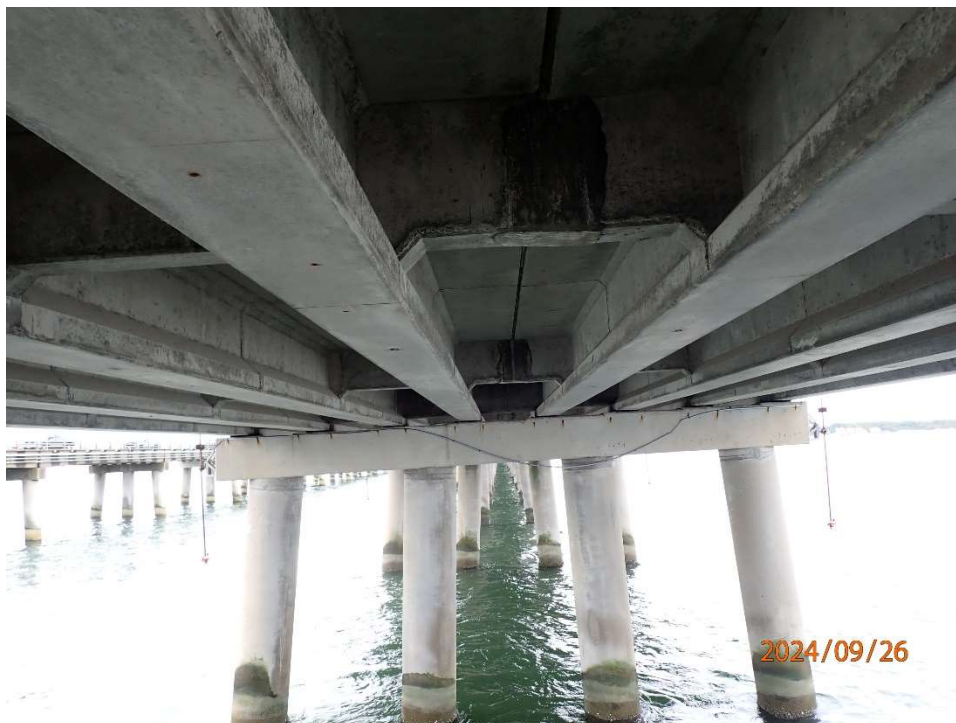
Photo 11: ASB71 Bent 71 north face typical good condition. Bent 71 has detached conduit for navigation light at bent cap.

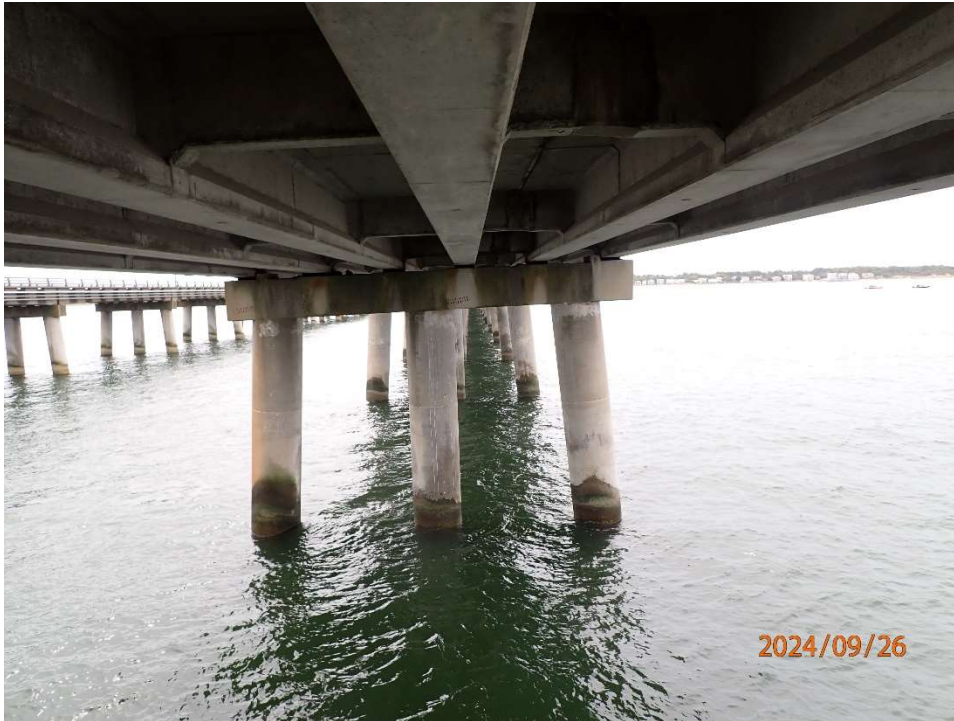
Photo 12: ASB67 typical substructure elevation. Substructure elements typically in good condition.

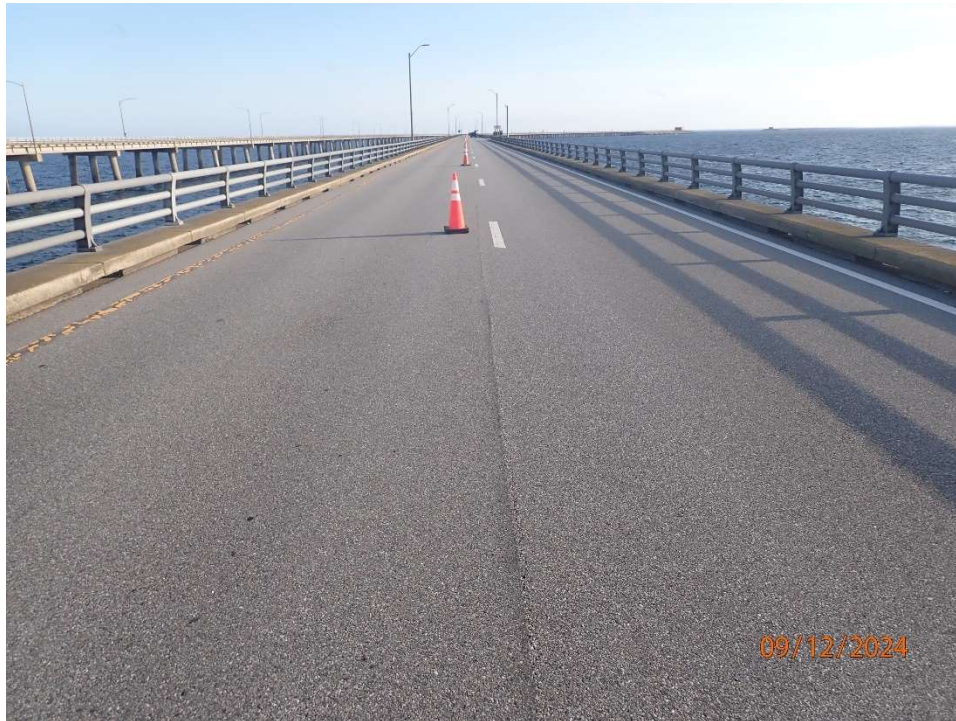
Photo 13: BNB160 – Asphalt wearing surface in good condition with pavement marking peeled and cracked.

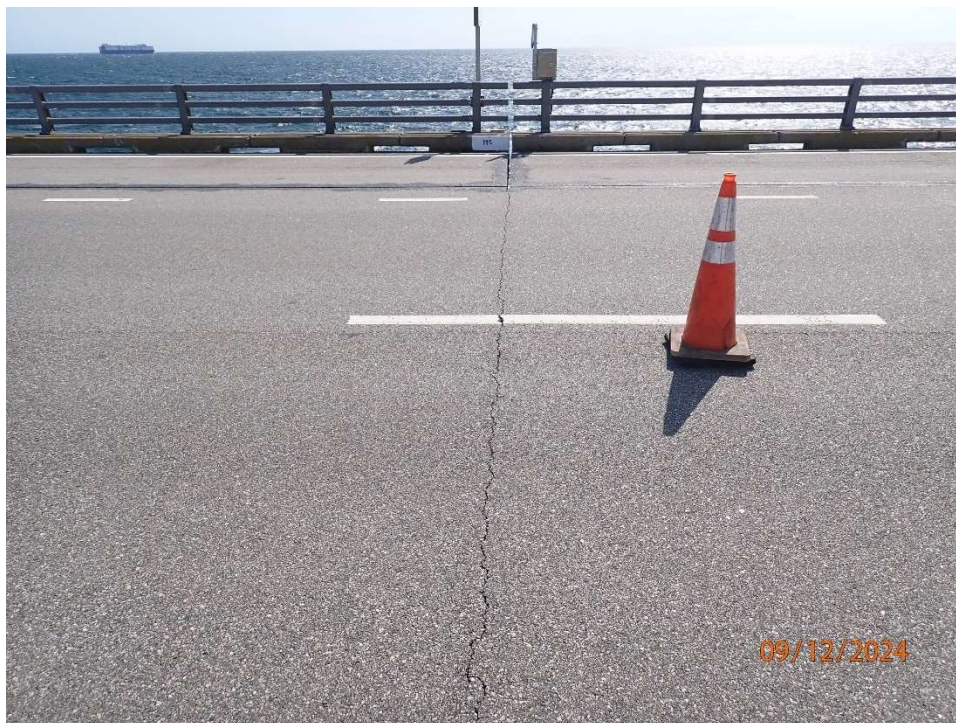
Photo 14: BNB167 – up to 1/8" wide transverse crack at expansion joint full width of roadway.

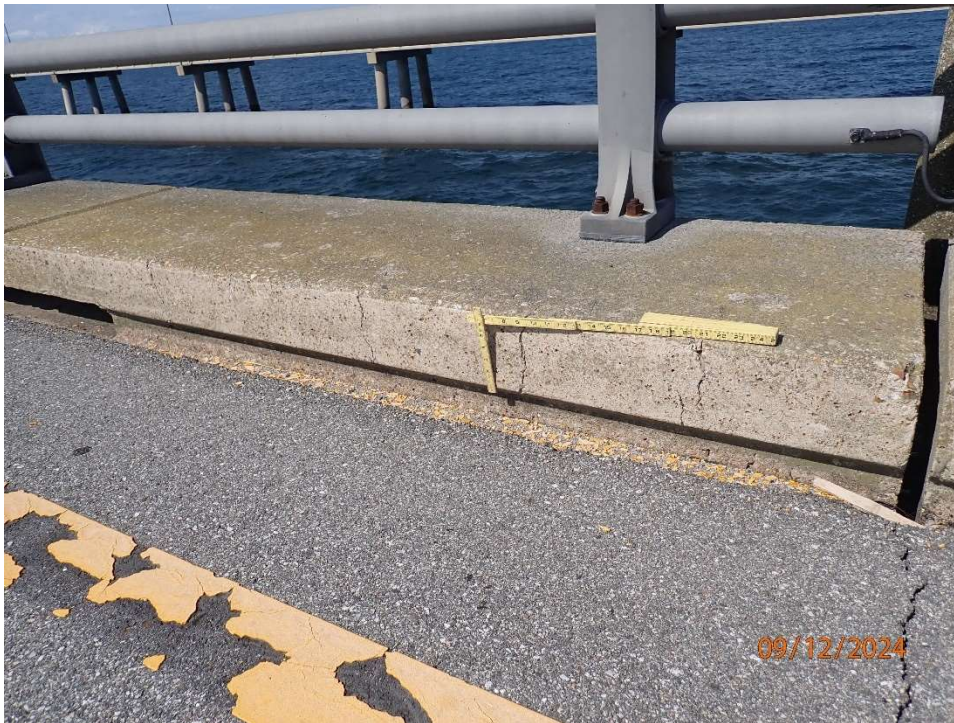
Photo 15: BNB165 – west curb with vertical cracks up to 1/8" wide.

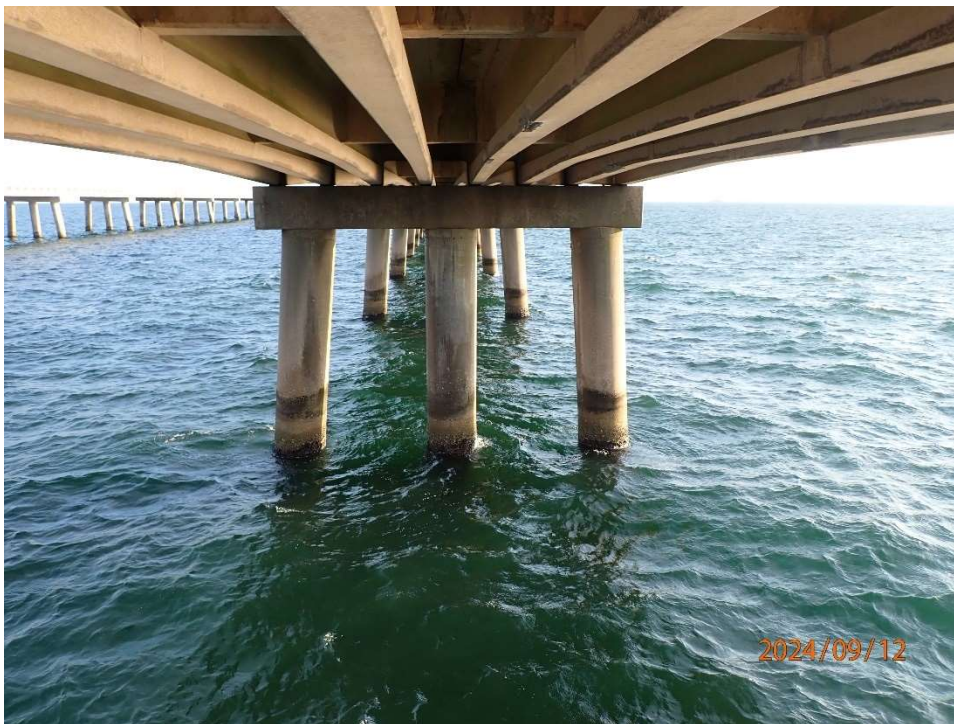
Photo 16: BNB178 – superstructure and substructure in good condition.

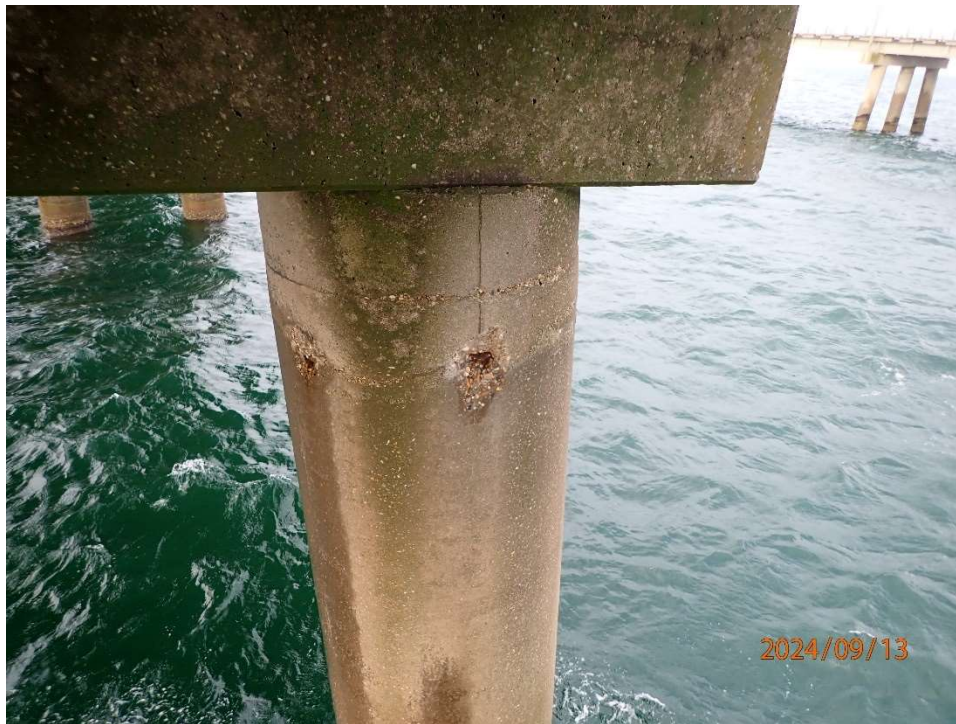
Photo 17: BNB199 – Pile A; 12" H x 6" W x 1" Deep spall with exposed reinforcement with up to 10% section loss.

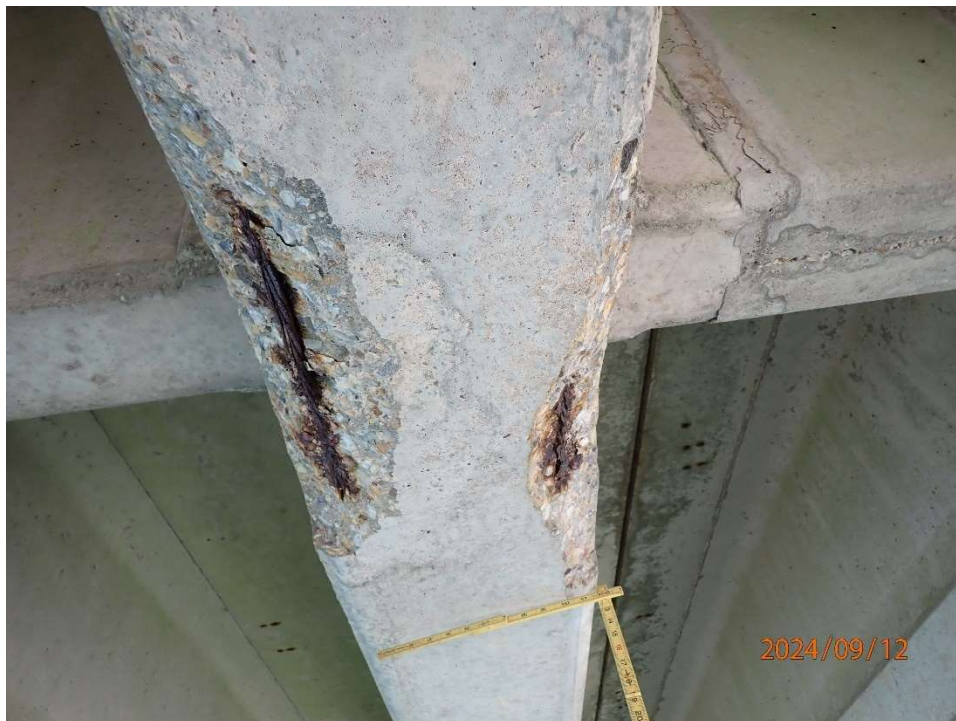
Photo 18: BNB192 Beam 5, Bay 5 at 1/3 span – spall 28" L x 4" H x 5" Under x 1-1/2" D with 1 exposed prestressed strand with 90% section loss and Bay 4 – spall 24" L x 4" H x 3-1/2" Under x 1-1/2" D with 1 exposed prestressed strand with 50% section loss.

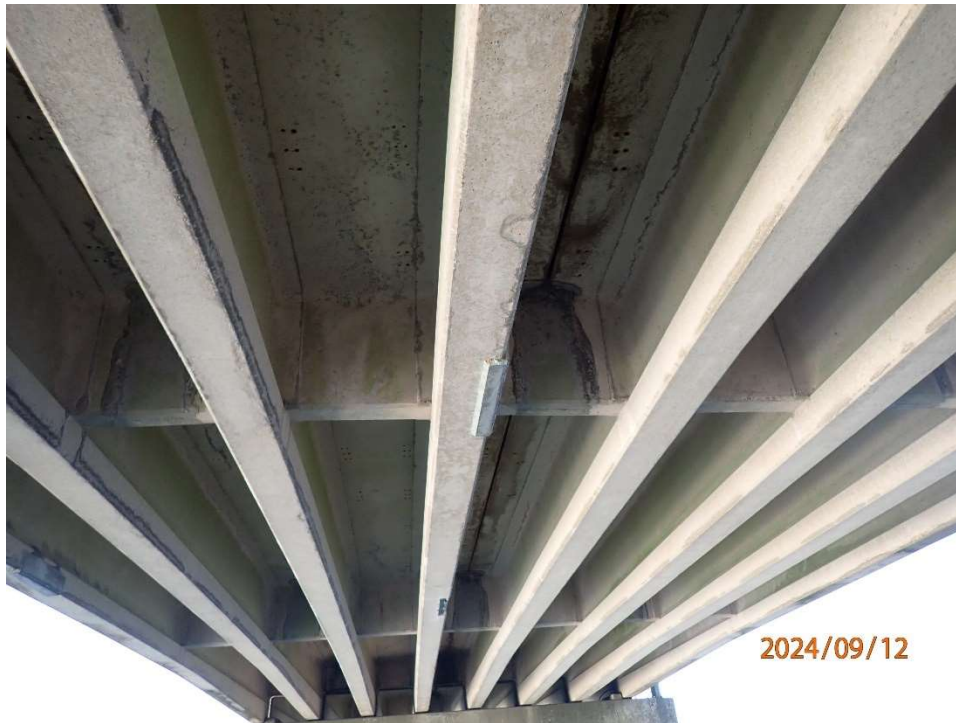
Photo 19: BNB177 under side of deck with previous beam repair noted on Beam 4.

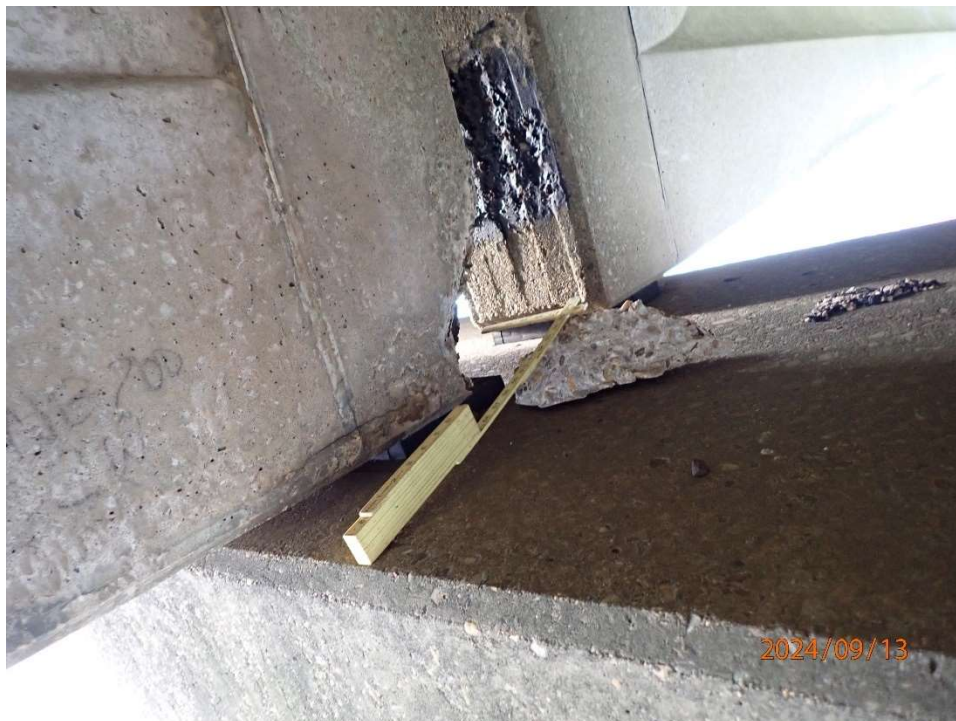
Photo 20: BNB200 at Beam 2 on Bay 2 side, beam end delamination/spall 18" L x 1' H x 6" back x 2" deep with exposed reinforcement with up to 50% loss of section at beam end and partial bearing loss.

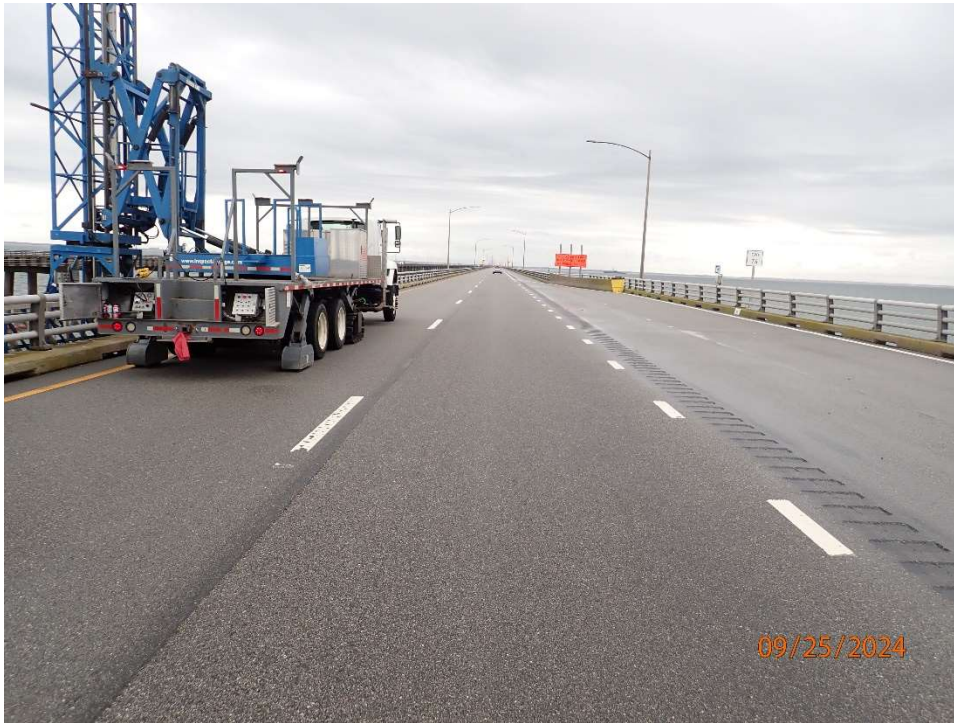
Photo 21: BSB100 Deck Wearing Surface in good condition and inspection equipment mobilized.

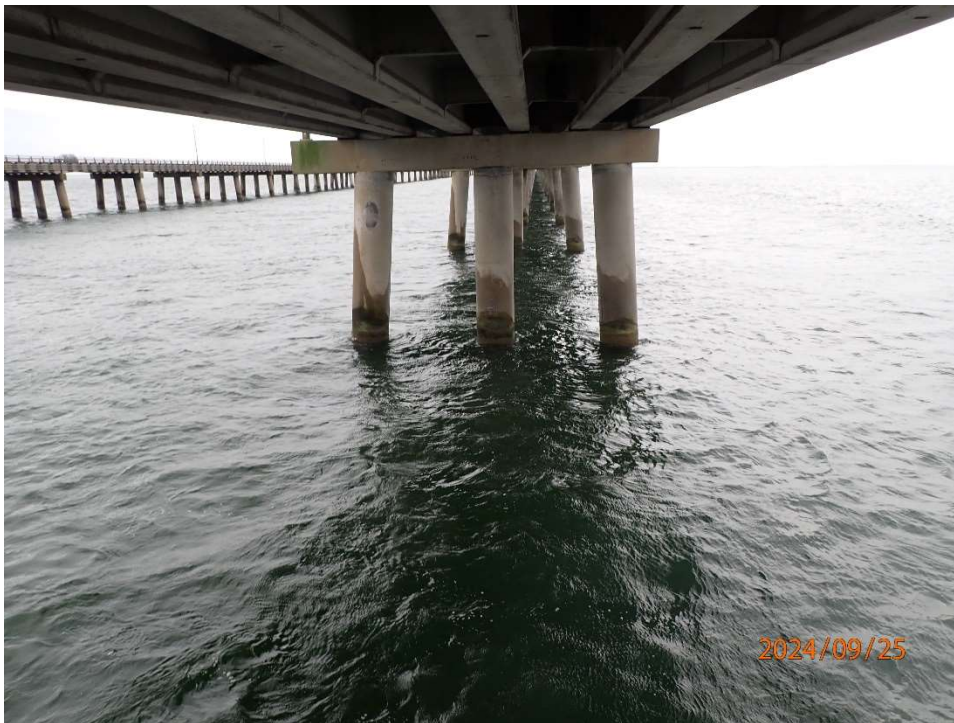
Photo 22: Superstructure in good condition.

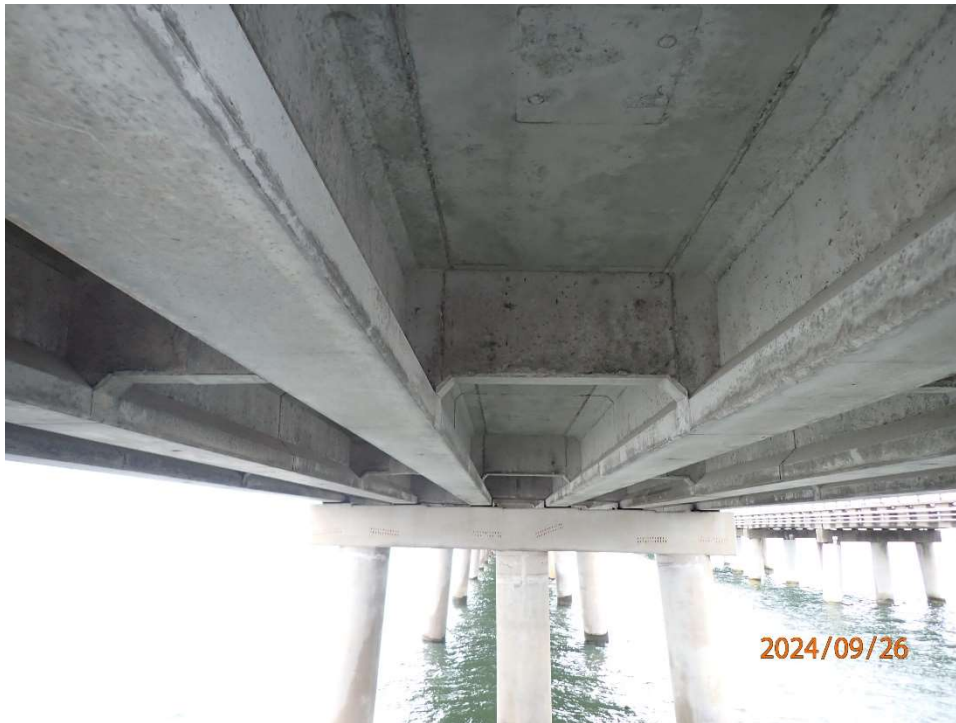
Photo 23: BSB96 Substructure in good condition.

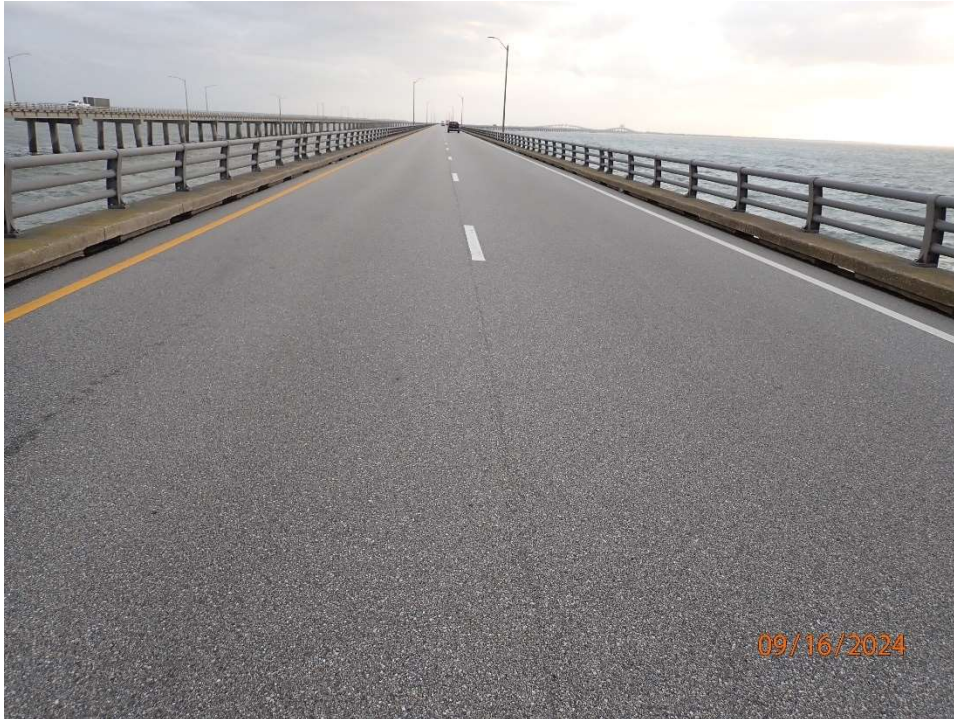
Photo 24: CNB199 Asphalt Wearing Surface – Typical Good Condition of Wearing Surface.

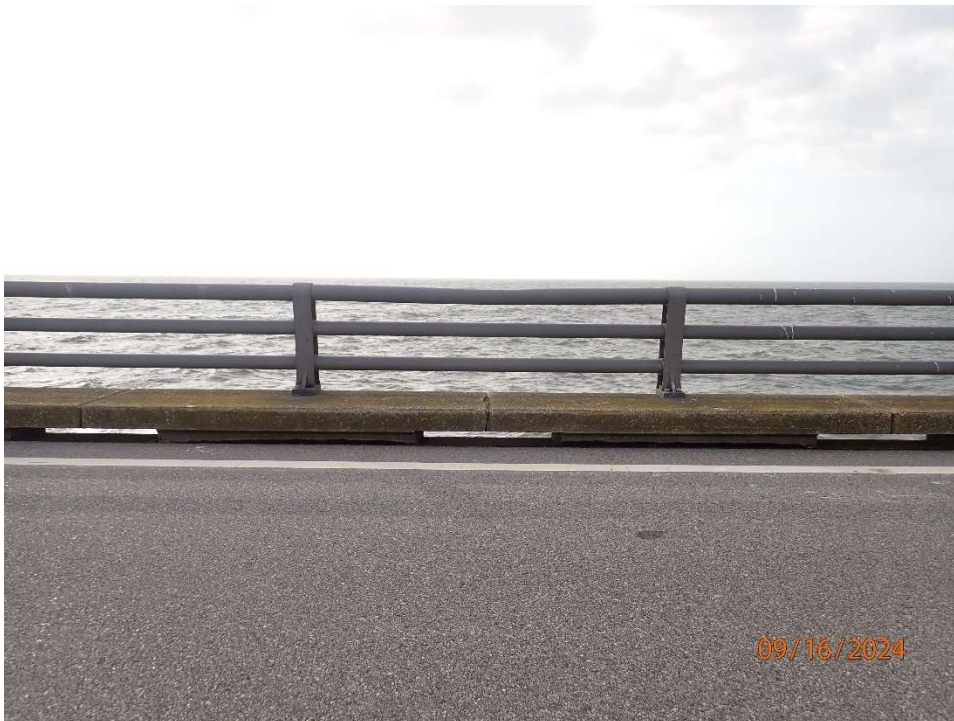
Photo 25: CNB201 Railing typically in good condition with minor impact damage at isolated locations.

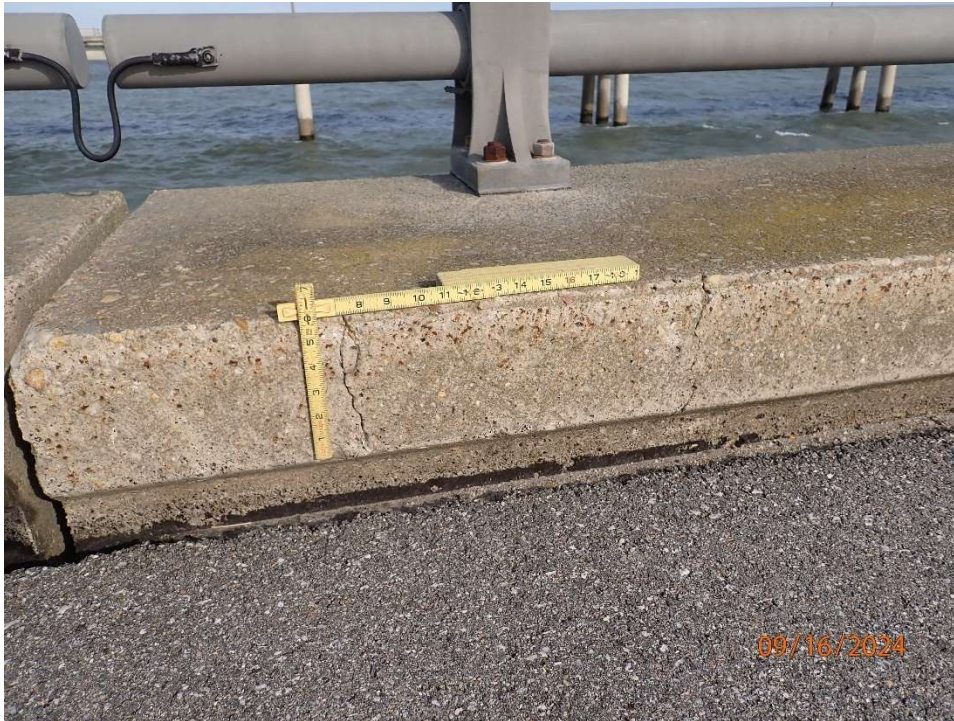
Photo 26: CNB203 Curb typically in good condition with minor cracking noted on face of curb at isolated locations.

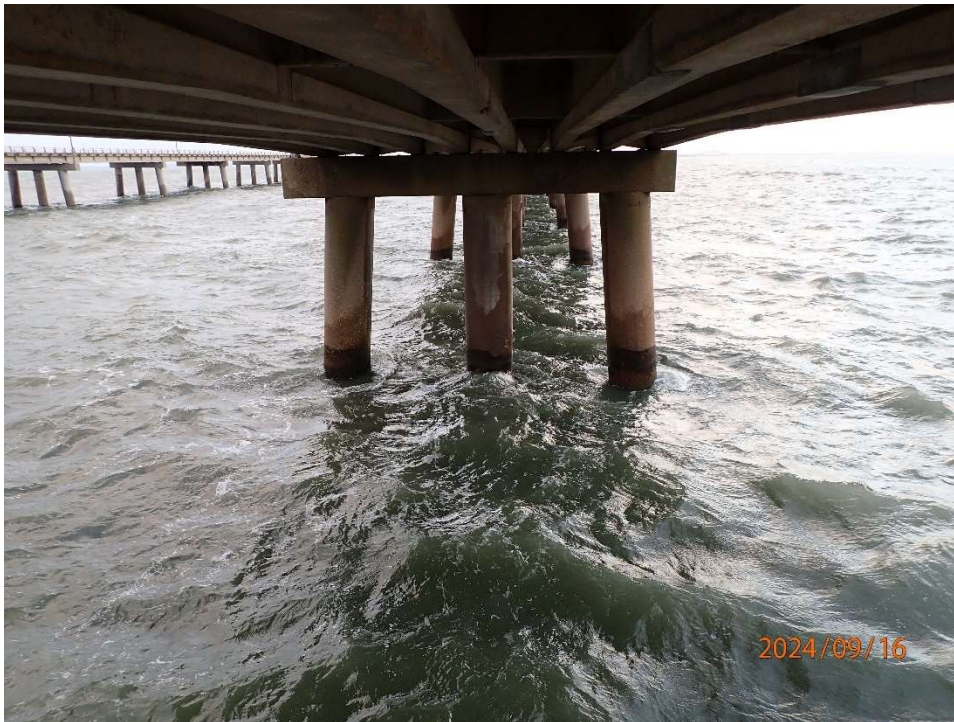
Photo 27: CNB198 Superstructure & Substructure in good condition.

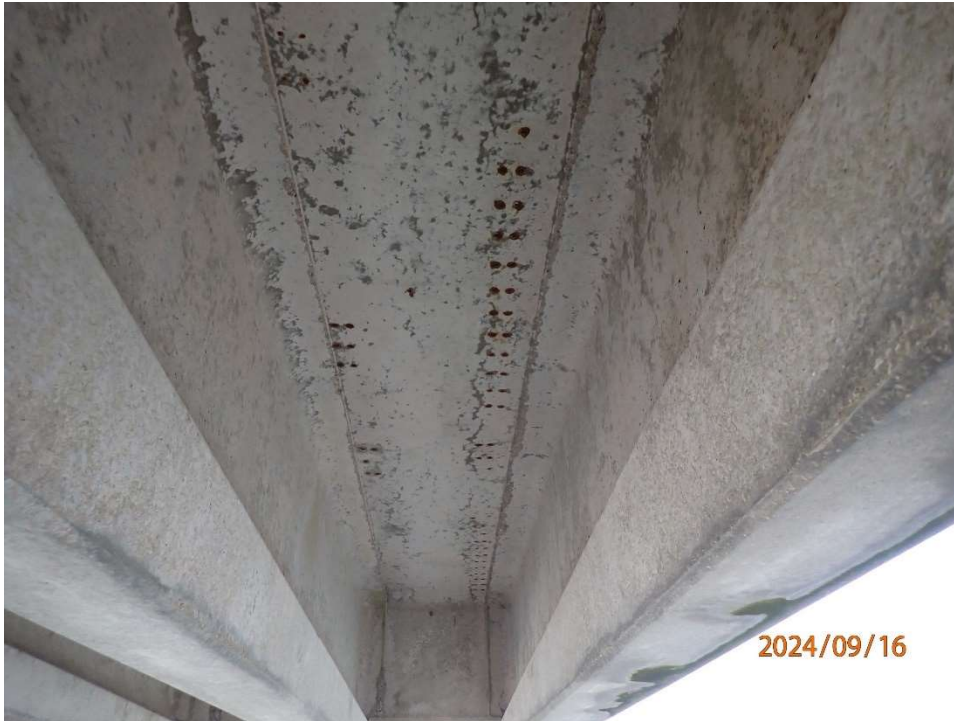
Photo 28: CNB197 Bay 7 typical underside of deck with exposed chairs at isolated areas.

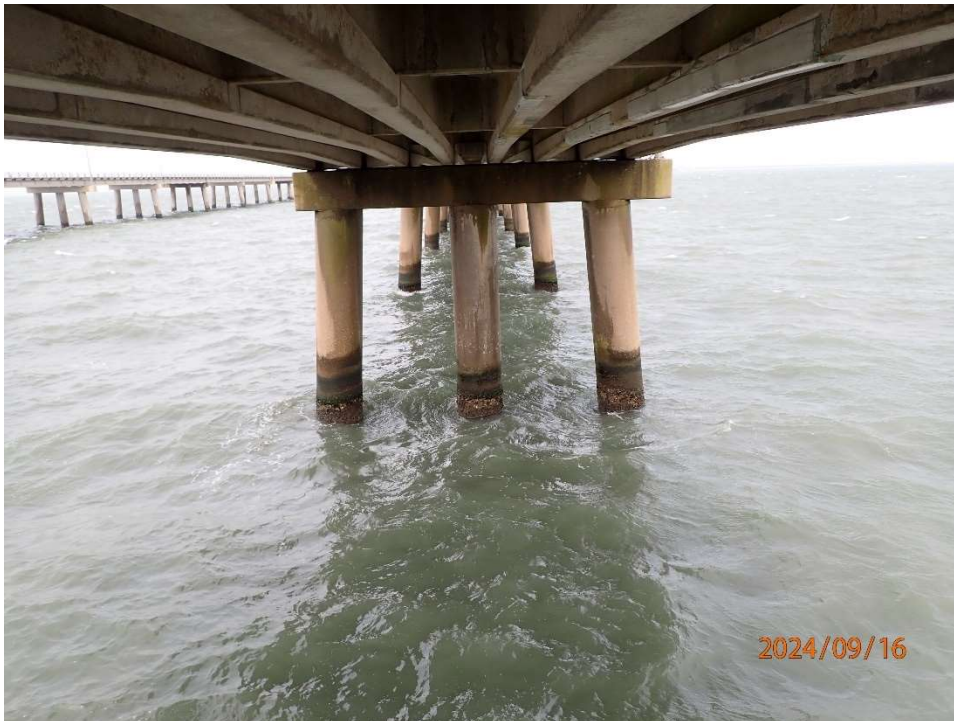
Photo 29: CNB213 Superstructure & Substructure in good condition.

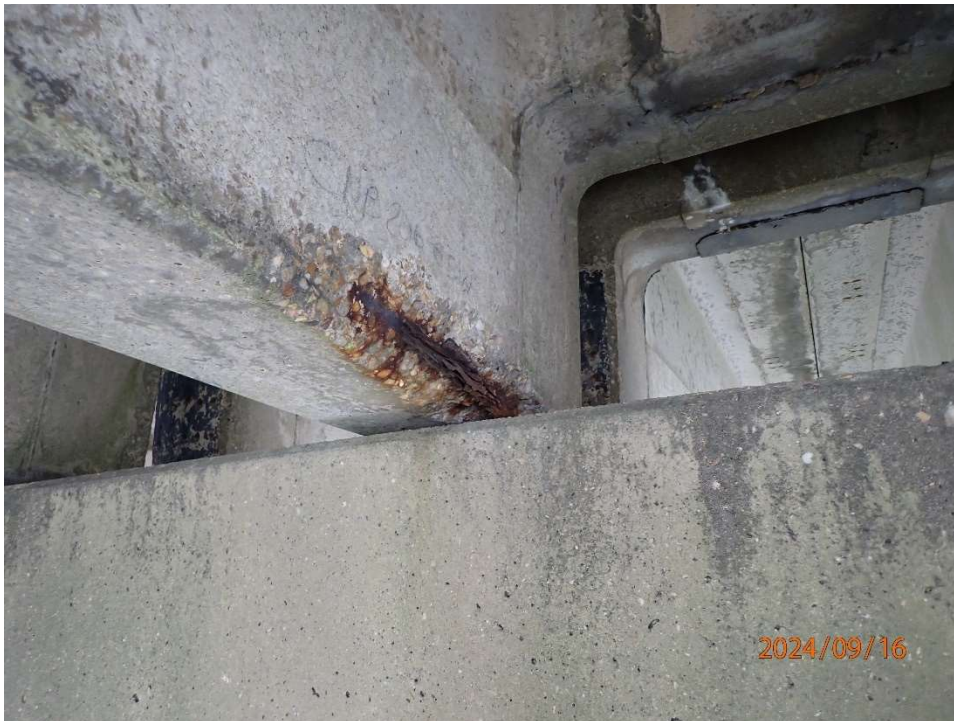
Photo 30: CNB206 Bent 207 Beam 5, Bay 4 – spall 30" L x 6" H x 5" under x 1" deep with exposed reinforcement with up to 100% section loss.

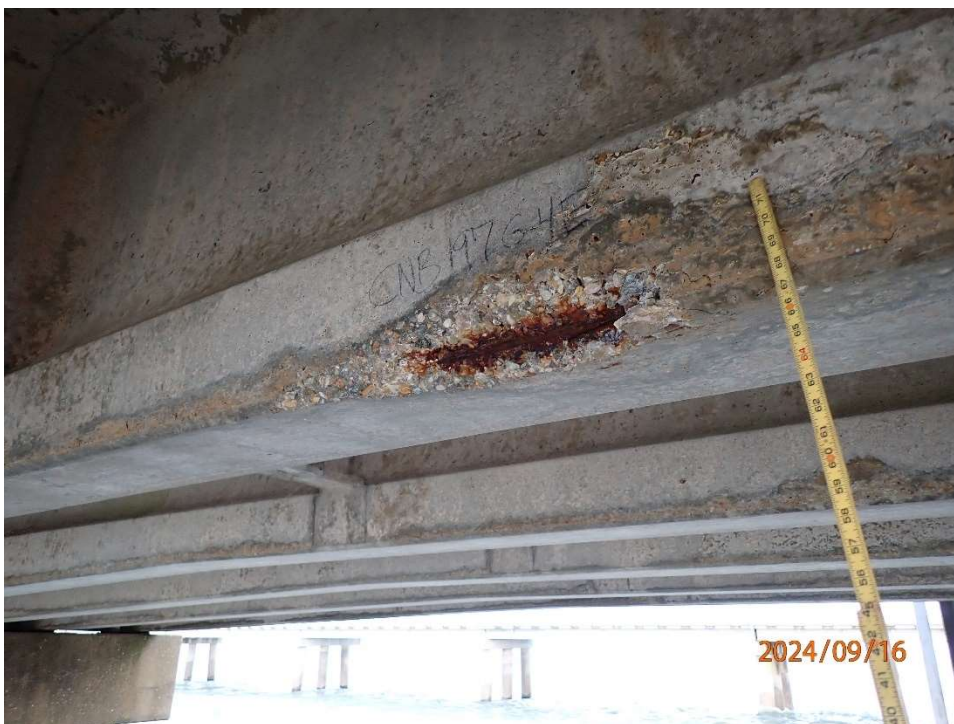
Photo 31: CNB197 Beam 4, Bay 3 1/3 span – spall 30" L x 5" H x 5" under x 1-1/2" deep with exposed prestressing strands with L1 having 10% loss of section.

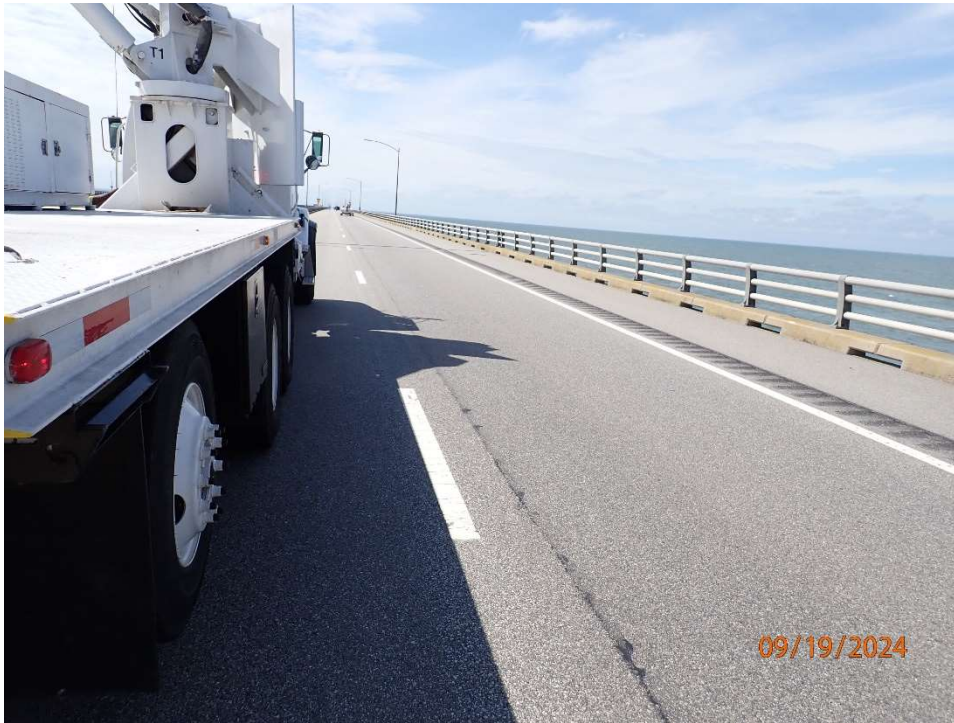
Photo 32: CSB97 Top of deck in good condition.
