moffatt & nichol
Creative People, Practical Solutions.®

FY2025 Annual Inspection and Underwater Inspection

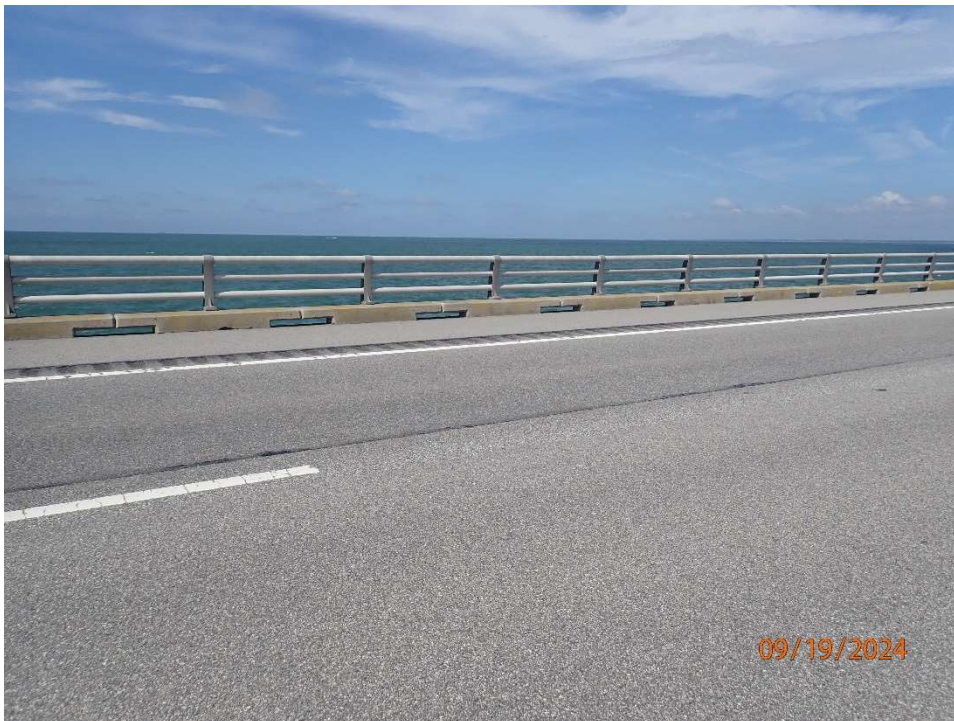
Photo 33: CSB90 Metal Bridge Railing— Typical Good Condition of Bridge Railing.

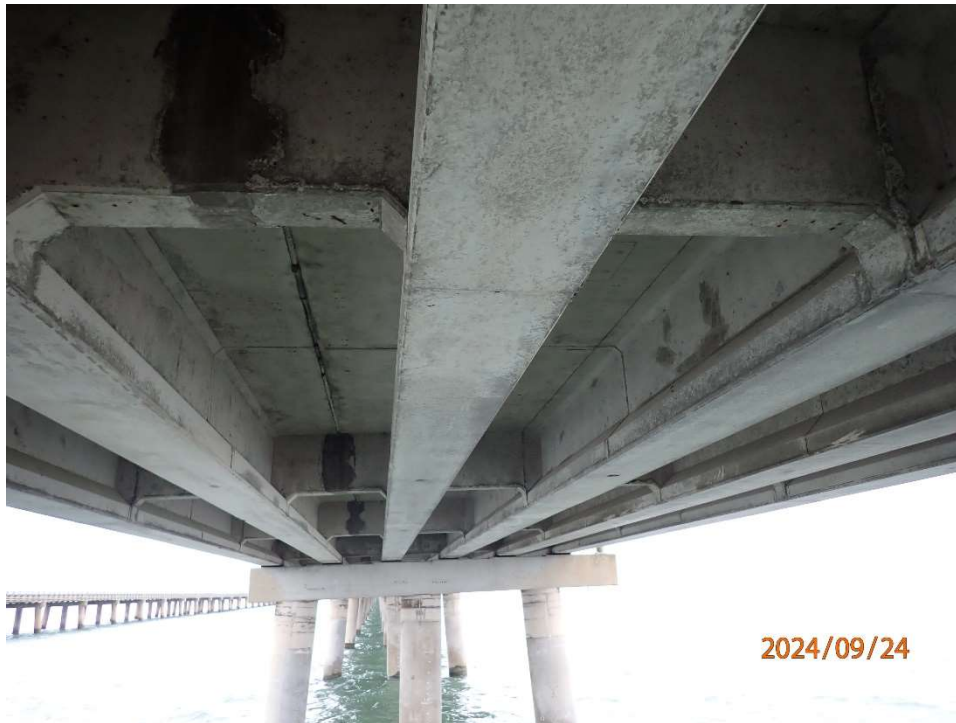
Photo 34: CSB91 Superstructure and Substructure in good condition.

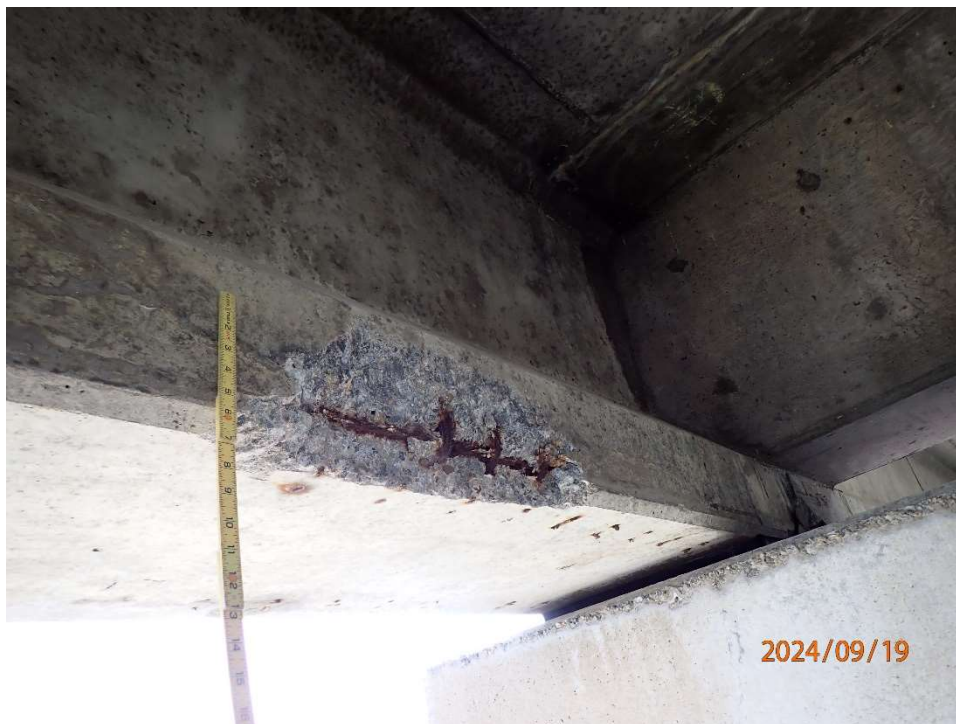
Photo 35: CSB90 Prestressed Girder 1 spall with exposed prestressing (L1) and reinforcement. Spall measures 2' L x 7" H x 2" under x 1-1/2" deep with 20% section loss to prestressing strand and reinforcement.

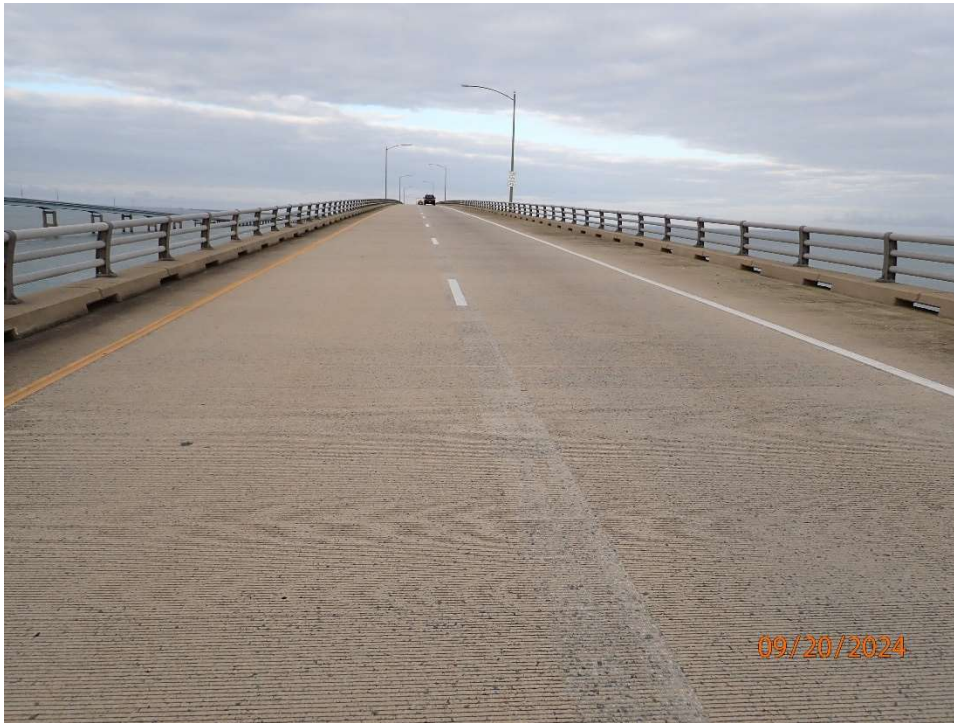
Photo 36: NCB-SB Deck and Wearing Surface – General Good Condition (Looking South)

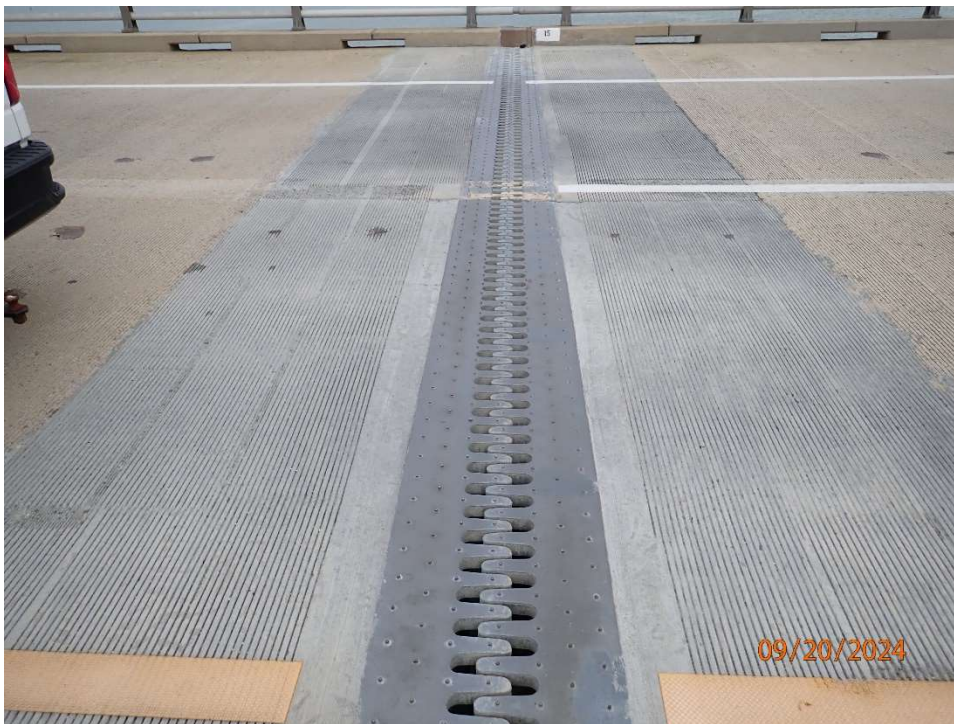
Photo 37: Modular Joint Seal – Typical Good Condition of Joint and Adjacent Deck Header, Pier 10 Shown (Looking West)

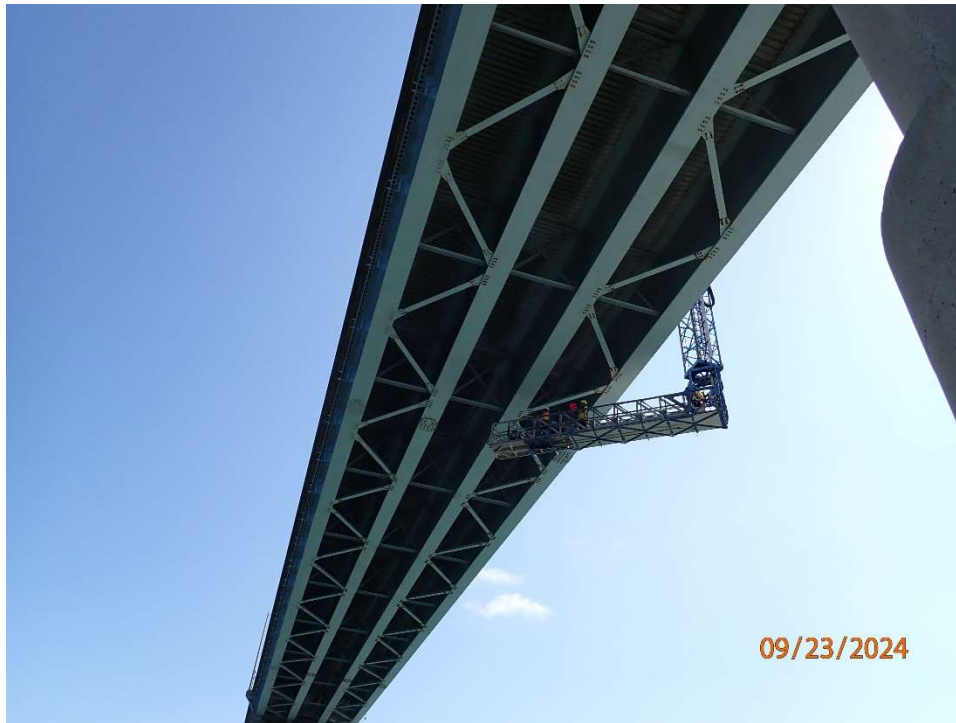
Photo 38: Superstructure – General Condition of Steel Superstructure

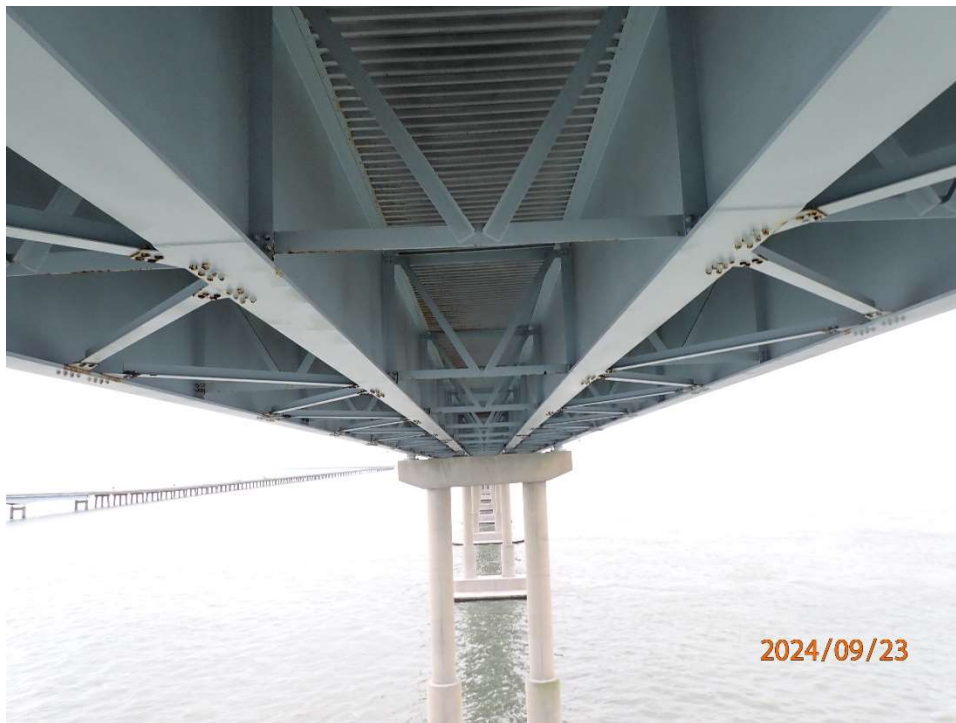
Photo 39: Superstructure – General Condition of Steel Superstructure in fair condition.

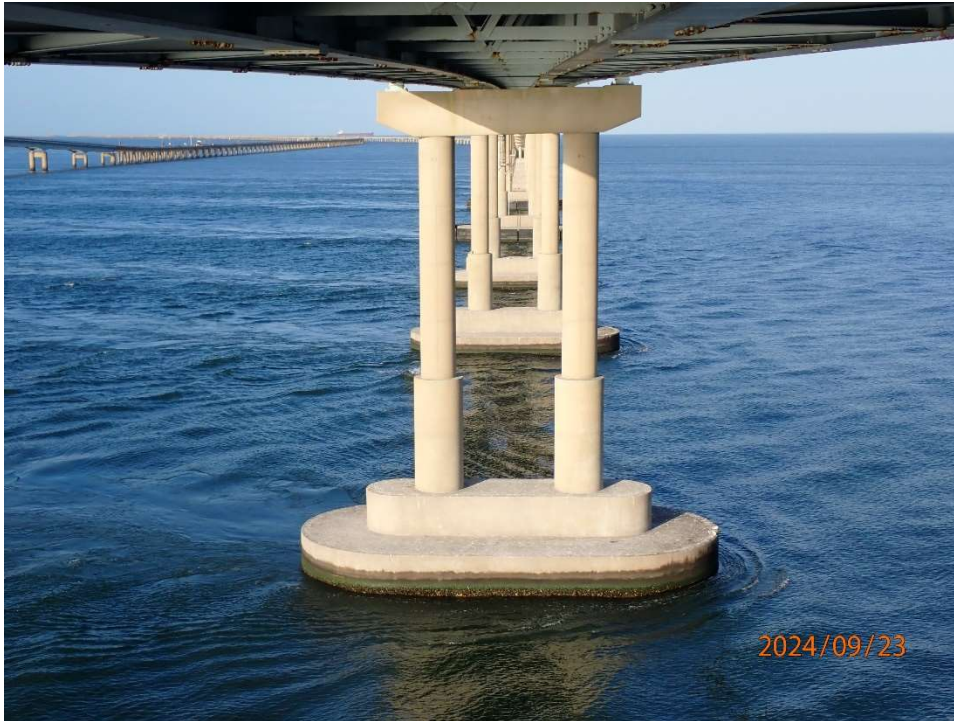
Photo 40: Substructure – General Condition of Pier Substructure

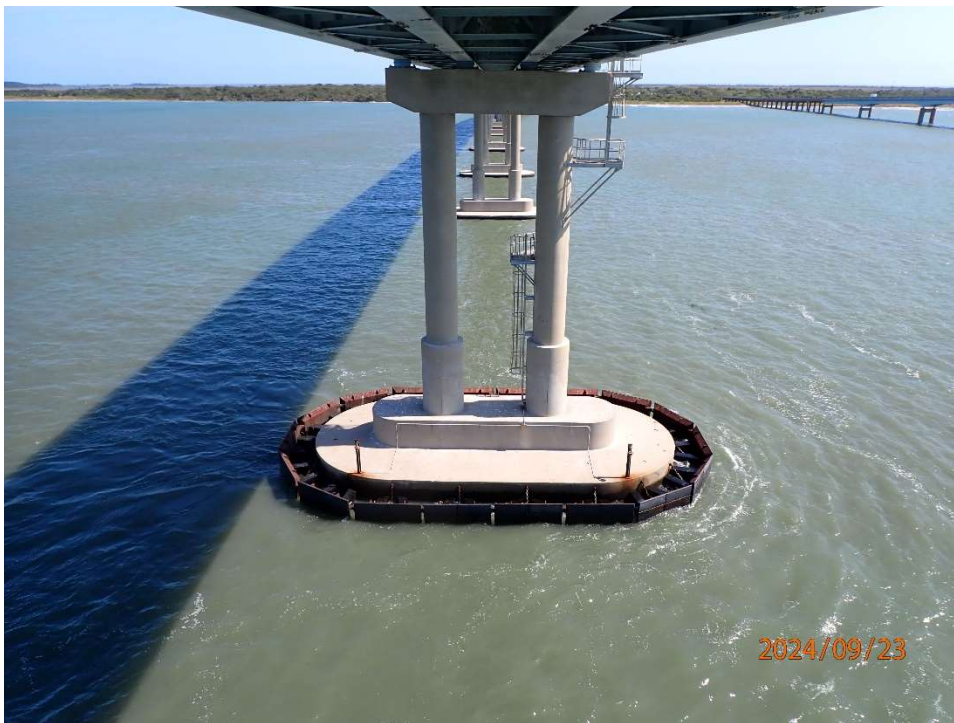
Photo 41: Fender System – Typical Condition of Pier Footing and Fender System.

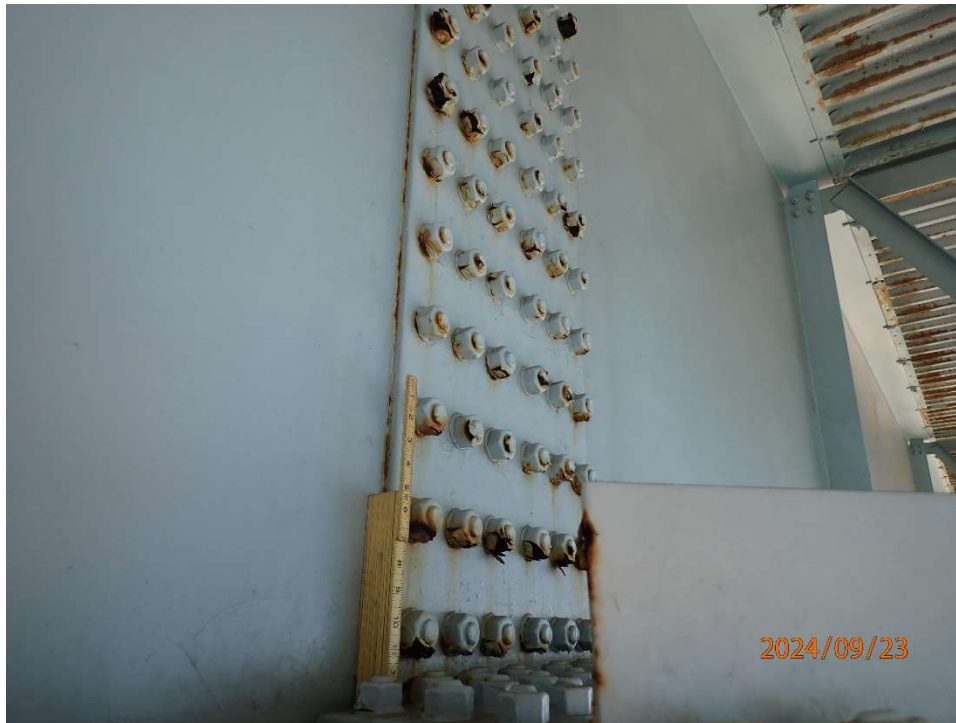
Photo 42: Superstructure – Blistering paint and corrosion on bolted connections.

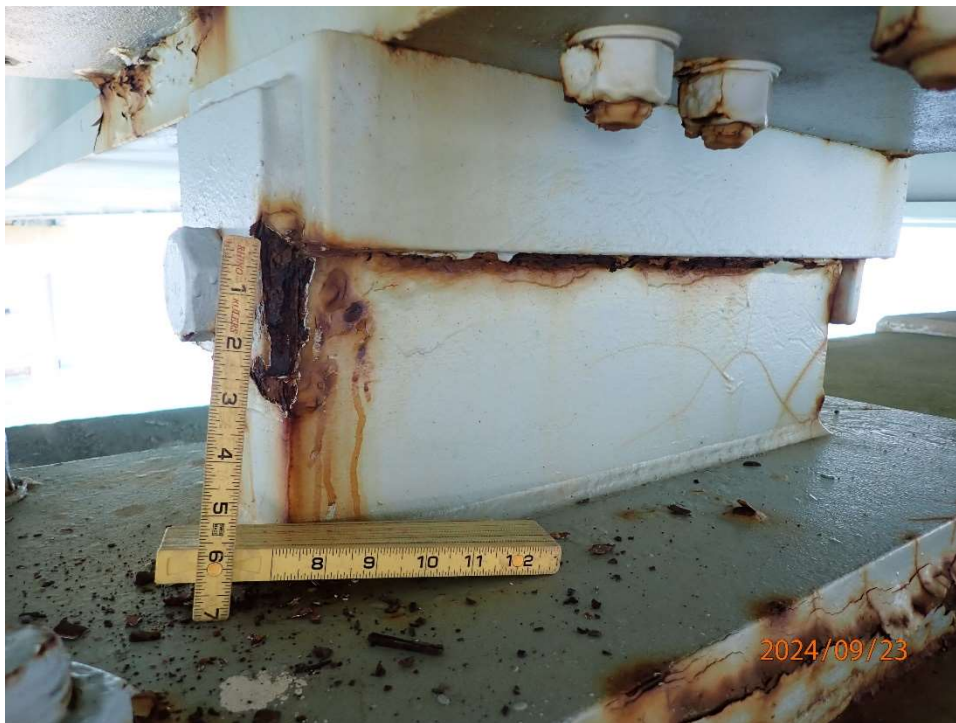
Photo 43: NCB-SB5 Bearings – Typical Peeling Paint with Surface Corrosion at Bearings (Looking Southeast)

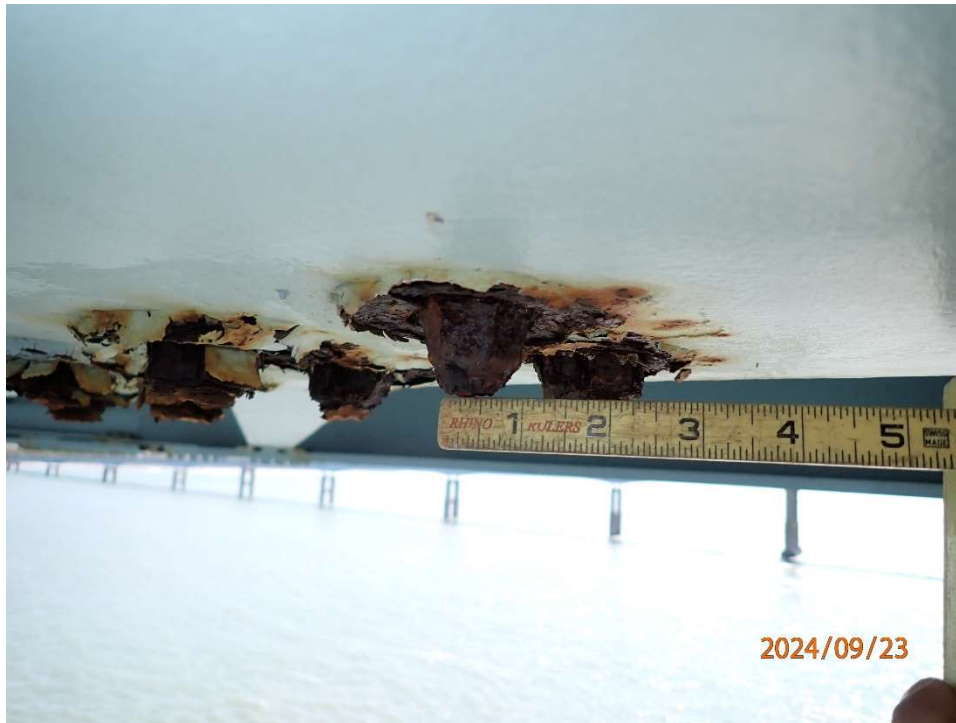
Photo 44 : NCB-SB – Typical Peeling Paint with Surface Corrosion and mushrooming of nuts on flange bolts.

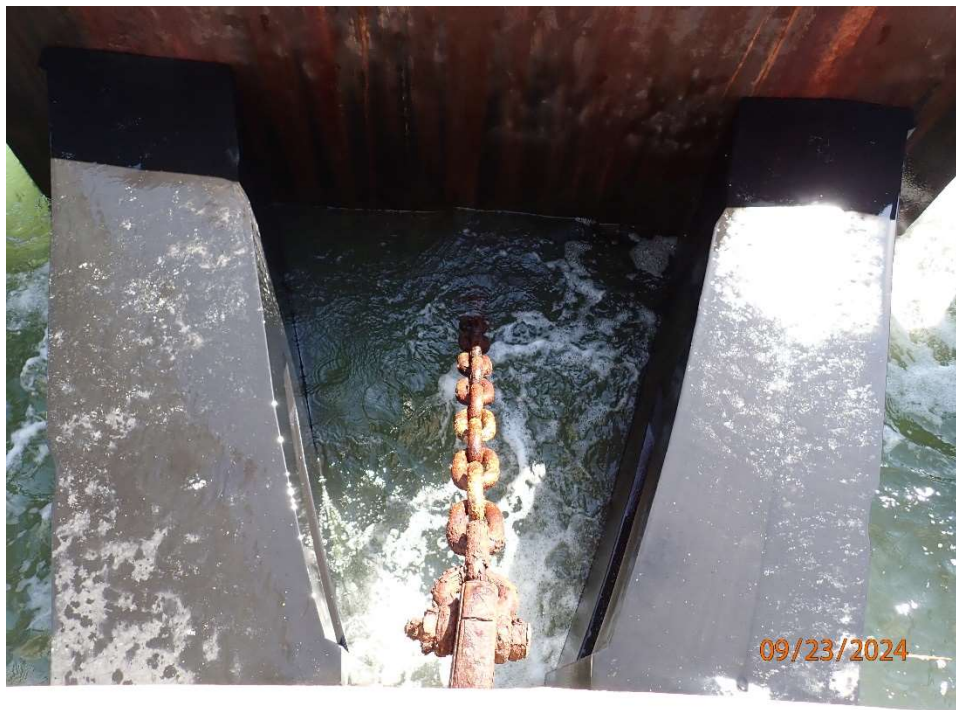
Photo 45: Fender System – Typical Minor Corrosion of Chain between Pier 9 Footing and Fender System (Looking South)

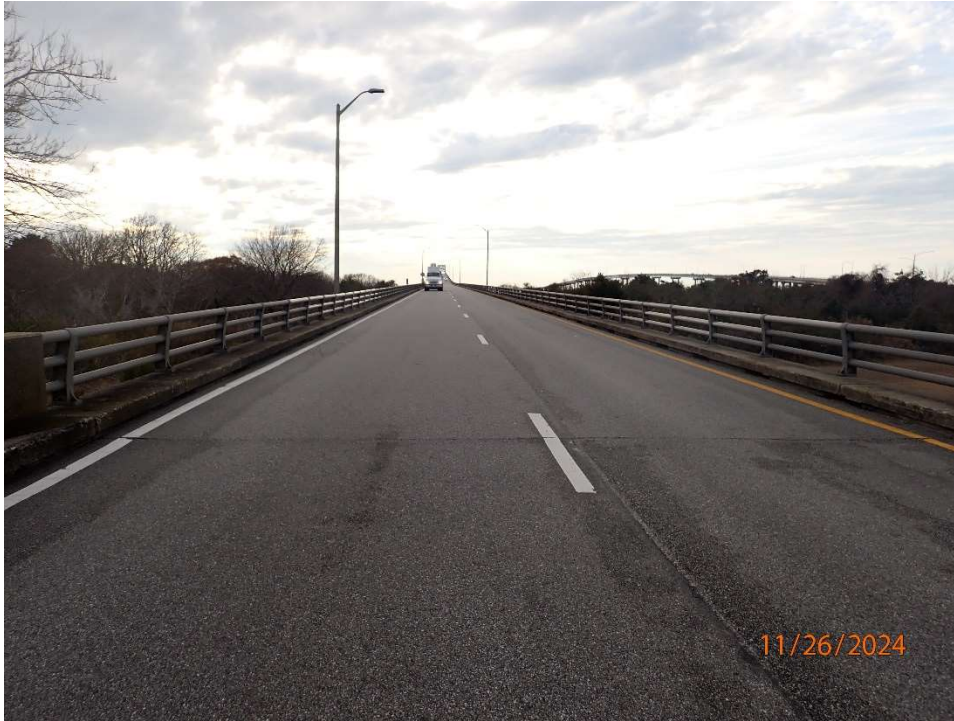
Photo 46: DNB Wearing Surface - General Good Condition of Deck and Wearing Surface (Looking South)

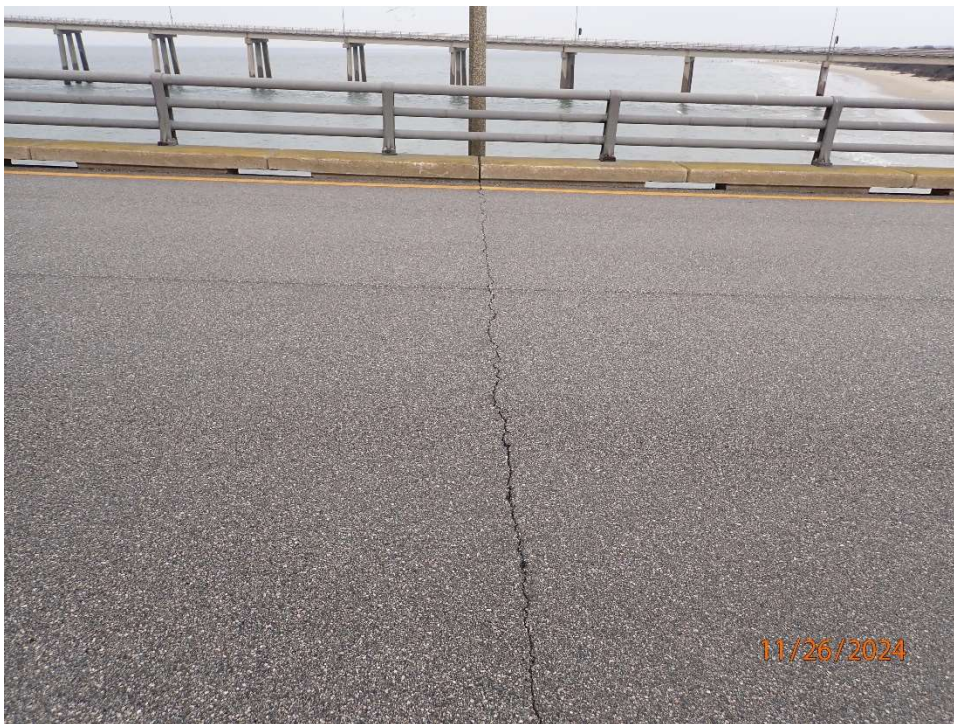
Photo 47: DNB2 Metal Bridge Railing & Expansion Joint - General Good Condition of Railing (Looking Northwest) and transverse crack over expansion joint.

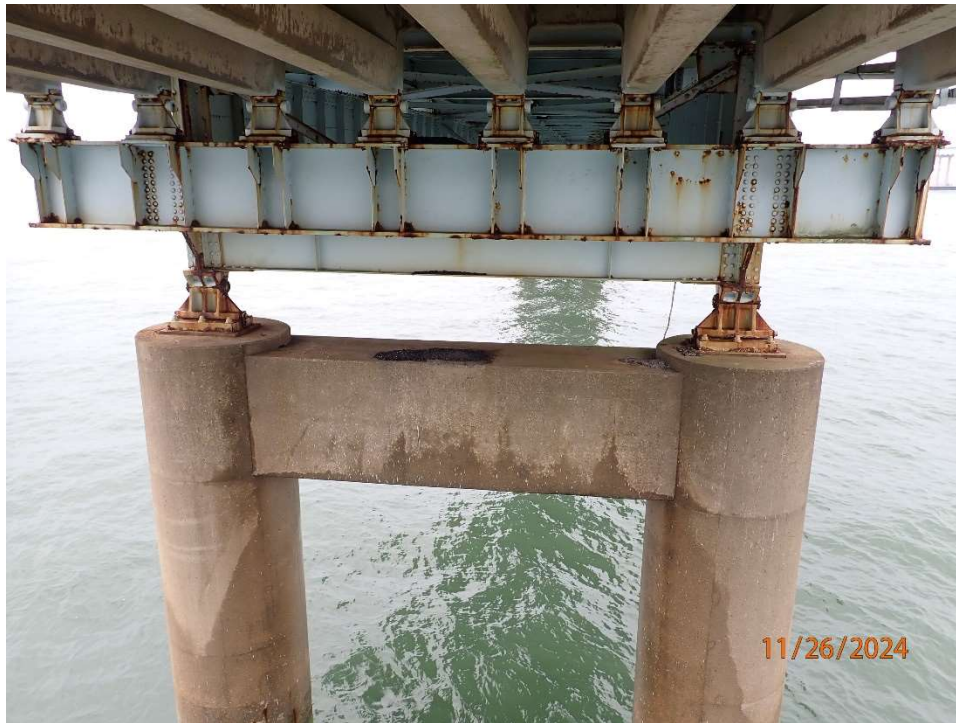
Photo 48: Superstructure – Typical condition of Superstructure with steel corrosion noted on up to 30% of surface area. Bearings in different degrees of expansion/contraction. Span 1 looking South.

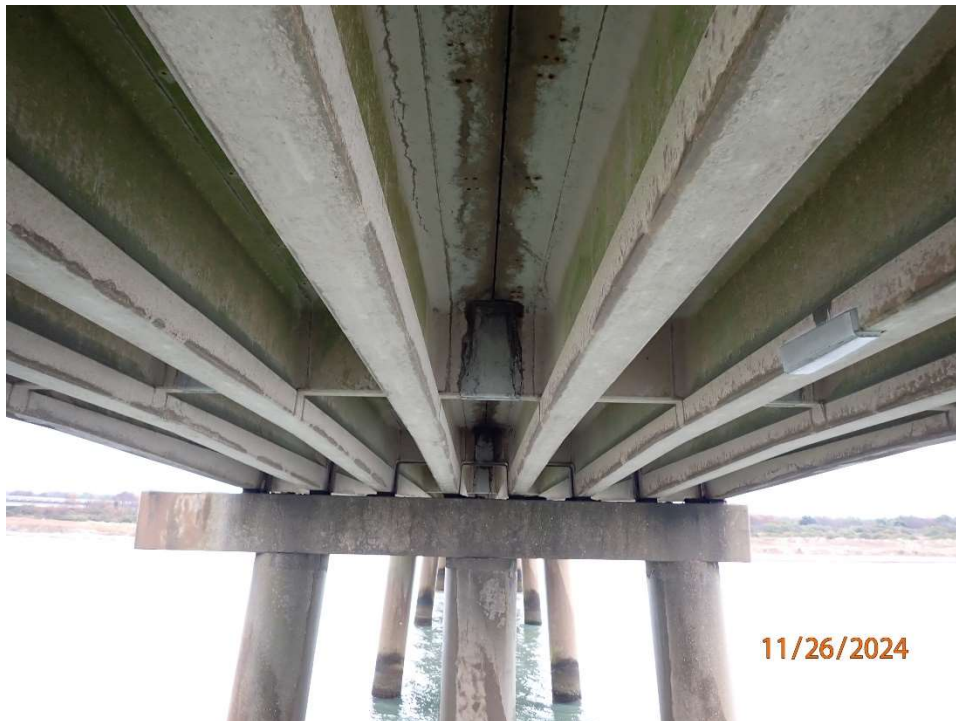
Photo 49: Superstructure and Substructure – Typical condition of Superstructure in Span 1 looking North.

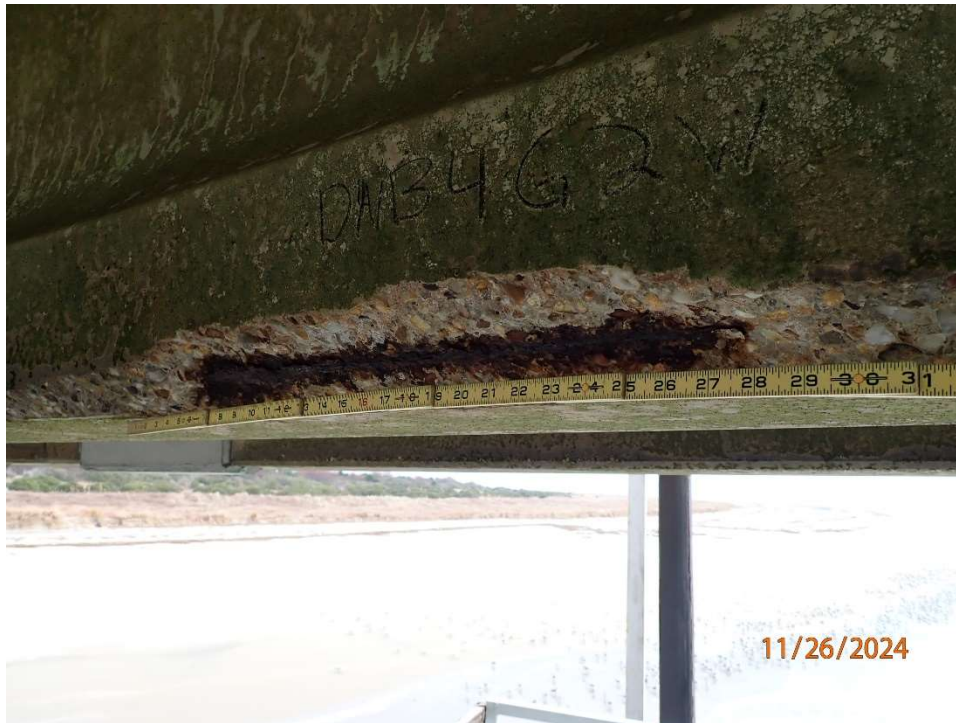
Photo 50: DNB-4 G2, Beam 2 Bay midspan 3' long x 6" high x 4" under with 1 exposed prestressing strand (L1) up to 50% section loss.

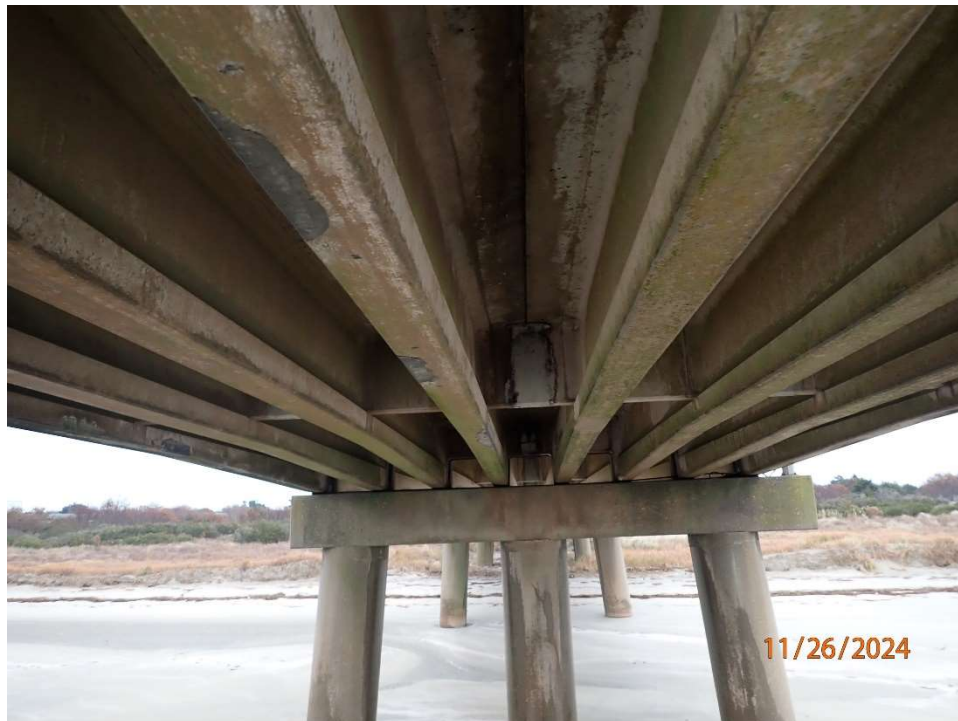
Photo 51: Superstructure & Substructure – Typical Good Condition of Beam and Piles (Span 5), Looking North.

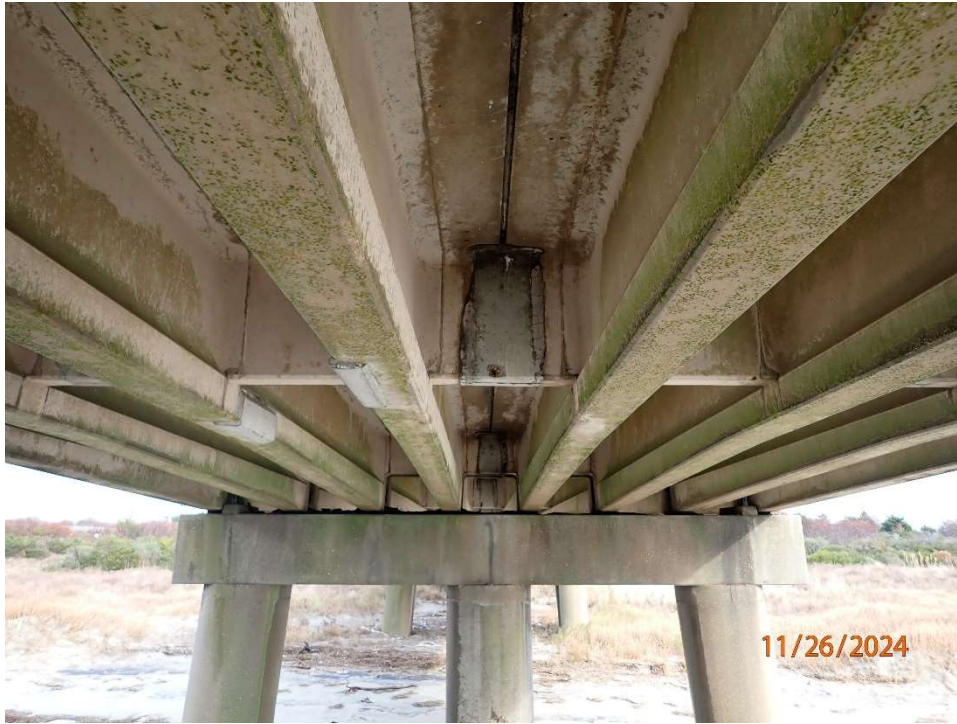
Photo 52: Typical Good Repair Patch on bottom of girder in Span 6 in 2 locations. Looking North.

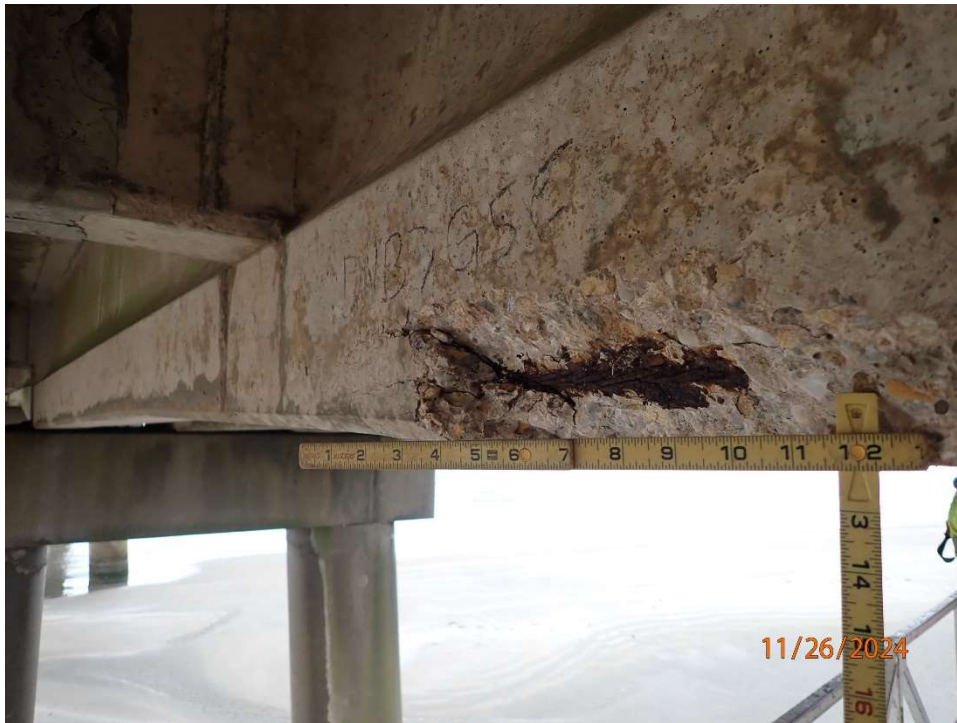
Photo 53: Prestressed Concrete Girders, DNB-7 G5, Beam 5 midspan 3' long x 5" high x 5" under x 2" deep with 1 exposed prestressing strand up to 100% section loss.

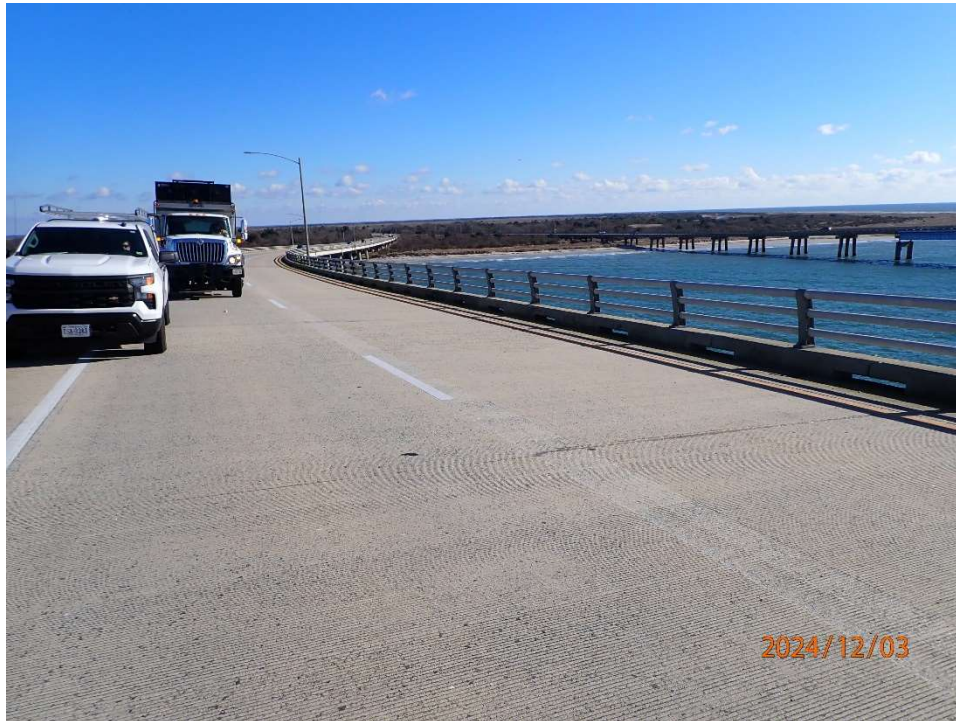
Photo 55 – DSB2 Deck in good condition with up to 1/16" wide cracking at isolated locations.

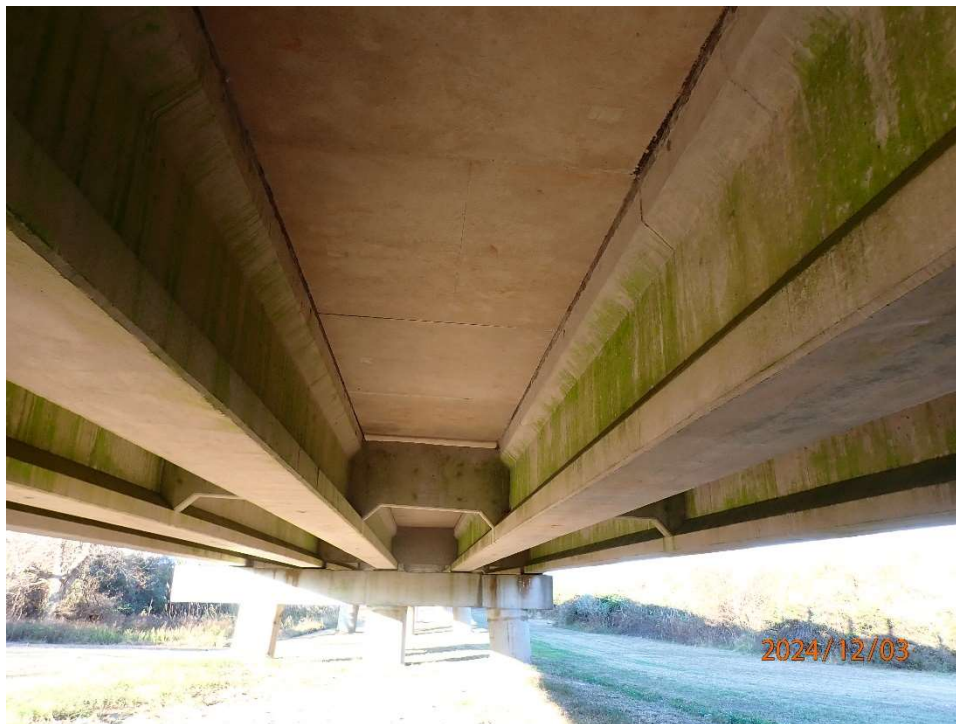
Photo 56 – DSB20 Superstructure in good condition. (Typical)

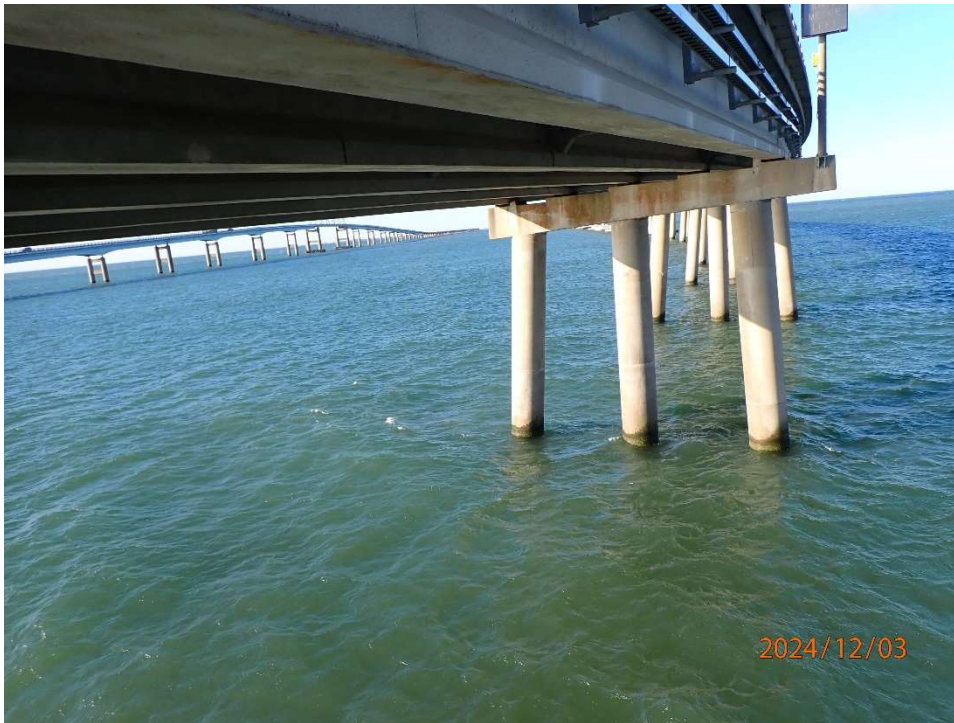
Photo 57 – DSB9 Bent in good condition (typical)

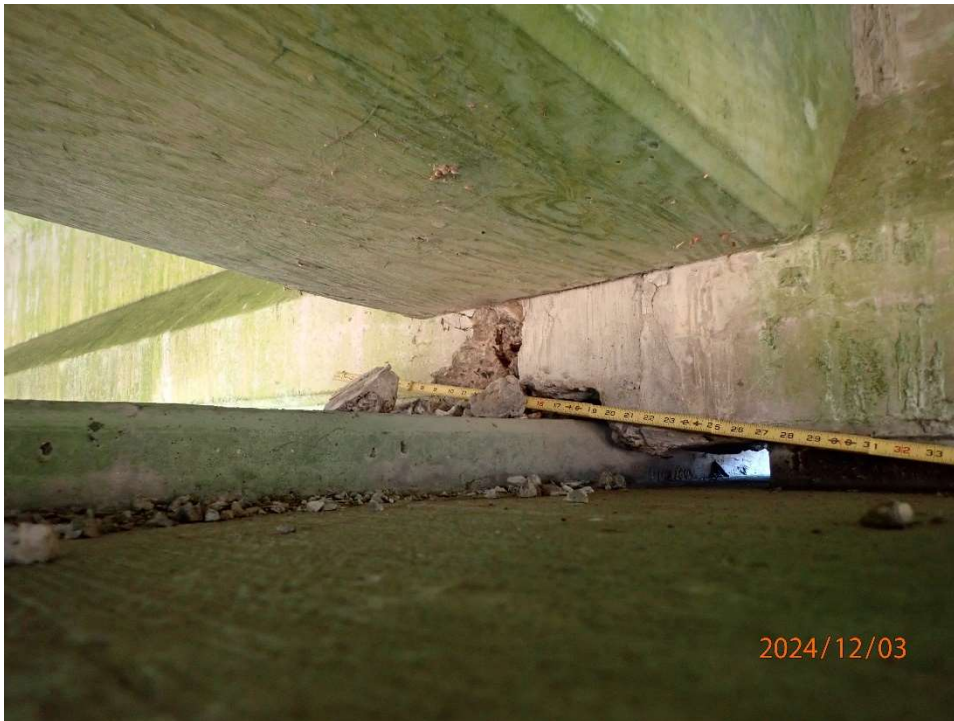
Photo 58: DSB20 Bent 20 Beam 5 Bay 4 with beam end spall; spall up to 6" H x 6" L x 4" Deep with exposed reinforcement. Spalls noted at isolated locations.

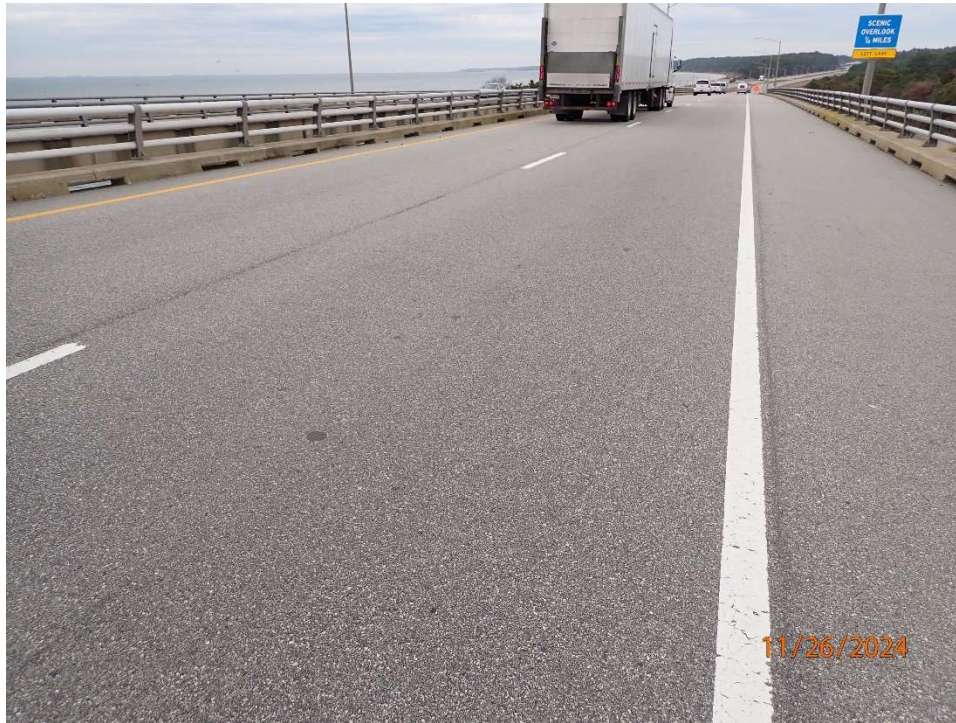
Photo 59: FNB2 - Wearing surface in good condition.

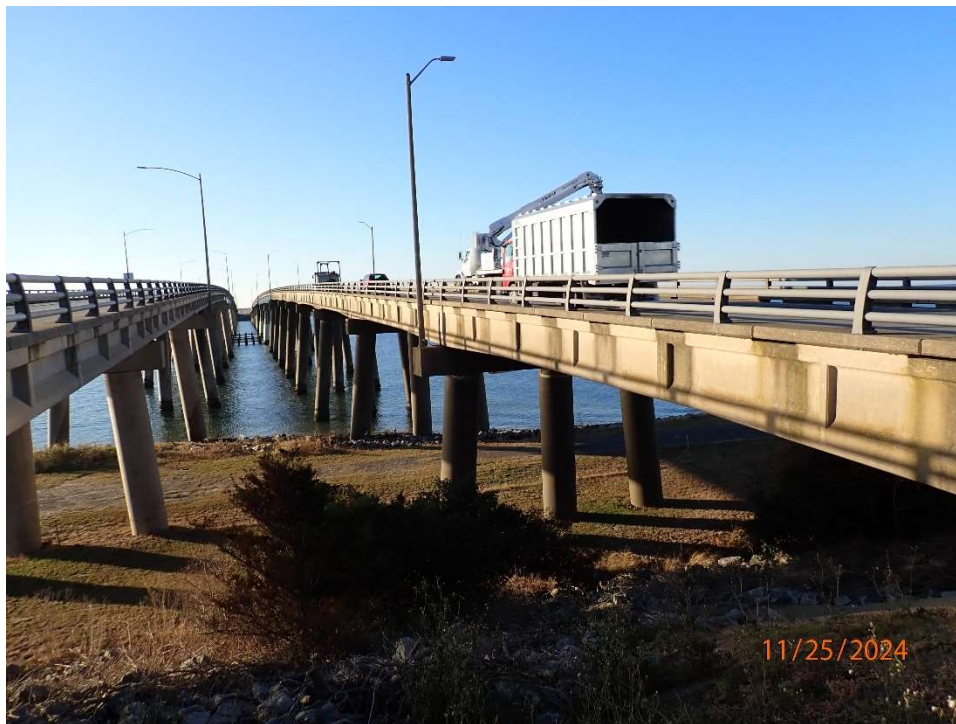
Photo 60: Elevation view of FIBNB and FIBSB.

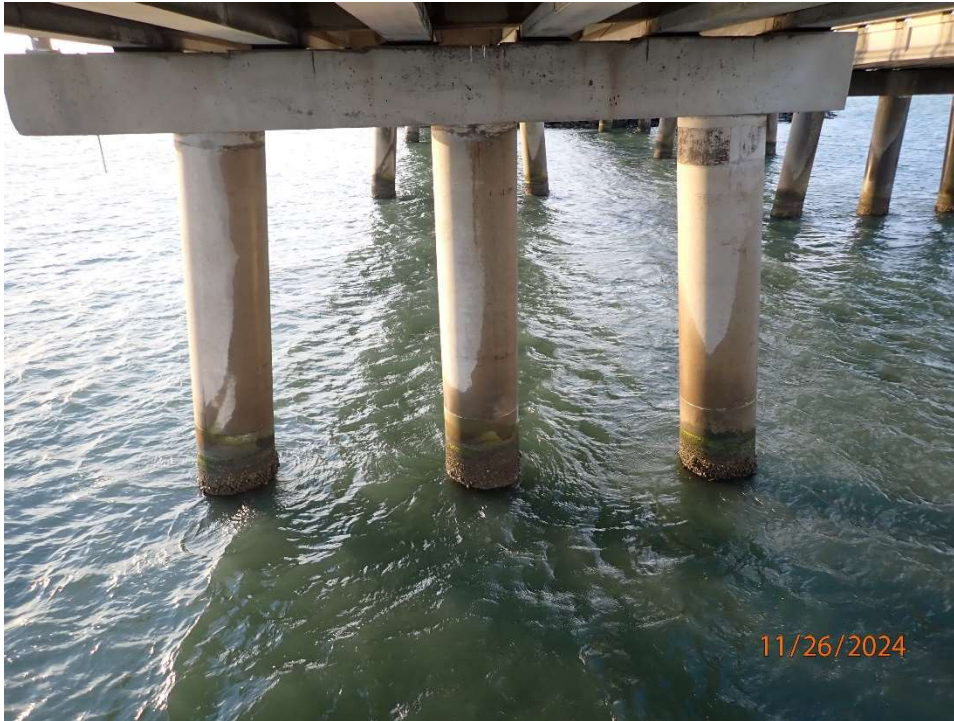
Photo 61: ENB4 Substructure in good condition.

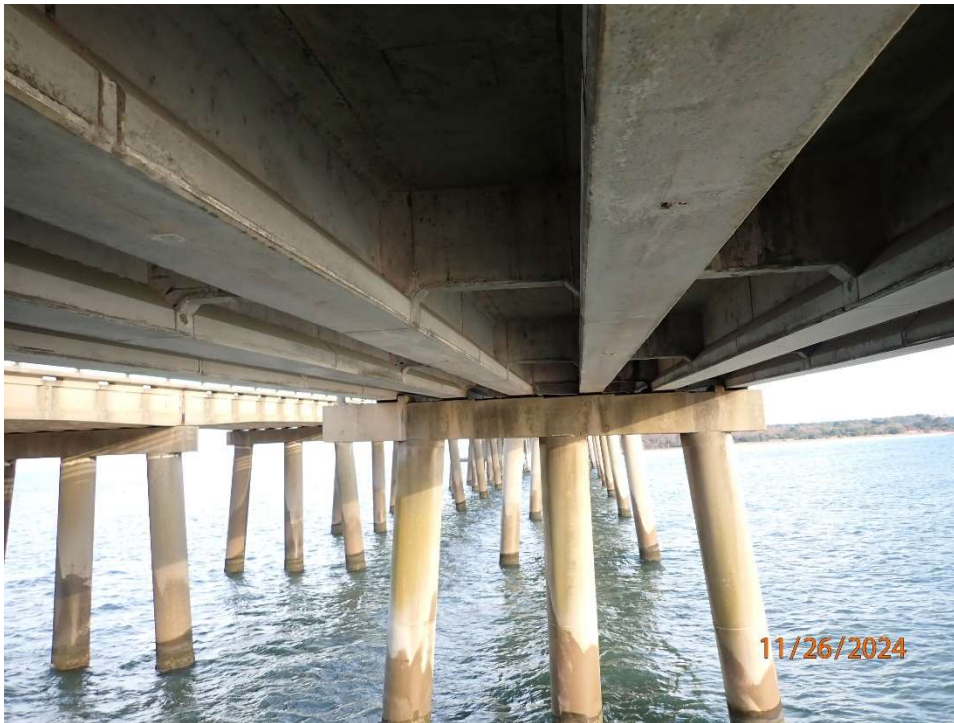
Photo 62: ENB5 Superstructure in good condition.

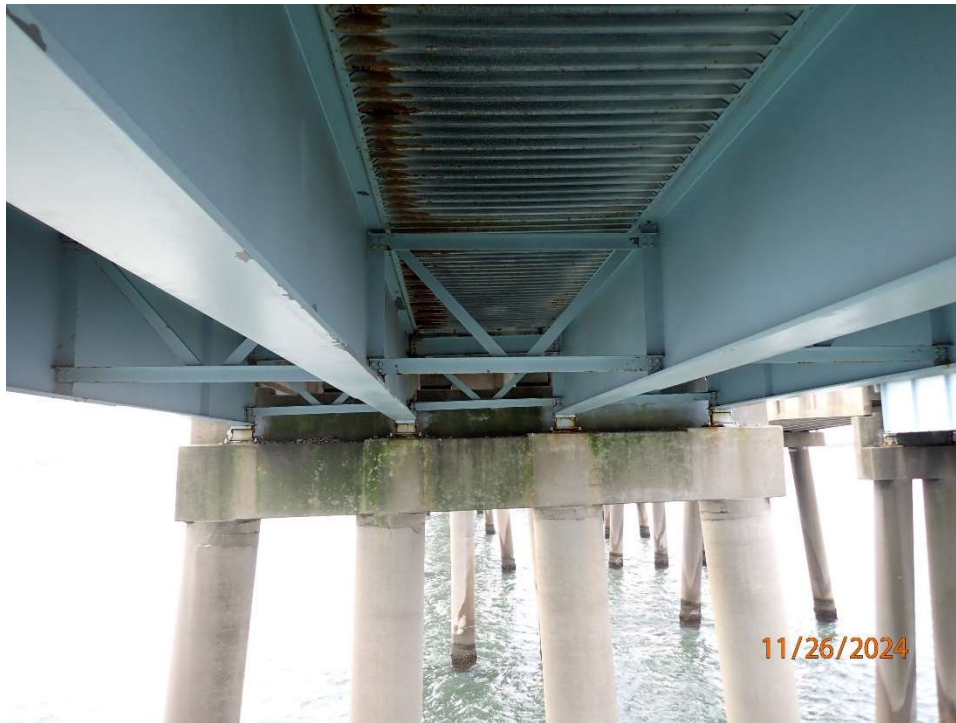
Photo 63: FIBNB1 Superstructure in good condition with isolated coating loss and surface corrosion.

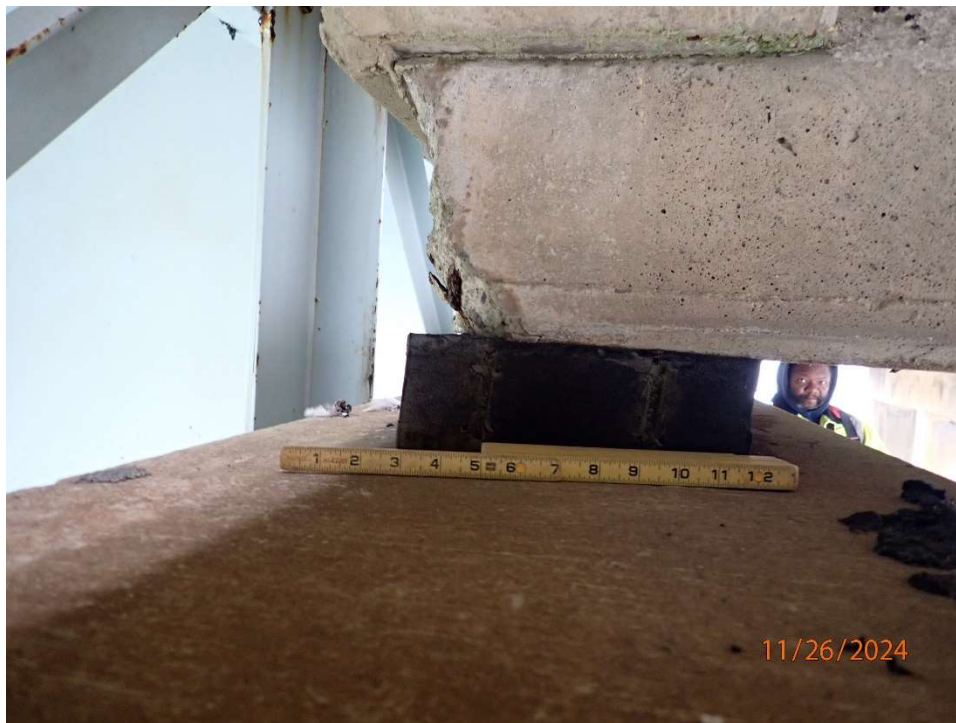
Photo 64: FIBNB4 G4 beam end spall 5" L x 8" H with up to 5% section loss on bearing area.

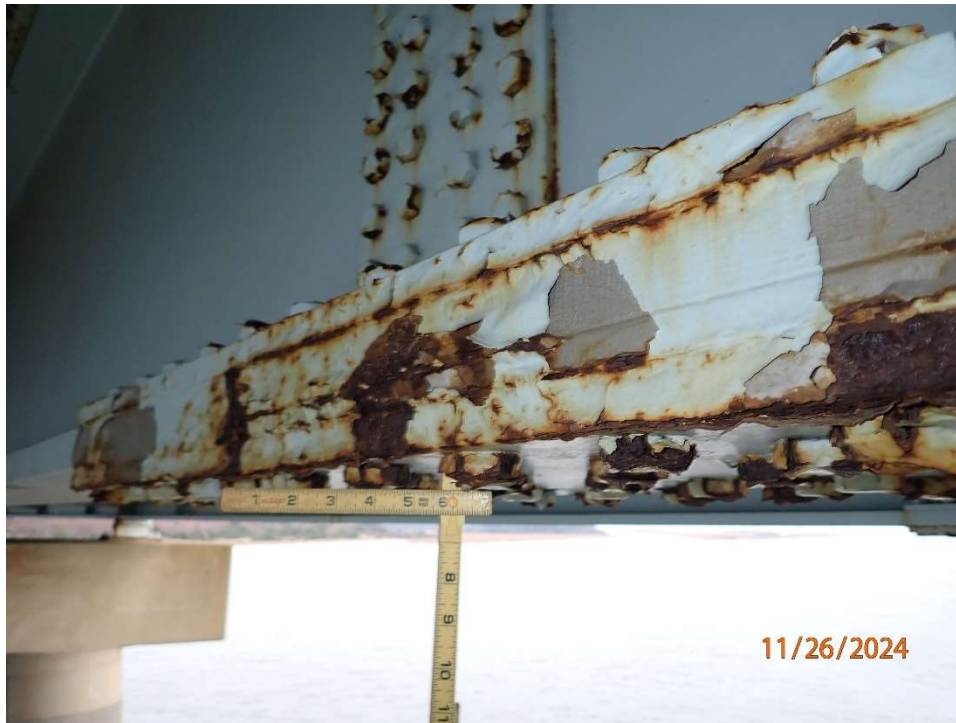
Photo 65: FINB1 Steel Superstructure at splice plate with blistering paint with surface corrosion.
