moffatt & nichol
Creative People, Practical Solutions.®

FY2025 Annual Inspection and Underwater Inspection

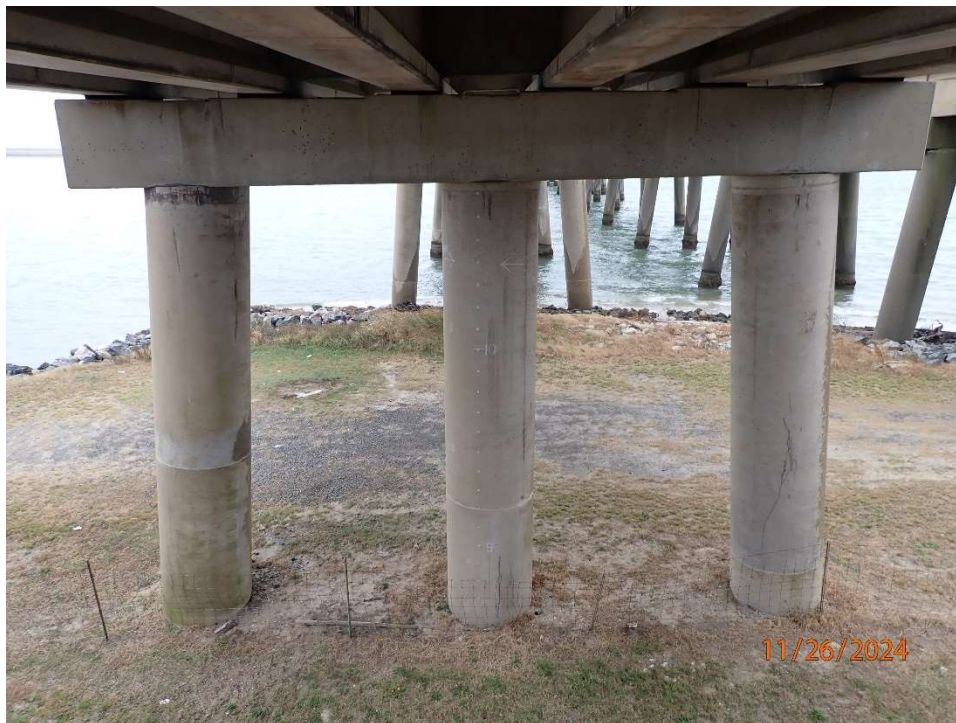
Photo 66: FNB6 Substructure in good condition.

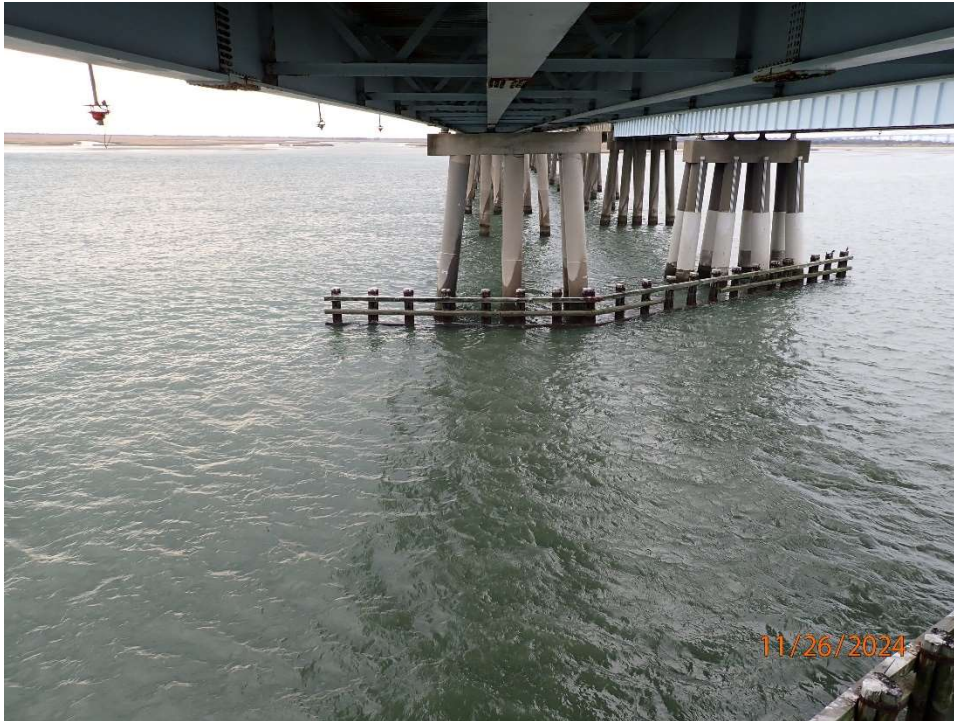
Photo 67: FINB2 Substructure and fender system in small boat channel.

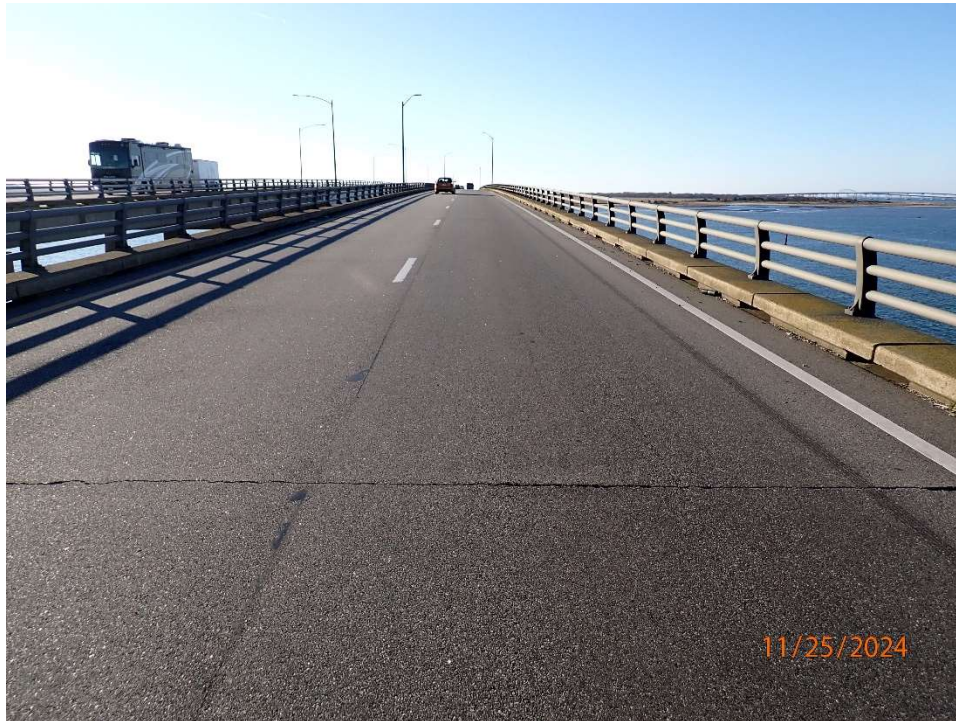
Photo 68: FSB4 Wearing surface in good condition.

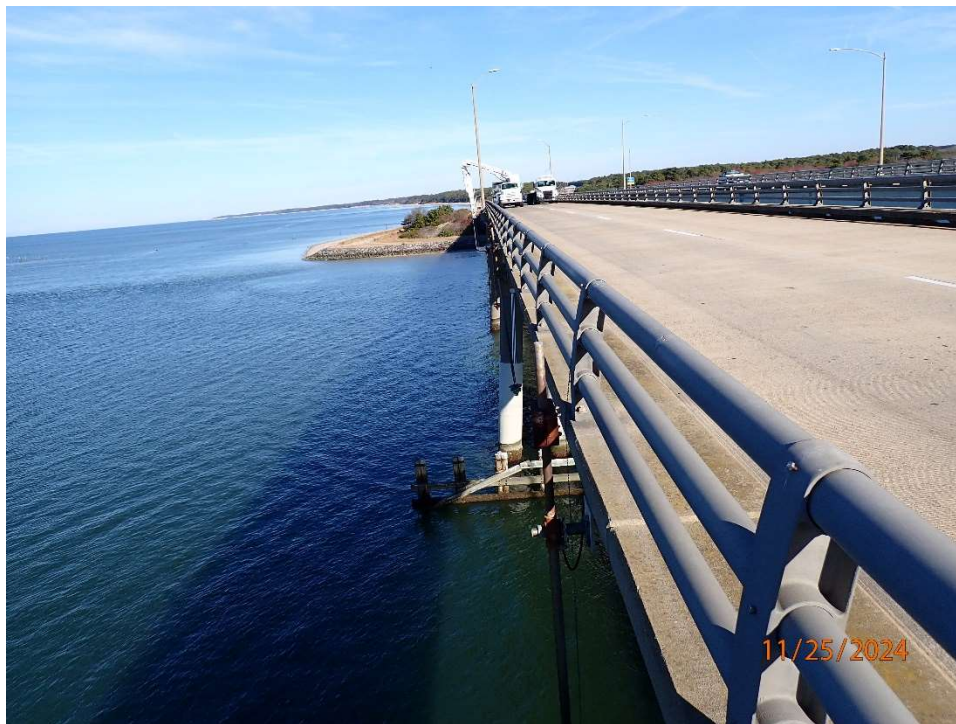
Photo 69: FIBSB2 Railing in good condition and navigation lights with light surface rust.

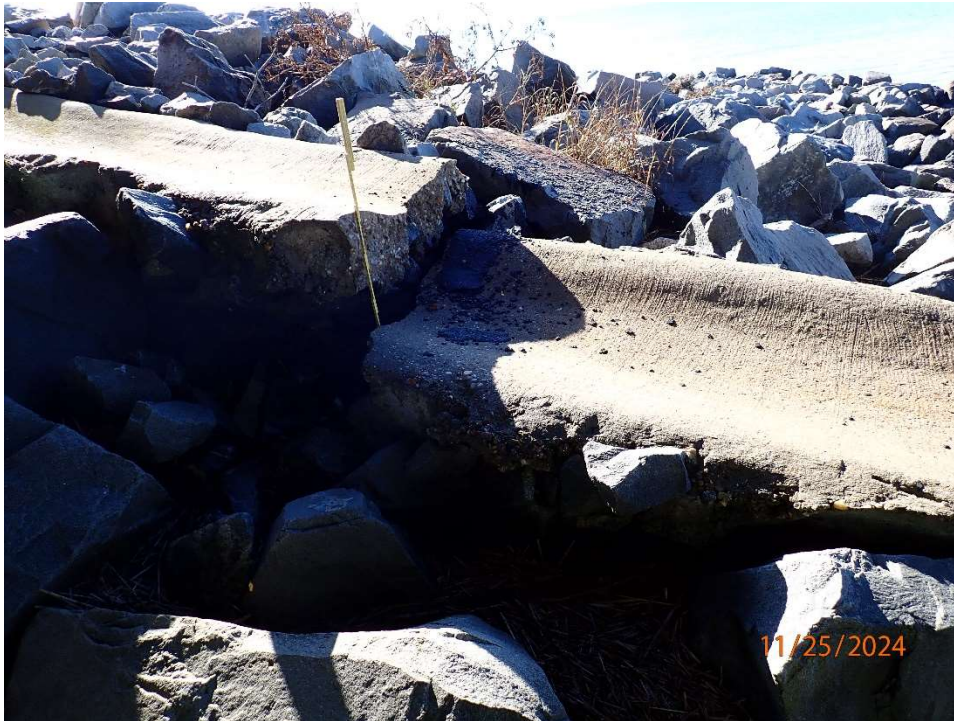
Photo 70: Abutment – drainage swale on west end settled and disconnected.

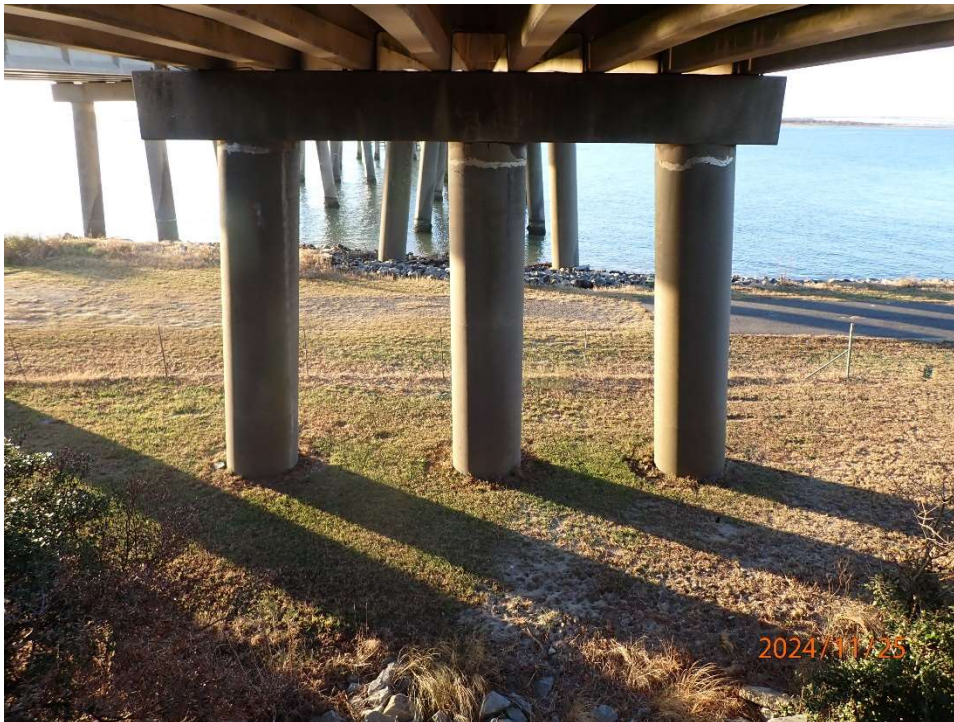
Photo 71: FSB4 Superstructure and substructure in good condition.

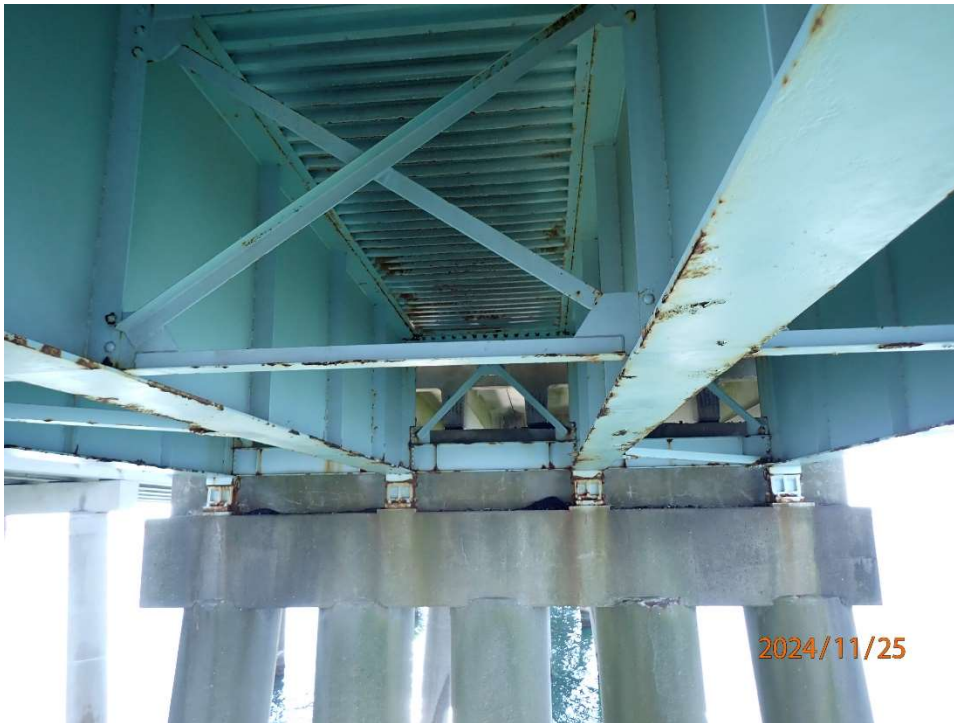
Photo 73: FIBSB Superstructure in good condition with isolated corrosion noted on bottom flange.

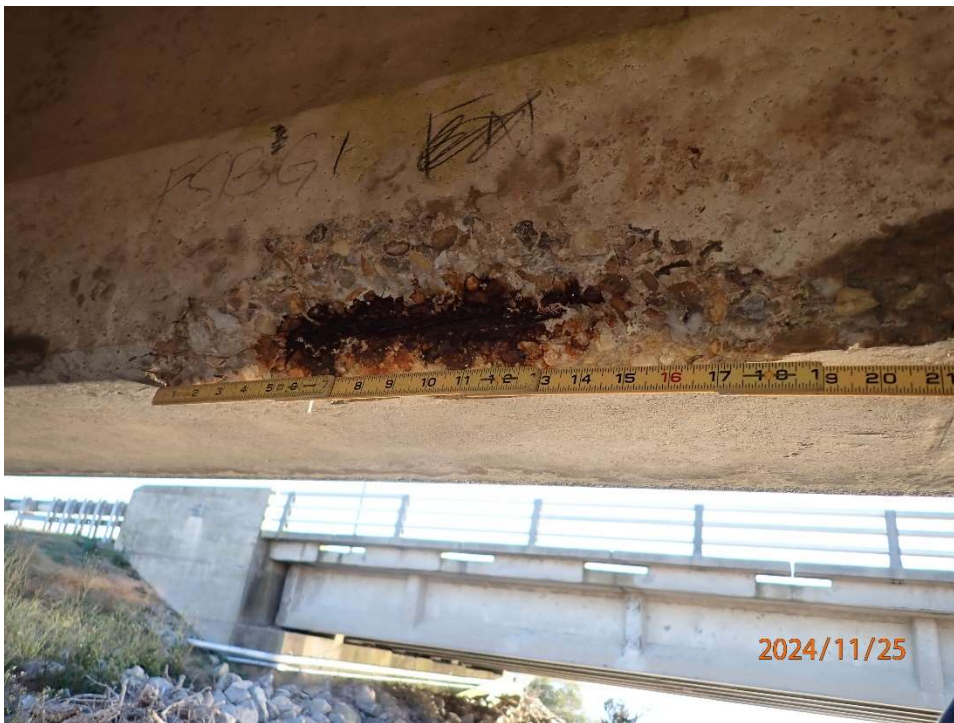
Photo 74: FSB8 Beam 1, Bay 1 spall 18" L x 5" H x 2" under x 2" deep with 1 exposed prestressing strand with up to 10% section loss.

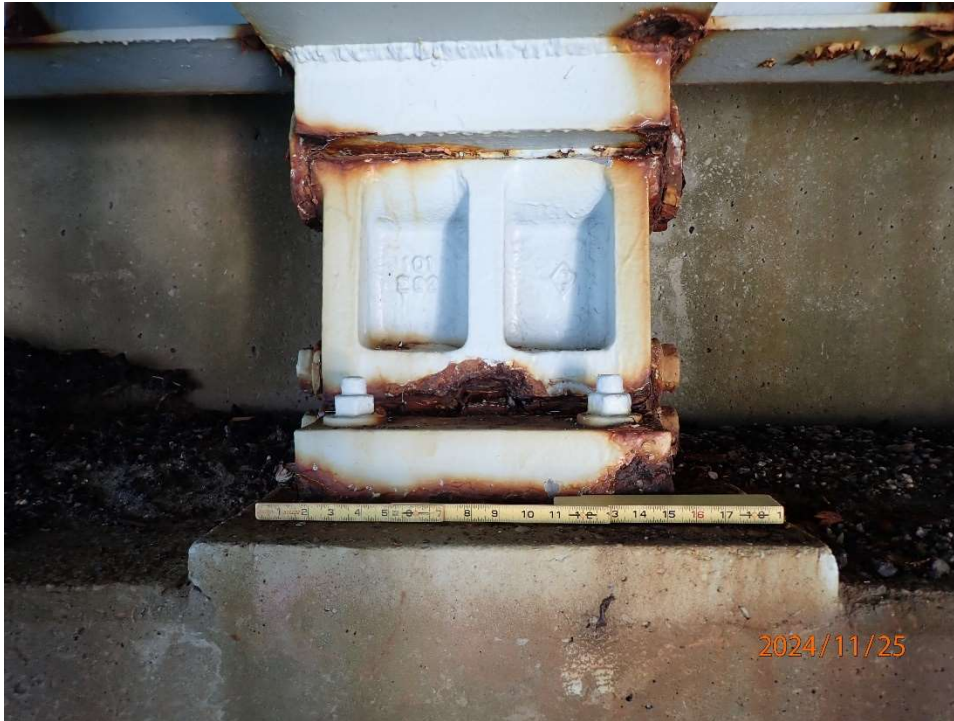
Photo 75: FIBSB3 Bearings have pack rust up to ¼" thick typical for bearings.

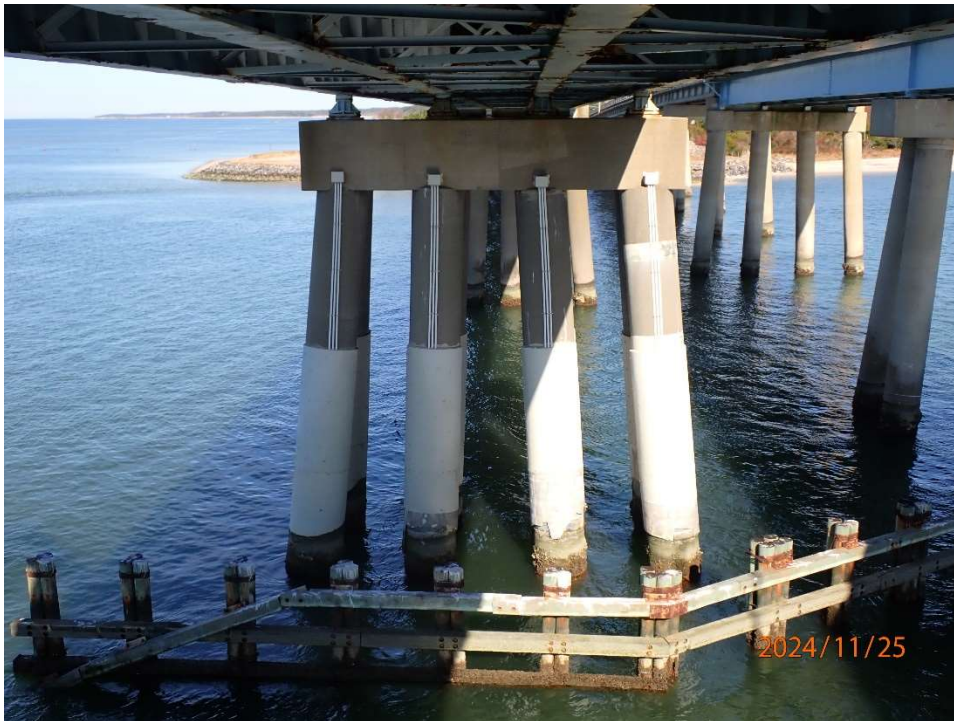
Photo 76: FIBSB Substructure with pile jacket and fender system with broken top wale and portions of lower wale within small navigation channel.

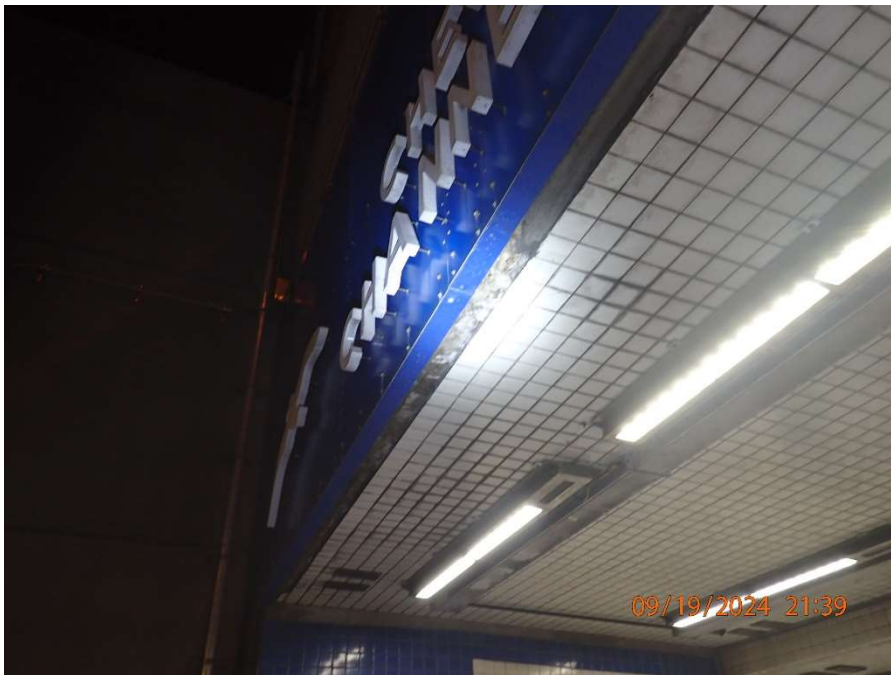
Photo 80: Tunnel Portal – General View of the Island 3 Portal Spalling (Looking West)

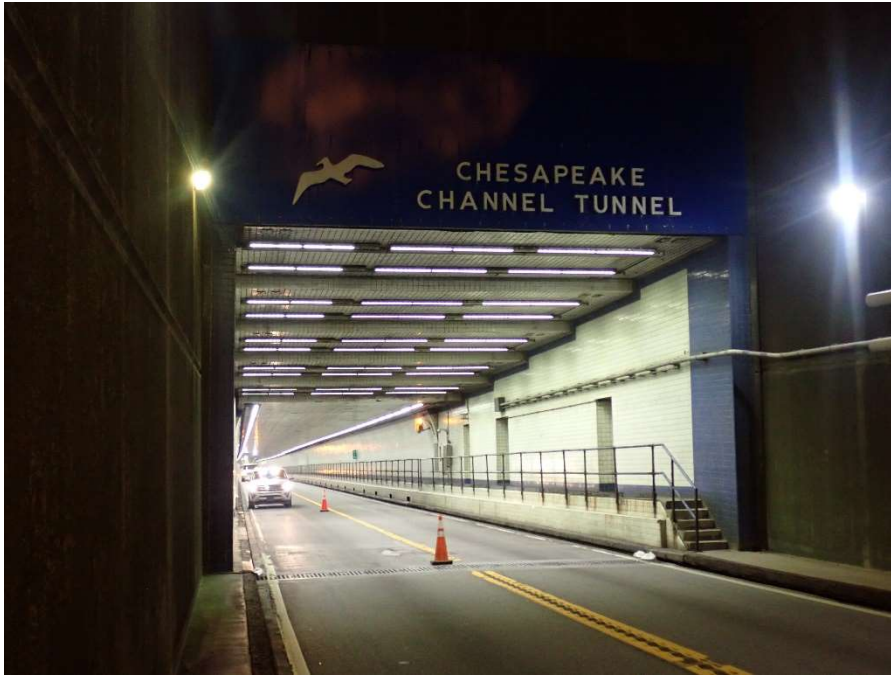
Photo 81: Tunnel Portal – General View of Island 4 Portal (Looking South)

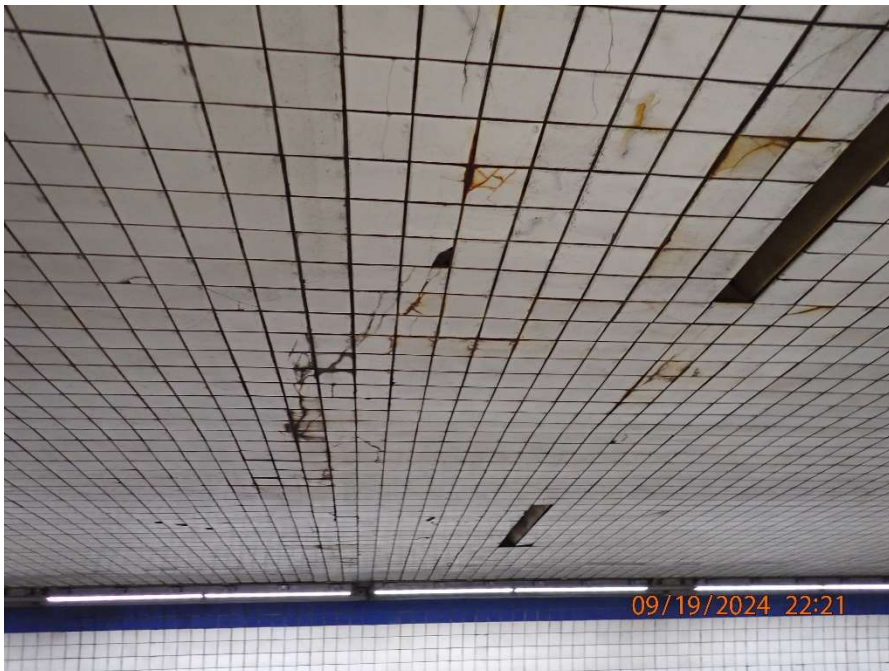
Photo 84: Tunnel Ceiling Slab – General View of Random Cracked Tiles in Tunnel Roadway Ceiling (Looking West)

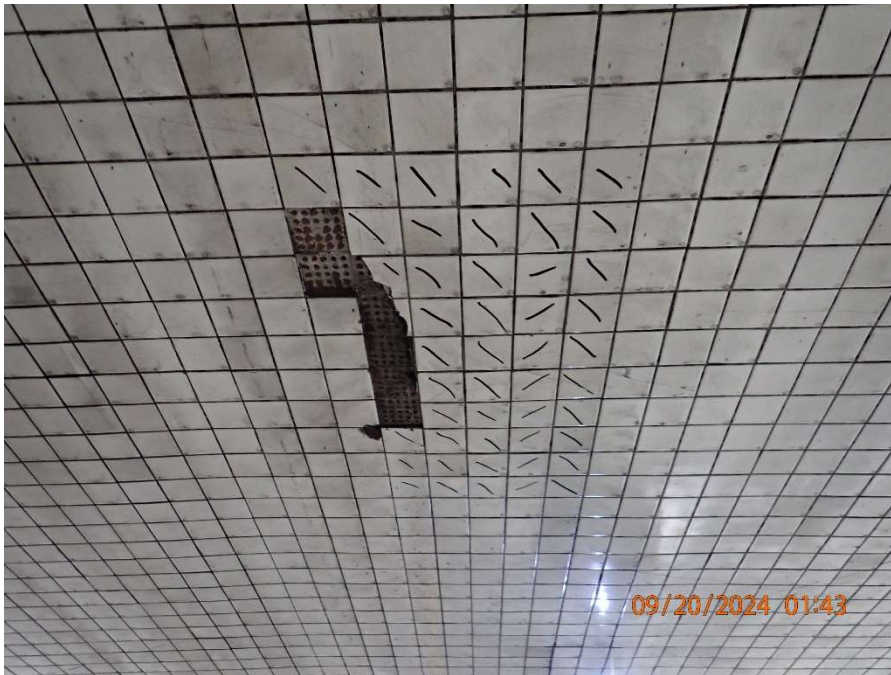
Photo 85: Tunnel Ceiling Slab – Isolated Area with More Significant Delaminated Concrete and Tile; and Missing Tiles in Tunnel Roadway Ceiling (Sta. 504+80 Looking South)

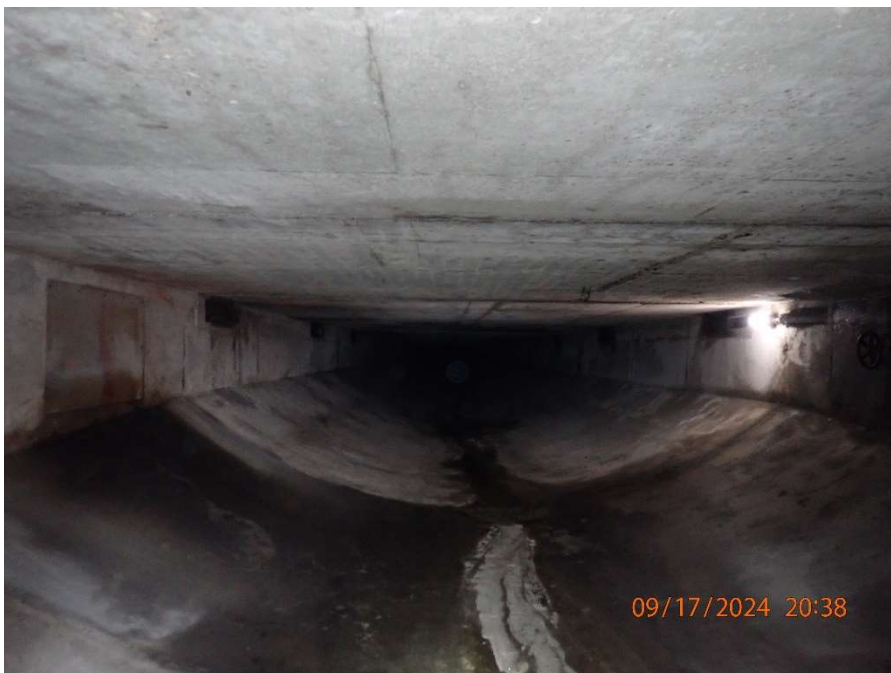
Photo 86: Fresh Air Duct – General View along Tunnel Liner and Invert (Looking North)

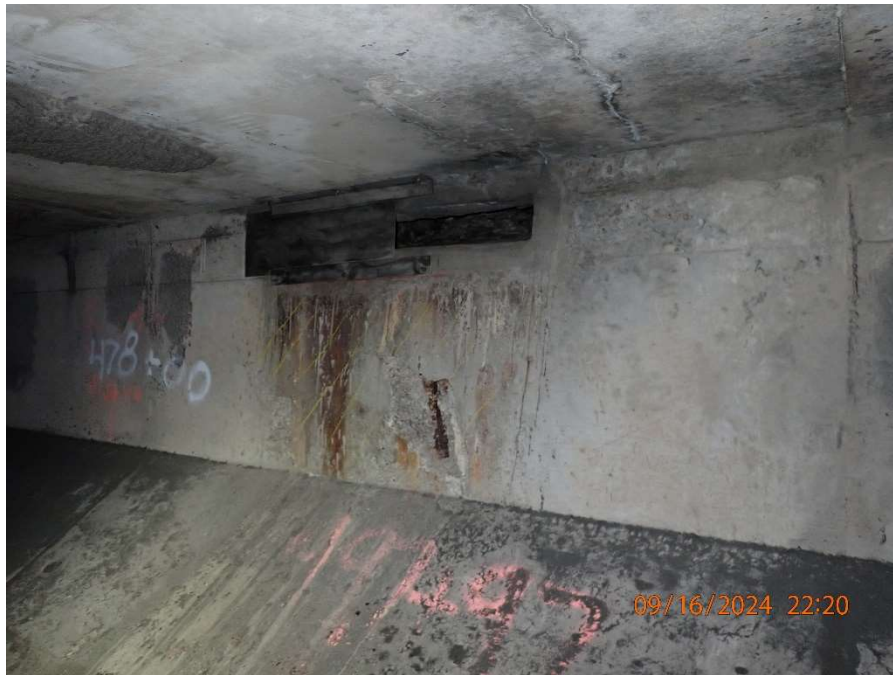
Photo 87: Fresh Air Duct – General View of Delamination and Spalling in the Tunnel Liner (Looking East)

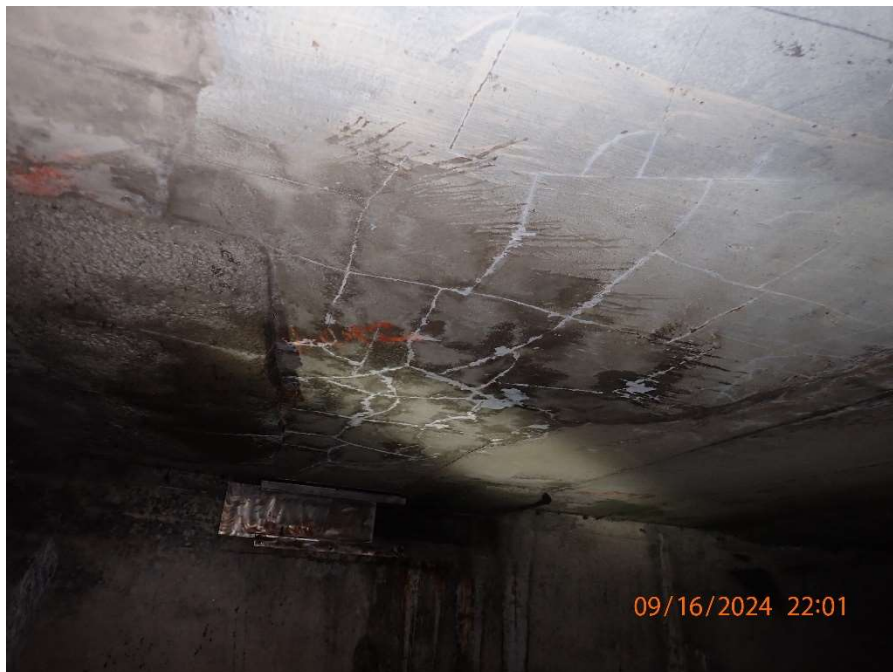
Photo 88: Fresh Air Duct – General View of Cracking with Efflorescence in the Invert Slab (Looking East)

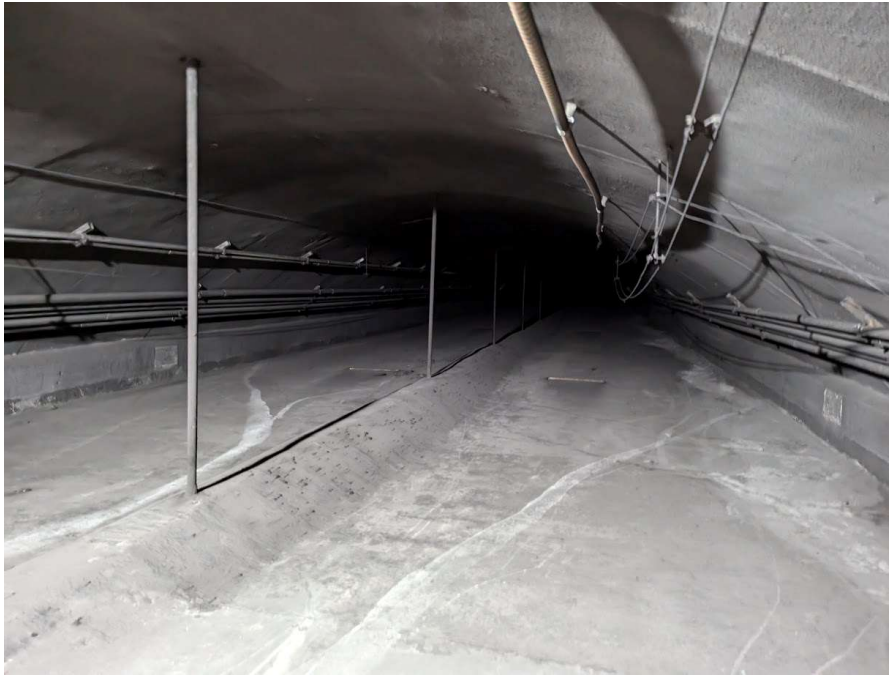
Photo 89: Exhaust Air Duct – General View along Tunnel Liner and Ceiling Slab (Looking North)

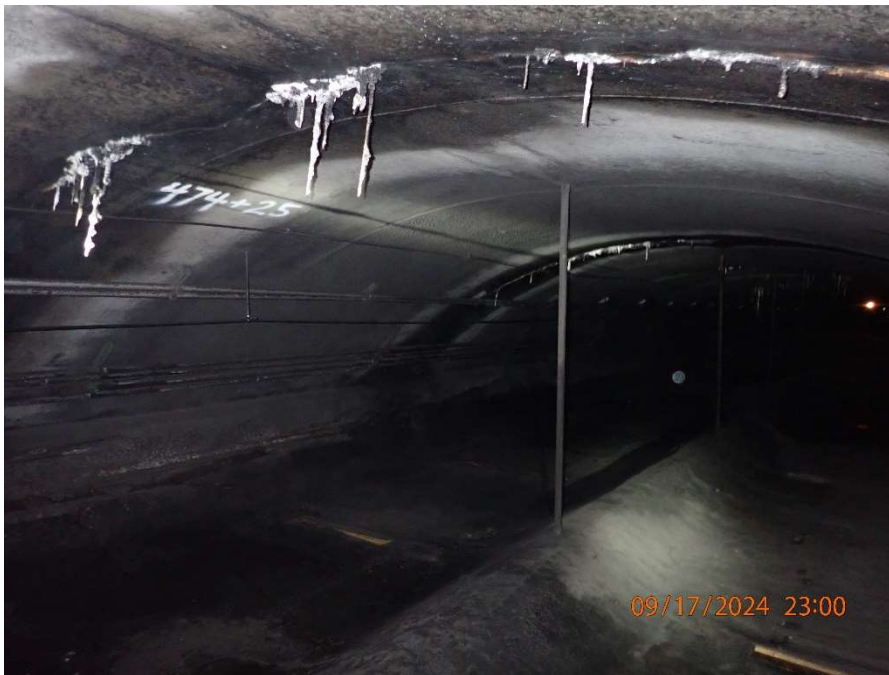
Photo 90: Exhaust Air Duct – General View of Random Transverse Cracking with Significant Efflorescence and Leakage in the Tunnel Liner (Looking West)

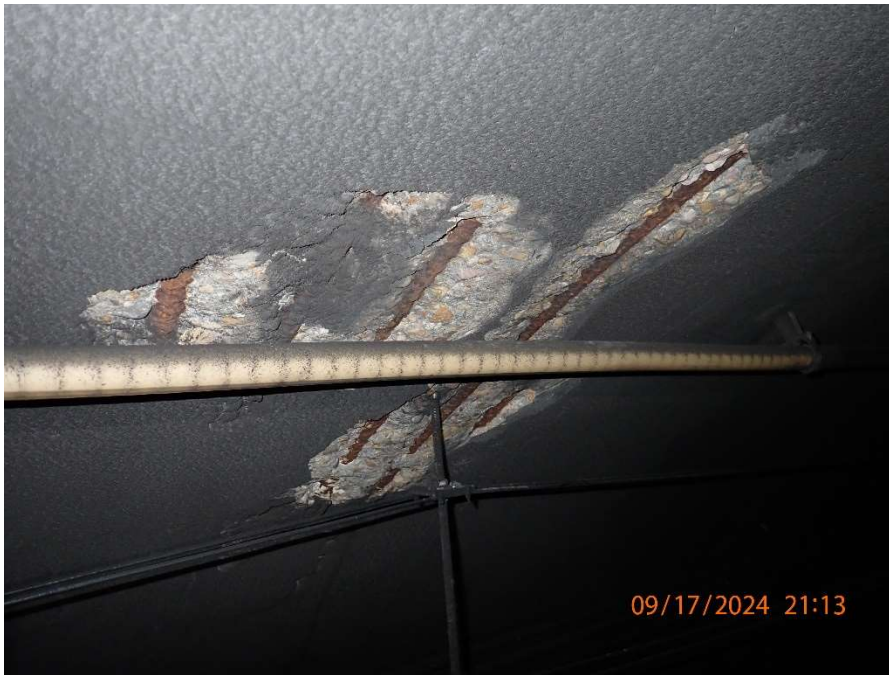
Photo 91: Exhaust Air Duct – General View of Random Spalling with Exposed and Corroded Reinforcement Steel in the Tunnel Liner (Looking West)

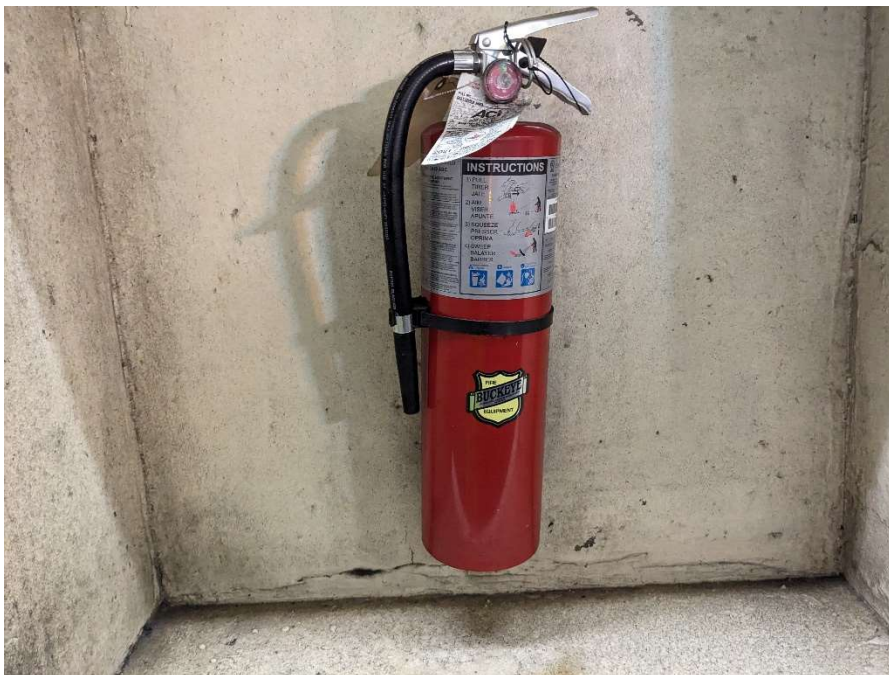
Photo 92: Fire Protection System – Typical Fire Extinguisher in Tunnel Roadway (Looking West)

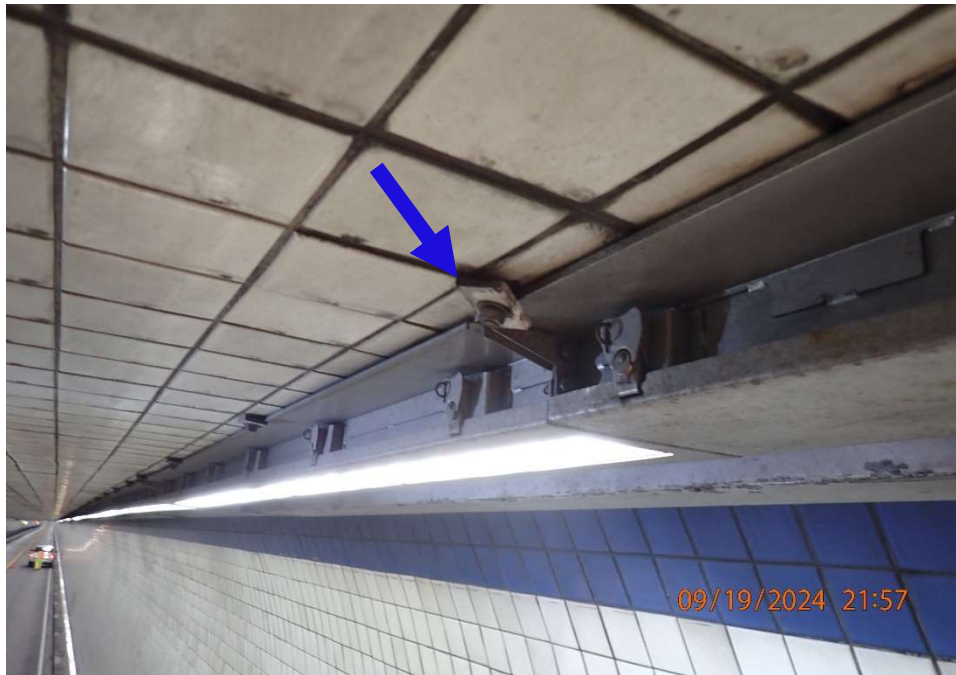
Photo 93: Tunnel Lighting Fixture – Loose anchorage/mounting hardware at East Station 469+60 (Blue Arrow)
(similar at East Station 469+30)

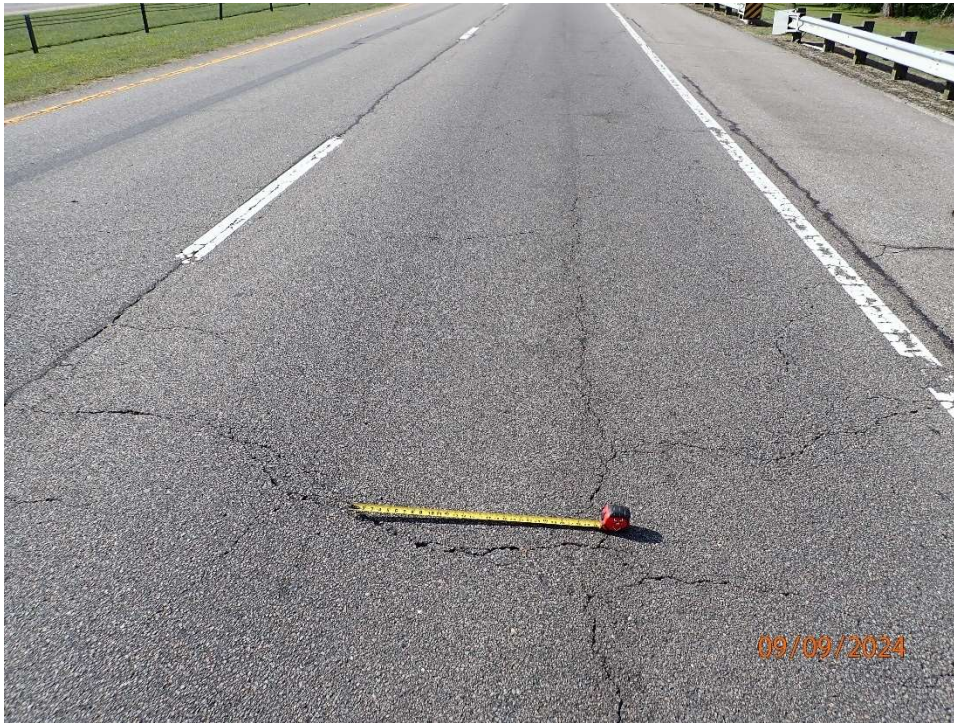
Photo 94: Approach Roadway (North); Asphalt with alligator cracking up to ¼" wide throughout.

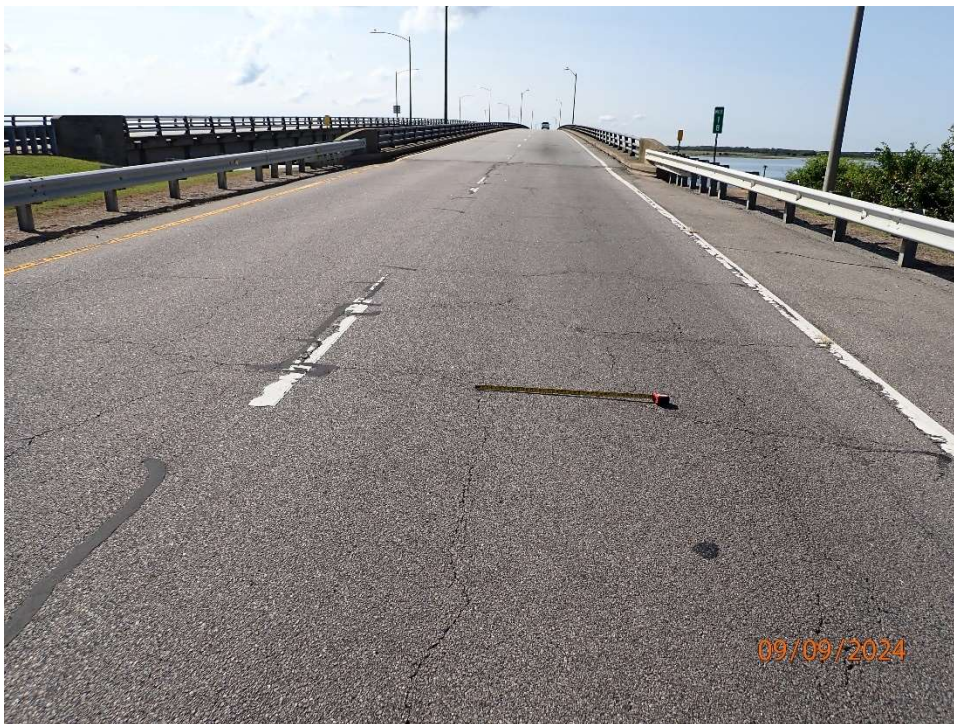
Photo 95: Approach Roadway (North) near FIB Bridge; Asphalt with alligator cracking up to ¼" wide throughout.

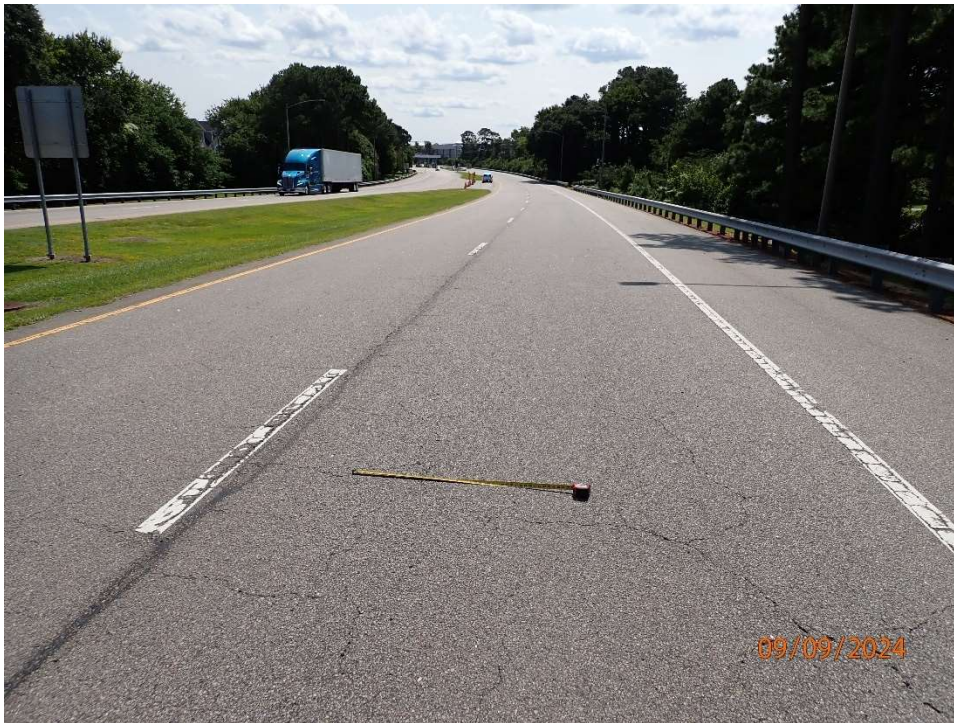
Photo 96: Approach Roadway (South) near Trestle ASB; Asphalt with alligator cracking up to ¼" wide throughout.

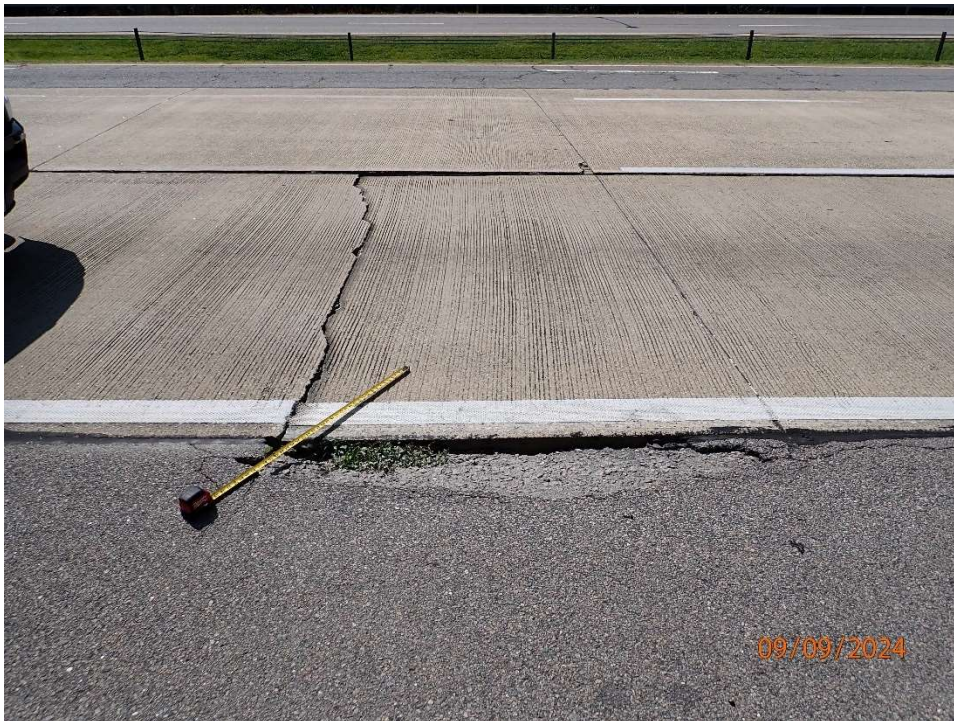
Photo 97: Approach Roadway (South) headed north approx. 675' south of gate; pothole and concrete pavement settled up to 1" with up to ¼" wide transverse crack.

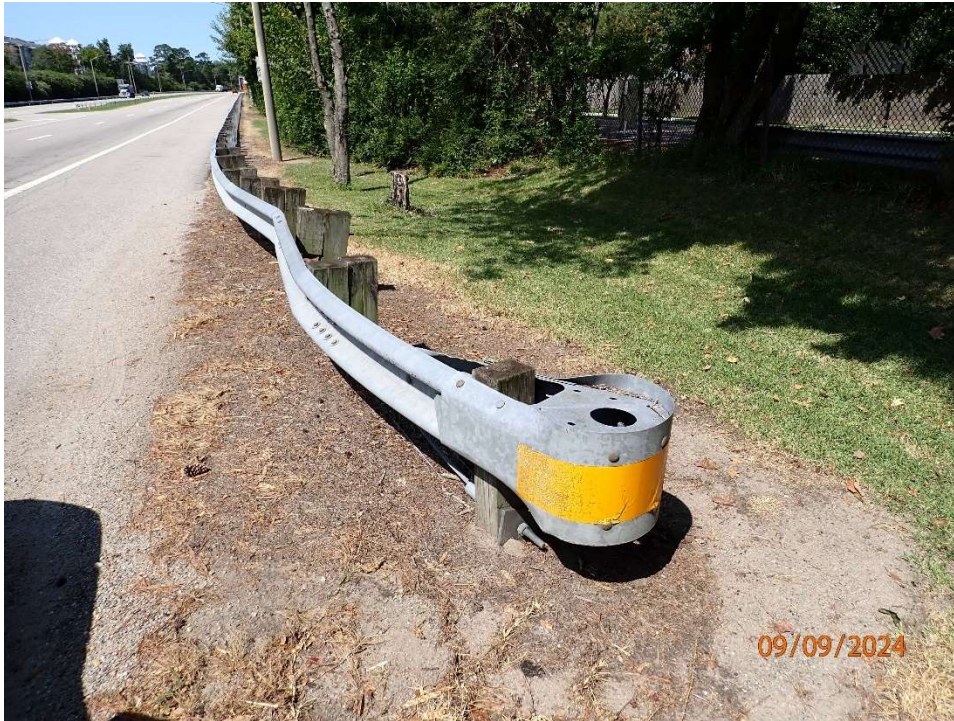
Photo 98: Approach Roadway (South); impact damage to guardrail pushed back up to 1' back (non CBBT property)

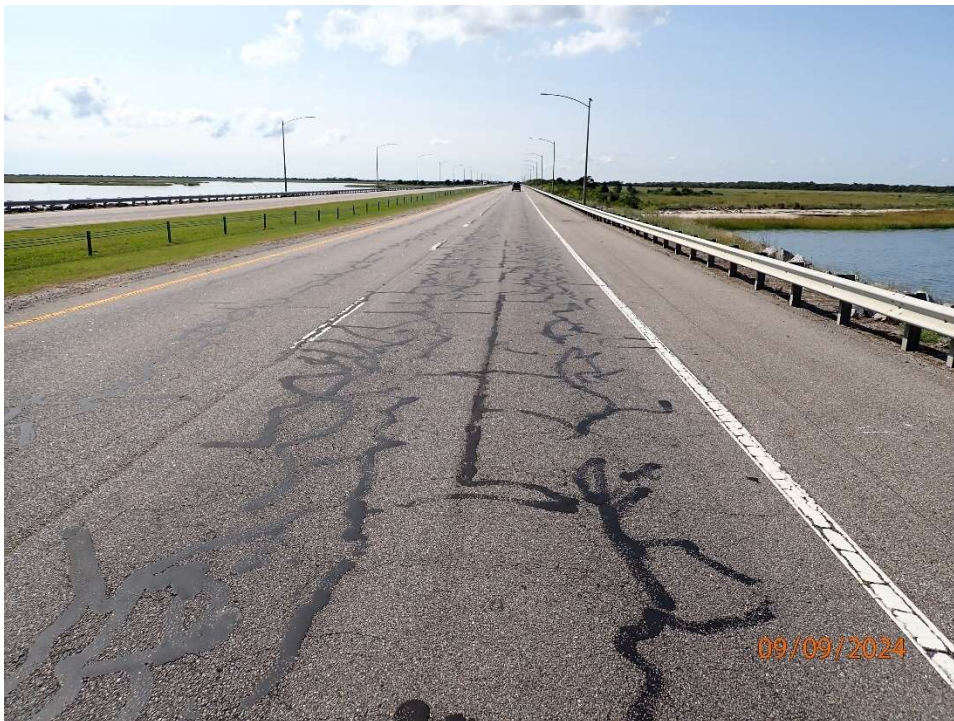
Photo 99: FIB Causeway looking south; Asphalt with up to 1/8" alligator cracking with majority sealed.

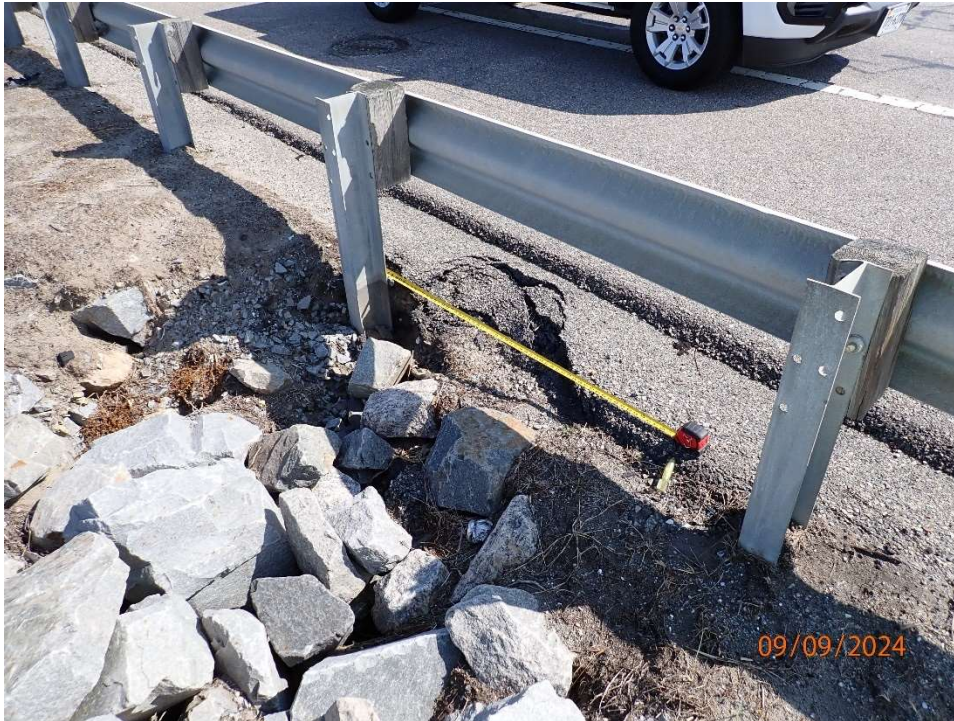
Photo 100: FIB Causeway headed south; Pothole/sinkhole at shoulder/guardrail with riprap. Sinkhole measures 42" wide x 24" long x 3" deep.

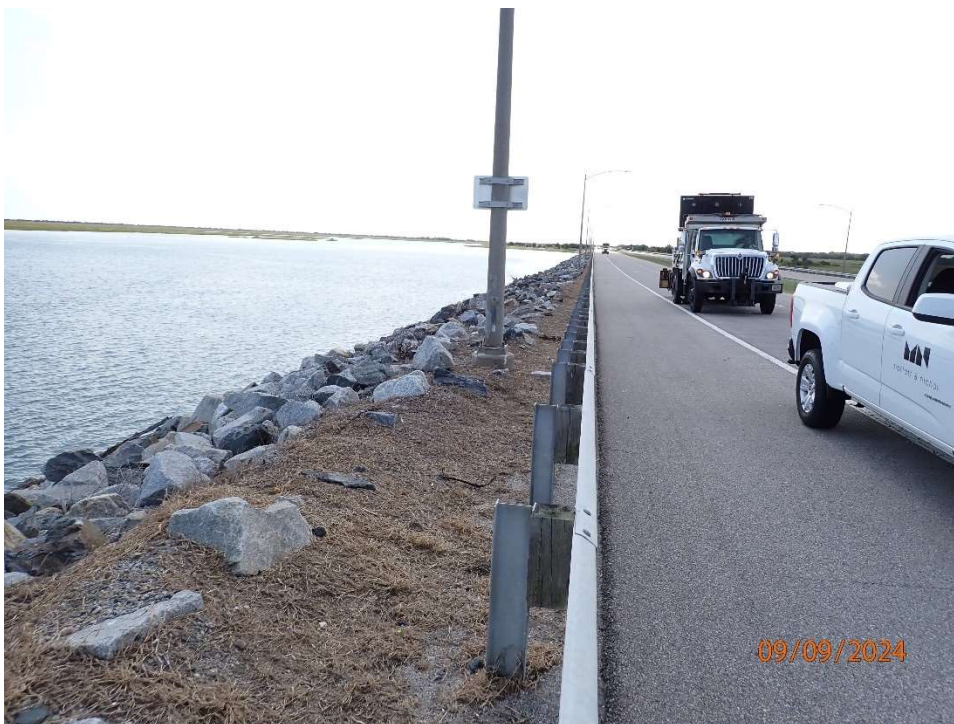
Photo 101: FIB Causeway headed north (looking south); Typical shoreline stabilization.

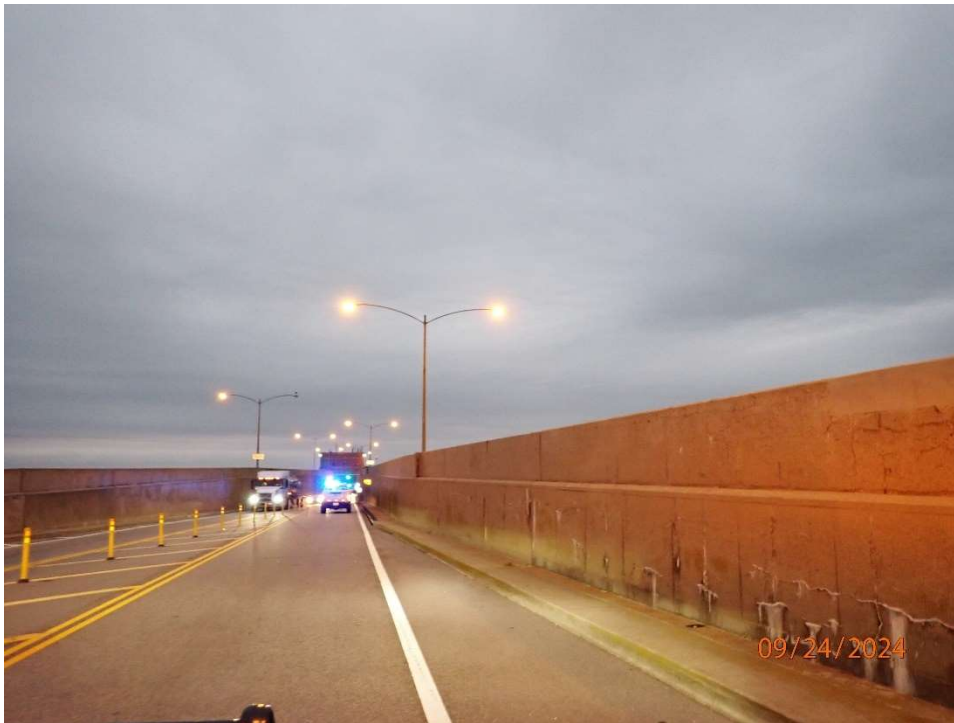
Photo 102: Portal Island 3 Approach Roadway and Approach Wall; vertical and transverse cracks in approach wall with efflorescence.

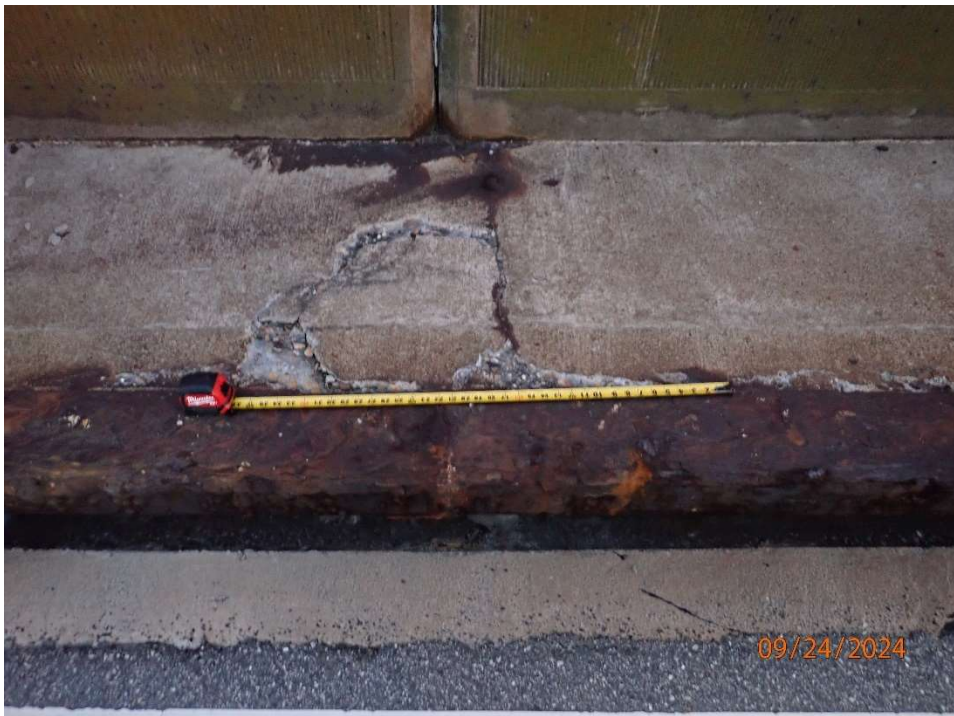
Photo 103: Portal Island 3 Approach Roadway; corrosion to rub rail throughout with isolated delaminations to sidewalk/curb.

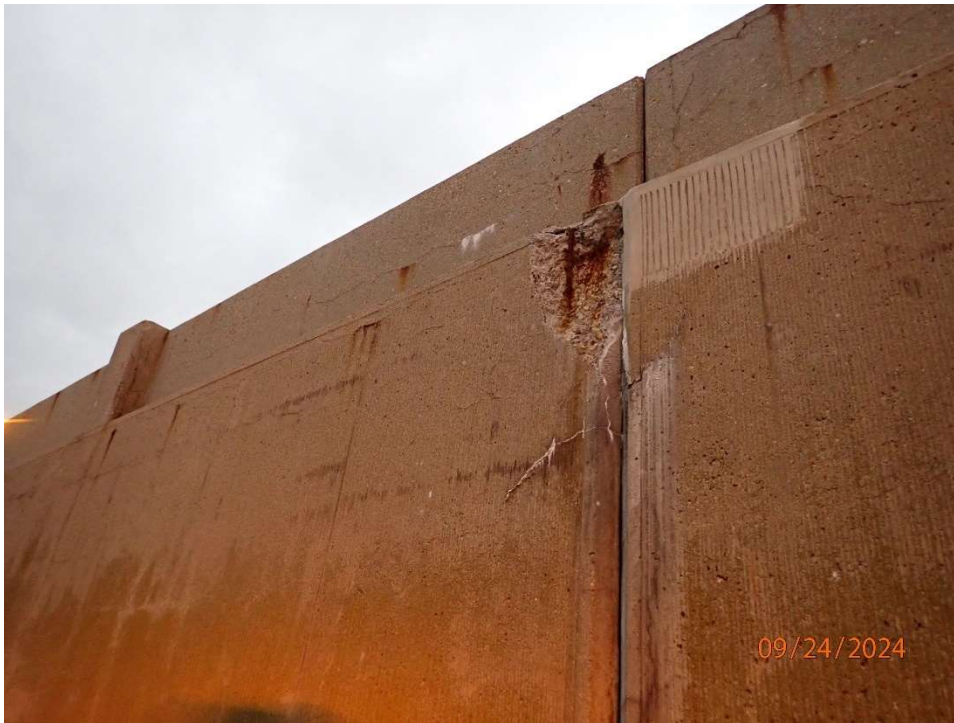
Photo 104: Portal Island 3 Open Approach Wall (east face); spall with exposed reinforcement with up to 100% section loss. Spalls noted at isolated locations and typically in the top 8' of wall.
