moffatt & nichol
Creative People, Practical Solutions.®

FY2025 Annual Inspection and Underwater Inspection

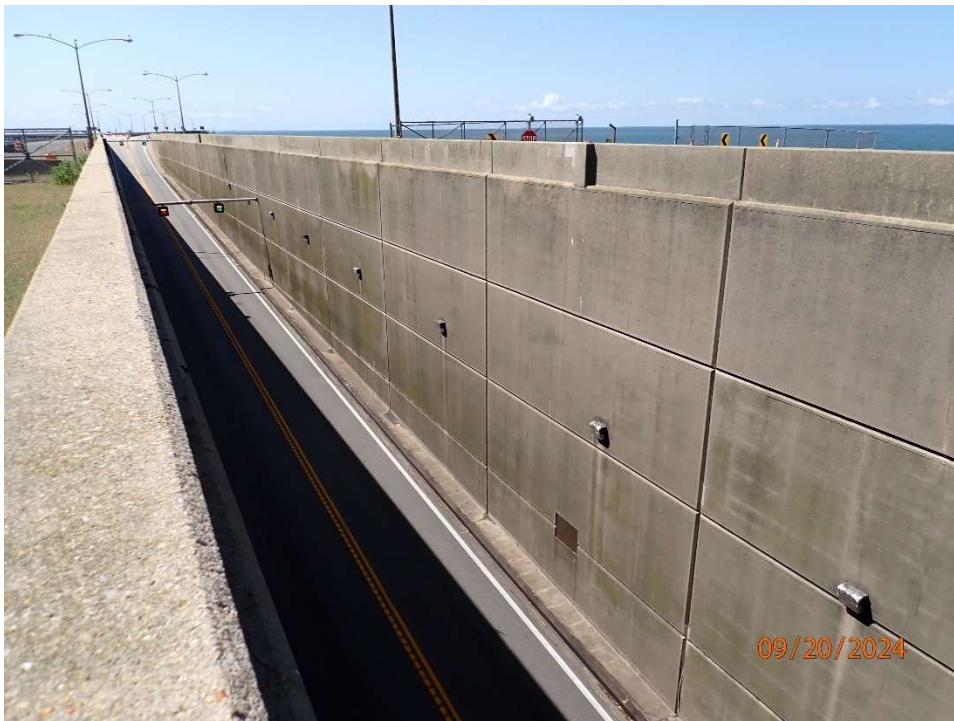
Photo 105: Portal Island 3 Open Approach Wall (west face); typical condition of approach wall.

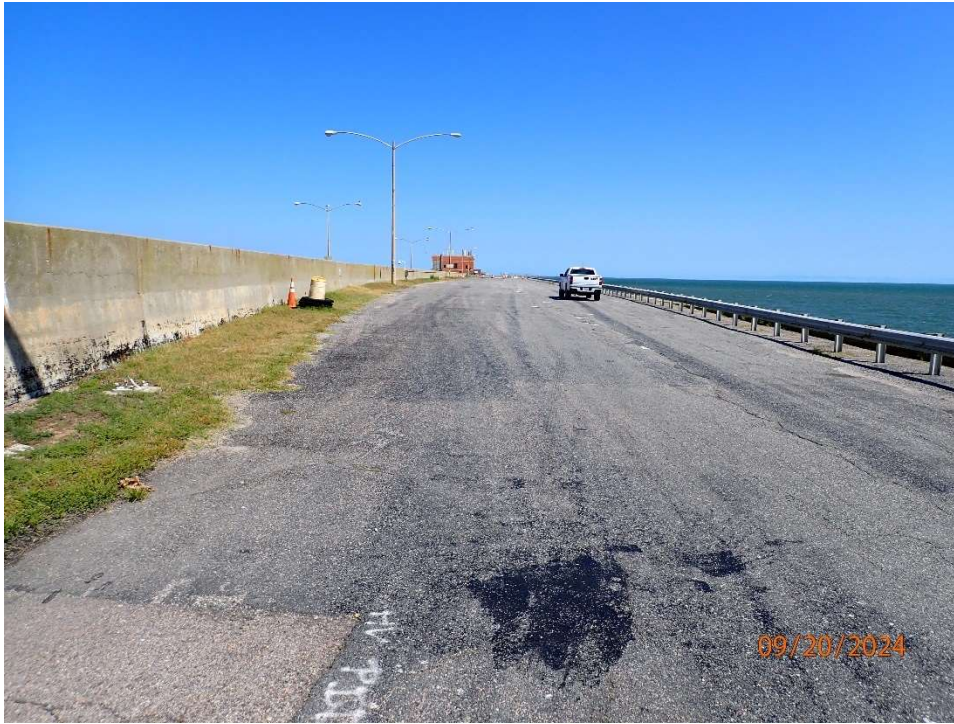
Photo 106: Portal Island 3; Surface; Typical pavement condition on east side of island.

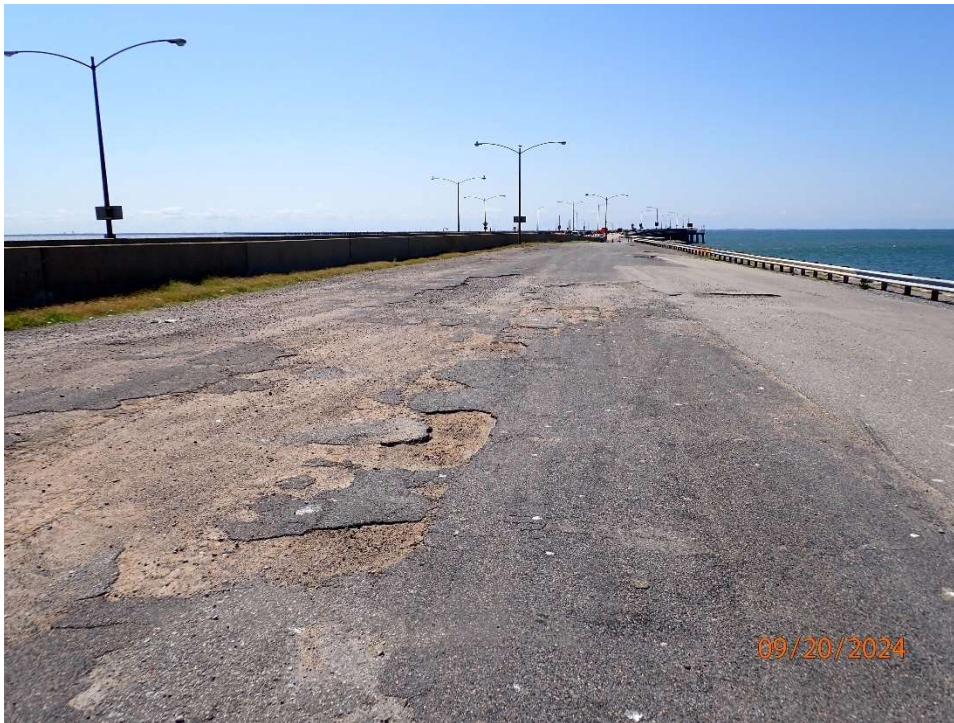
Photo 107: Portal Island 3; Surface; Typical pavement condition on west side of island.

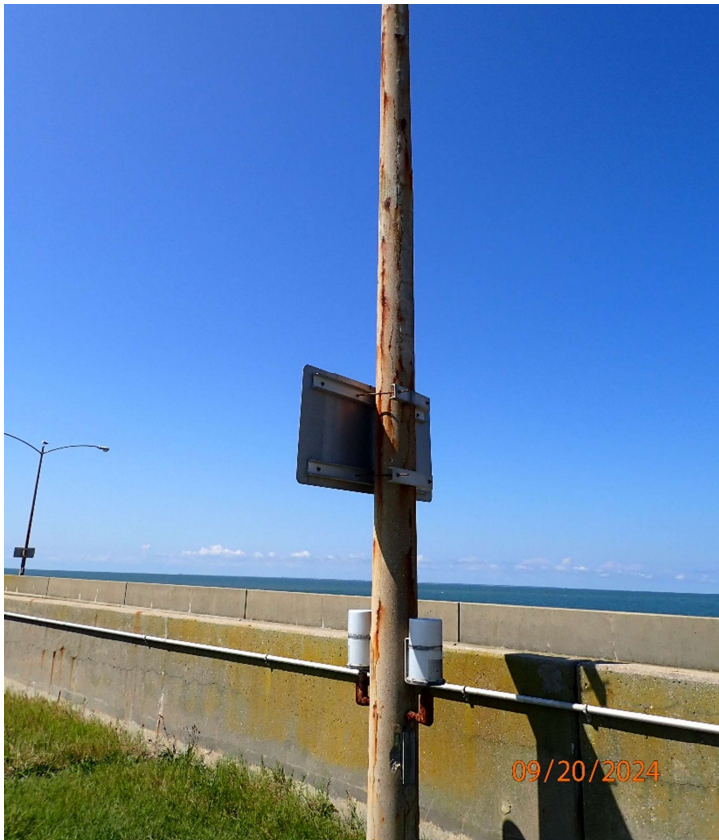
Photo 108: Portal Island 3; concrete light poles typically exhibit vertical cracking and spalls with exposed reinforcement.

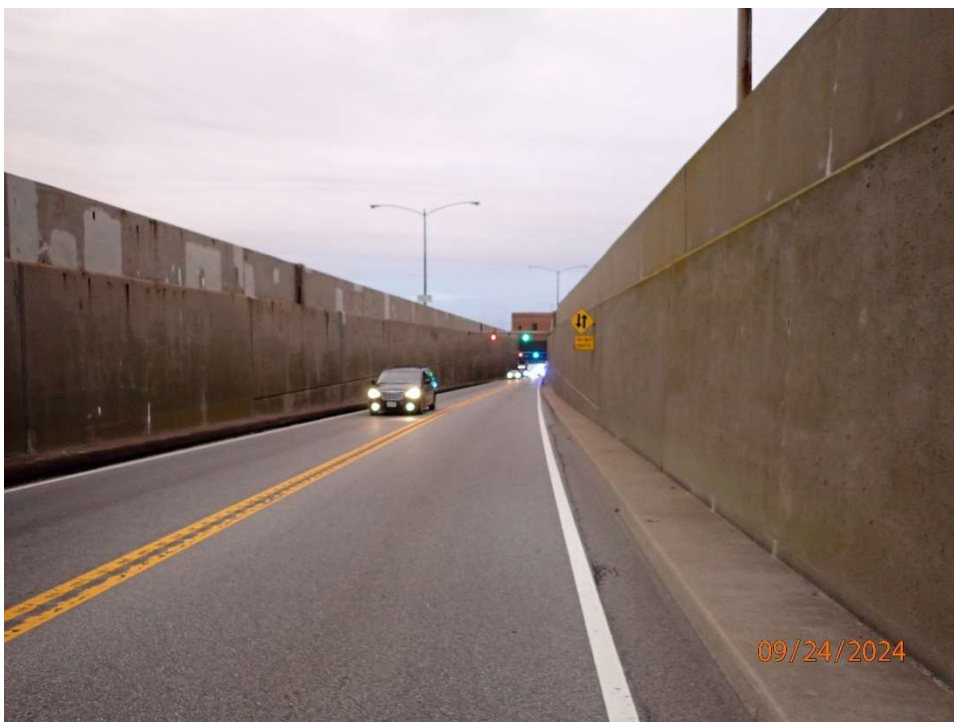
Photo 109: Portal Island 4; Open Approach Roadway

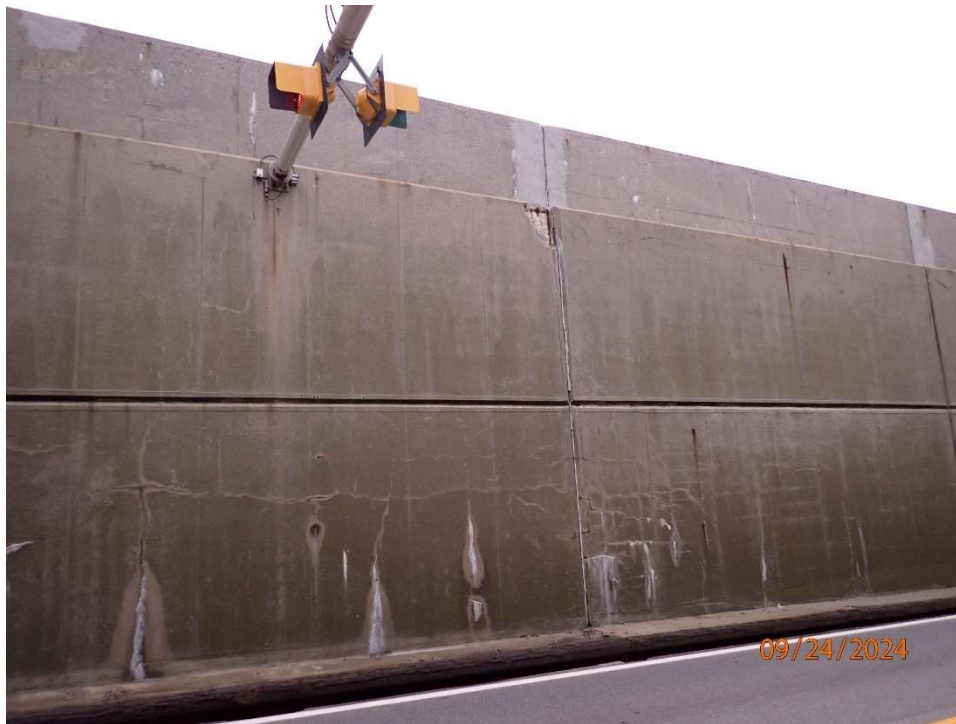
Photo 110: Portal Island 4; Open Approach Walls; hairline crack with rust staining and minor efflorescence.

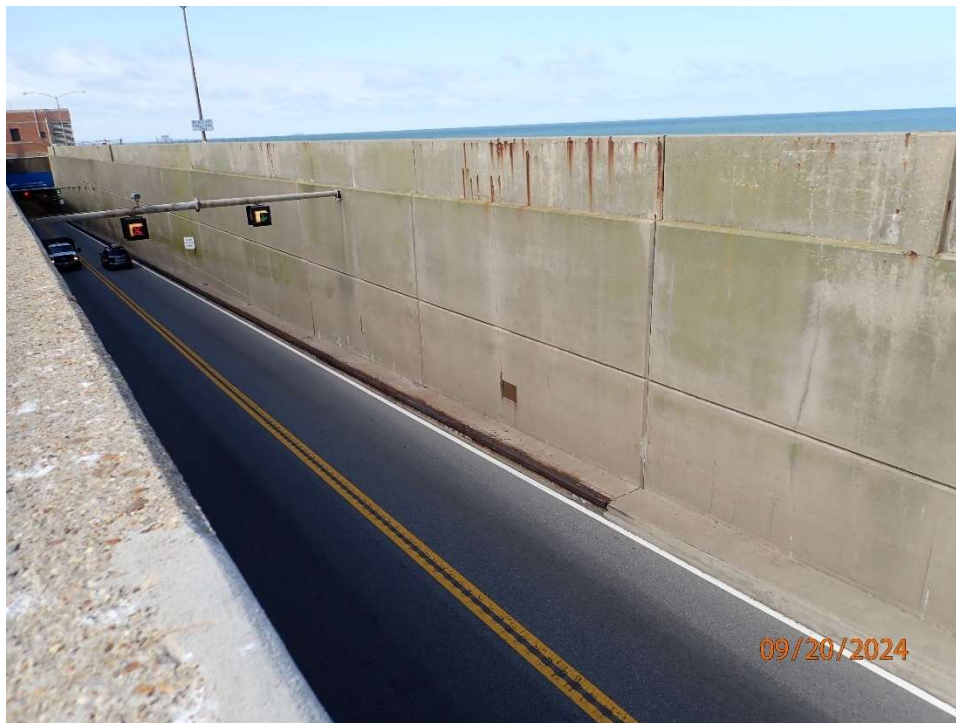
Photo 111: Portal Island 4: Open Approach Roadway and Walls; typical condition .

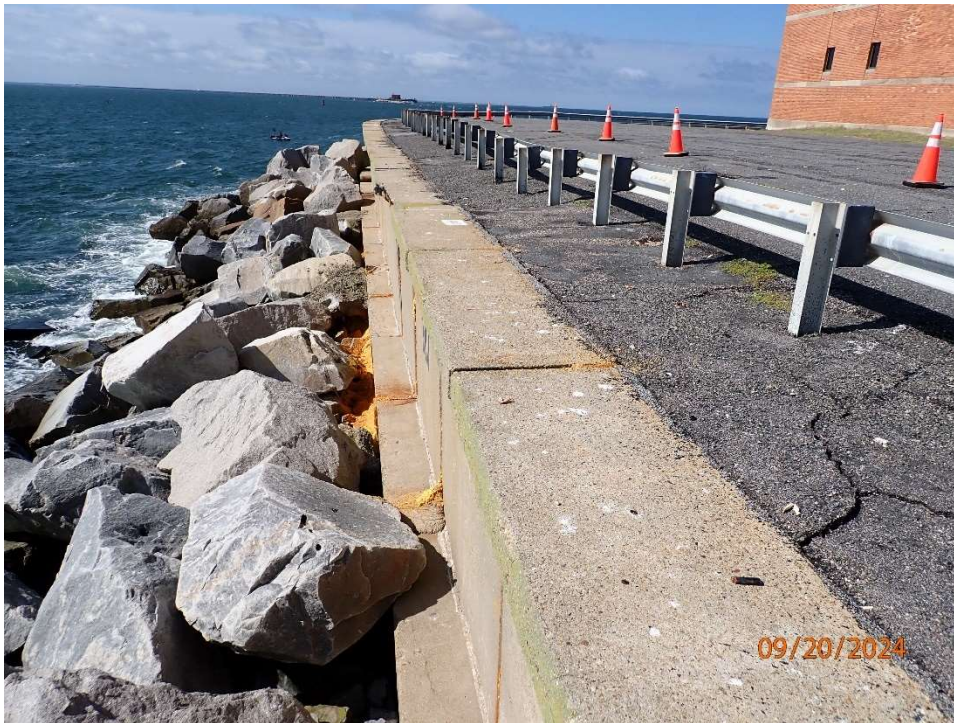
Photo 112: Portal Island 4 Splash Wall; Repair to previous sinkhole with urethane material out of joints.

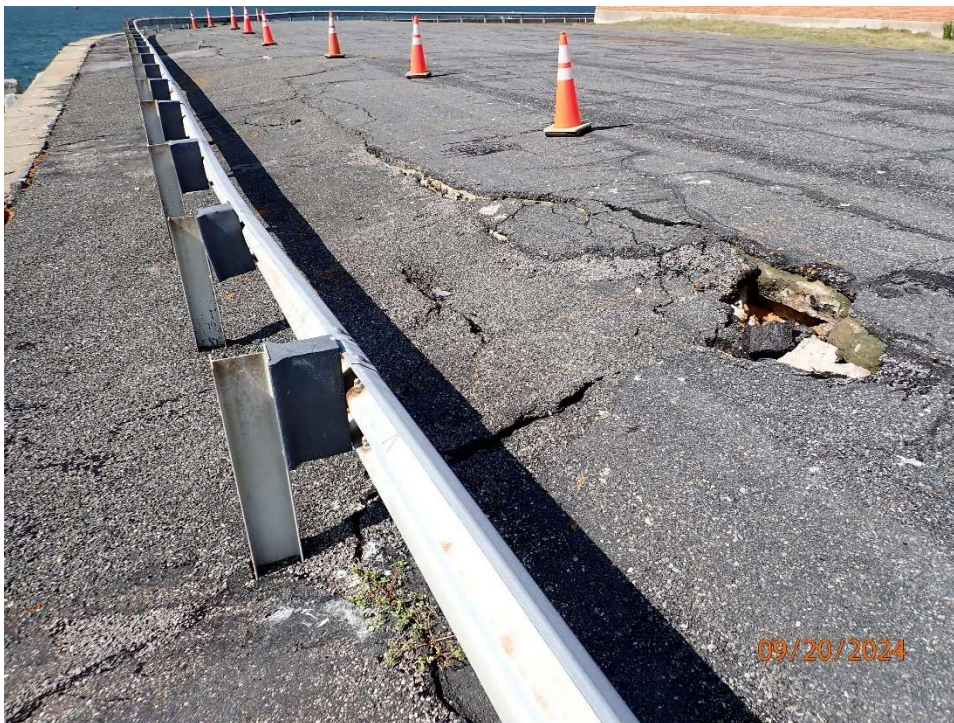
Photo 113: Portal Island 4 Splash Wall; Repair to previous sinkhole with urethane material. Sinkhole is still present in roadway with void under asphalt at time of inspection. The District noted in December 2024 that repair was made to this location.

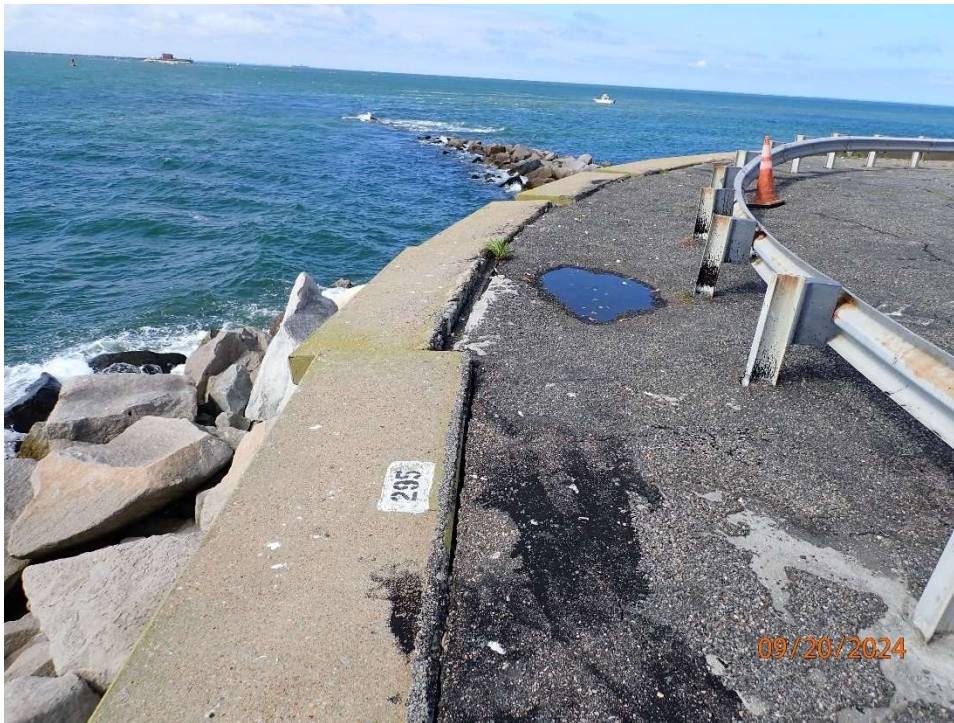
Photo 114: Portal Island 4 Splash Wall; Minor rotation to splash wall just south of sinkhole repair.

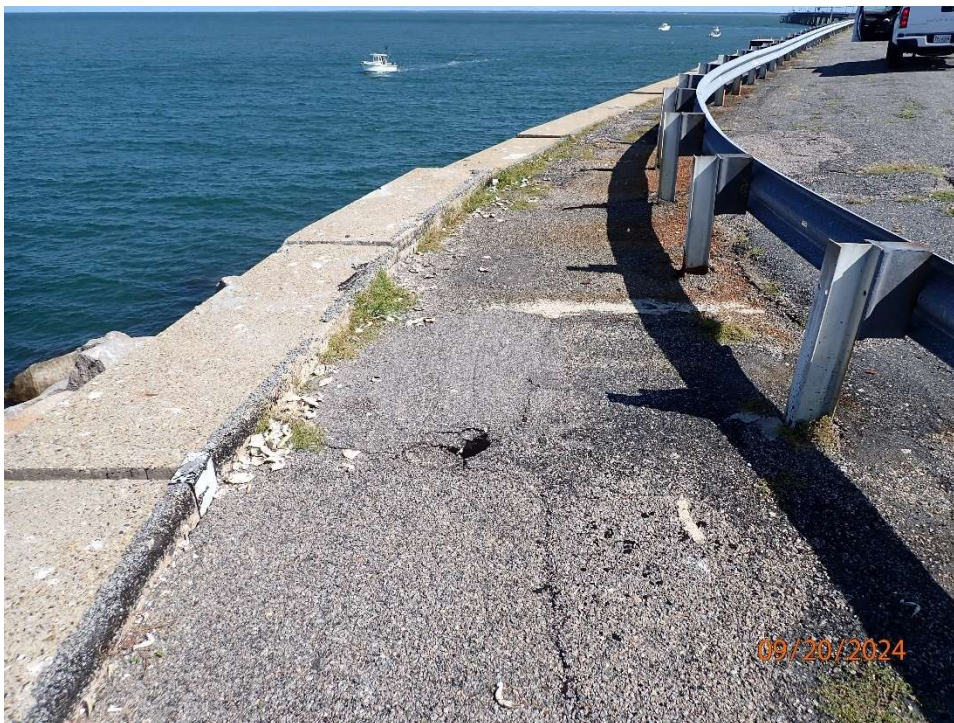
Photo 115: Portal Island 4 Splash Wall; newly forming sinkhole behind guardrail on west side of island. Depth of sinkhole could not be verified.

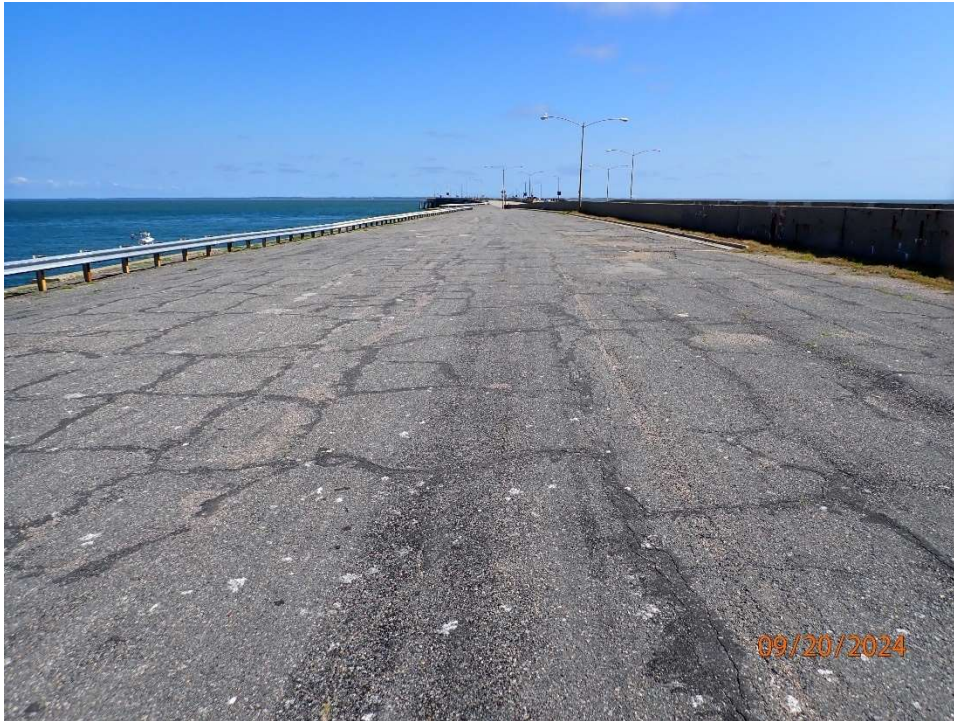
Photo 116: Portal Island 4 Surface; typical asphalt condition on portal island.

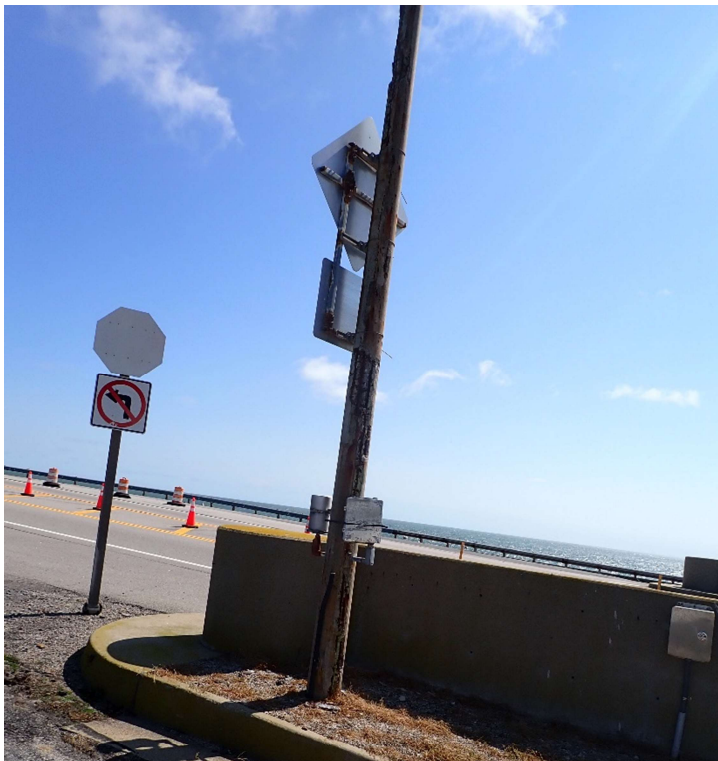
Photo 117: Portal Island 4 Concrete Light Pole; typical condition of poles with areas of spalls with exposed reinforcement up to 20% section loss of reinforcement.

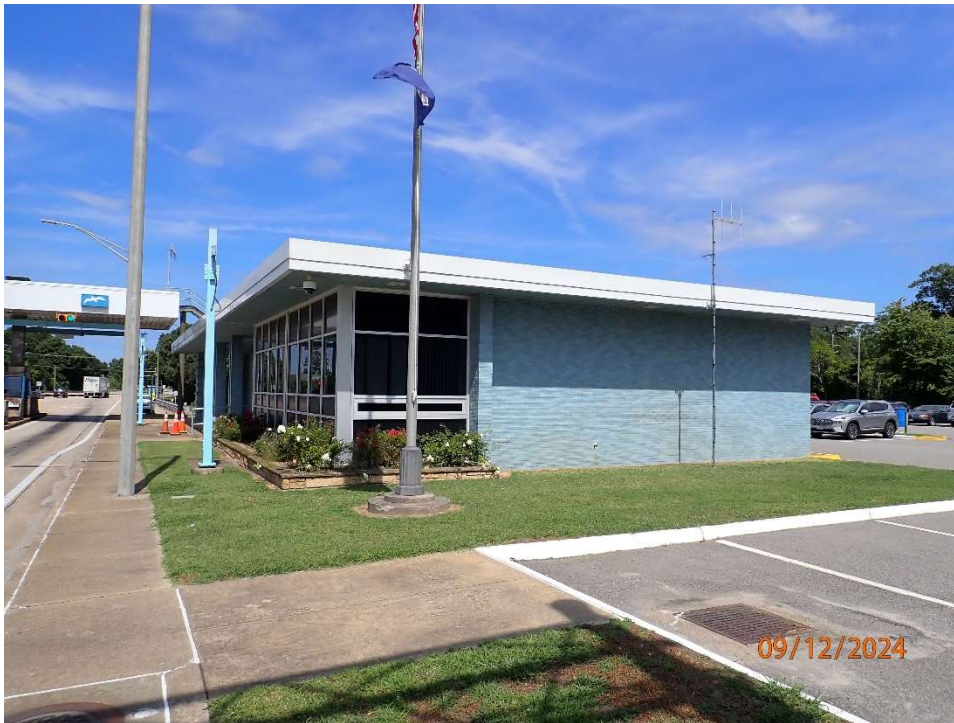
Photo 118: South Toll Plaza; Toll Office Building

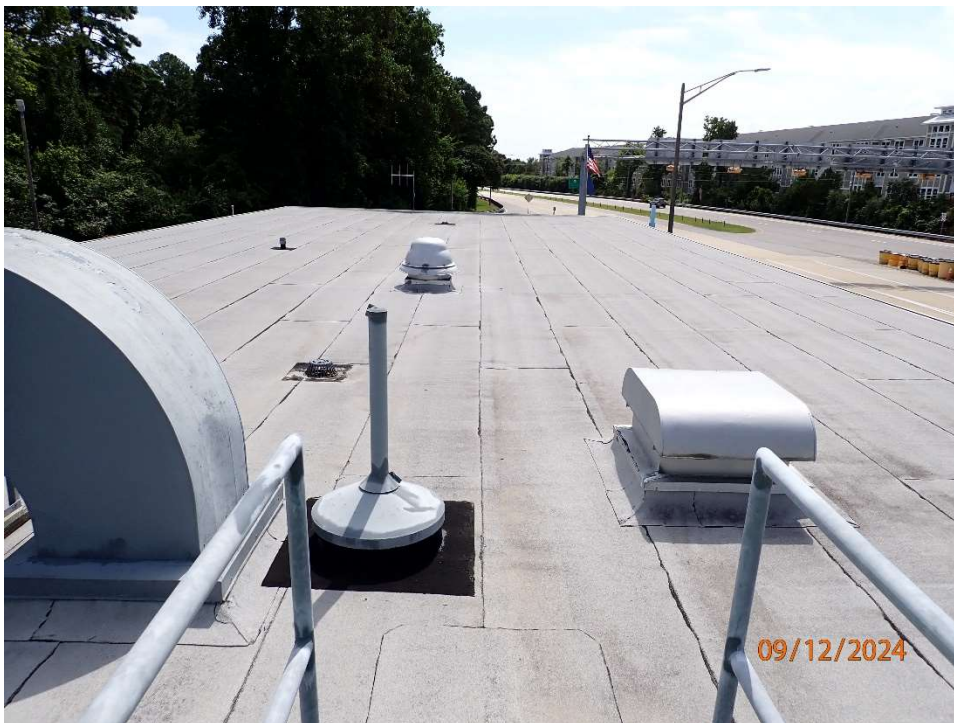
Photo 119: South Toll Plaza; Toll Office Building Roof in good condition with no notable defects.

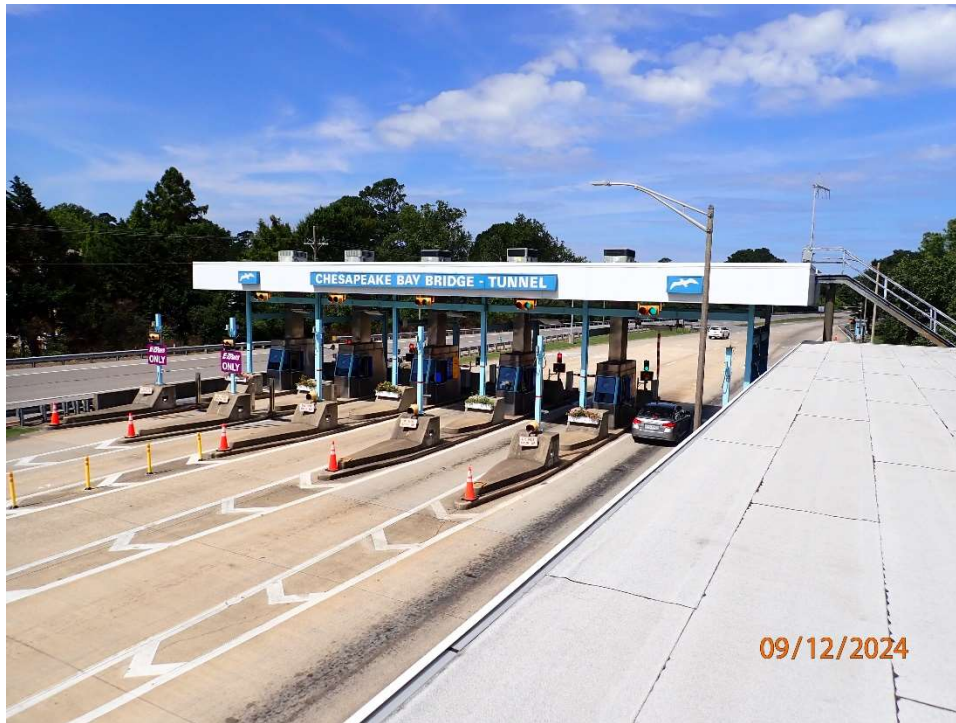
Photo 120: South Toll Plaza; Toll Booth Plaza in good condition.

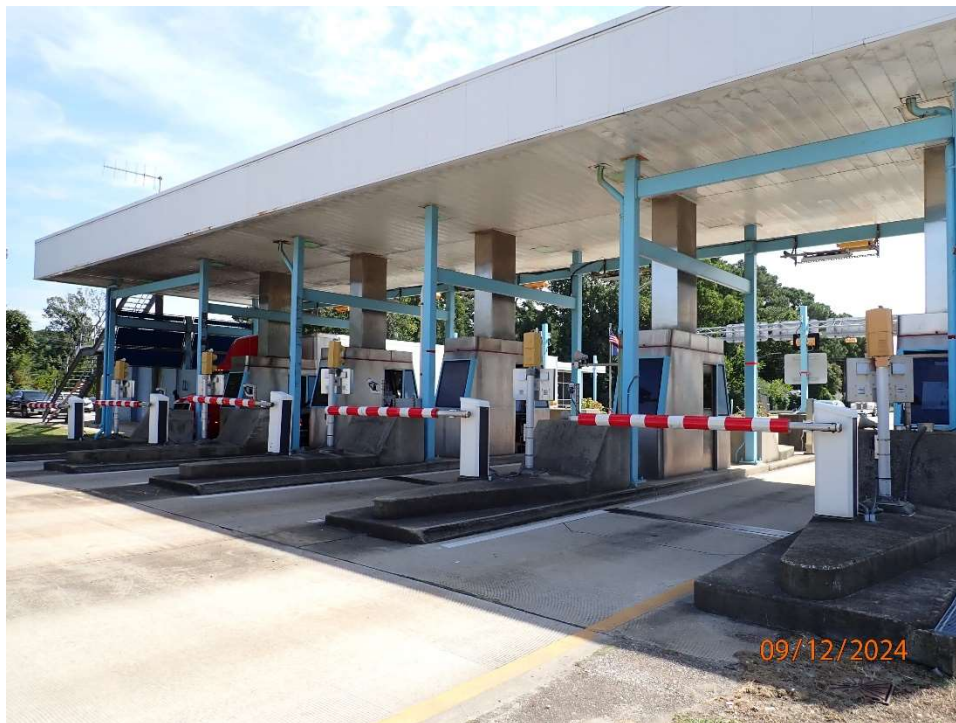
Photo 121: South Toll Plaza; Toll Booth Plaza in good condition.

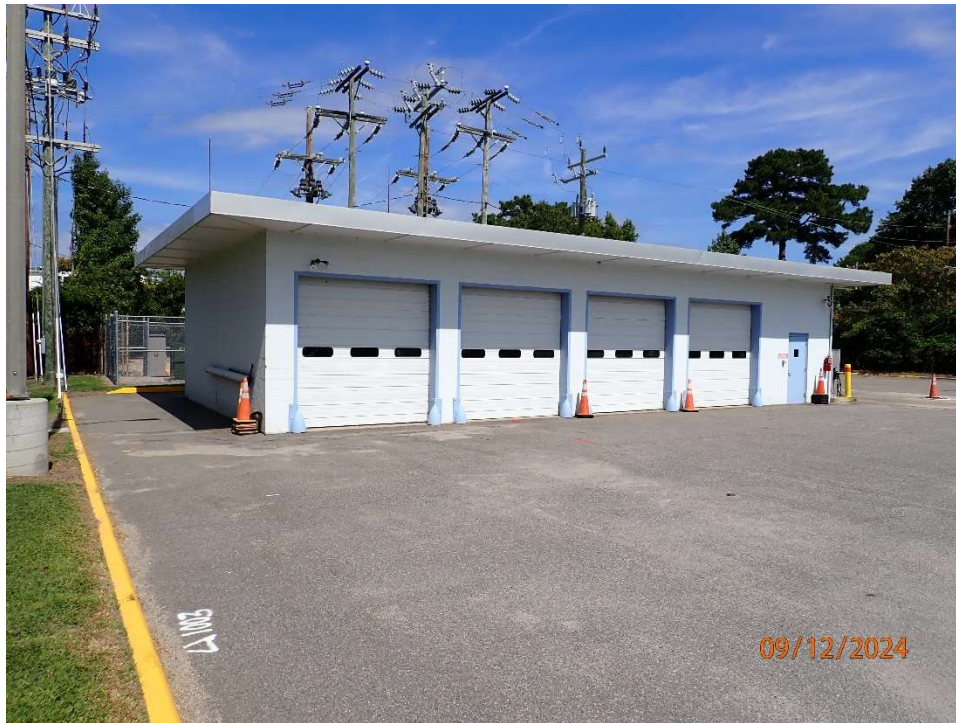
Photo 122: South Toll Plaza; Garage in good condition.

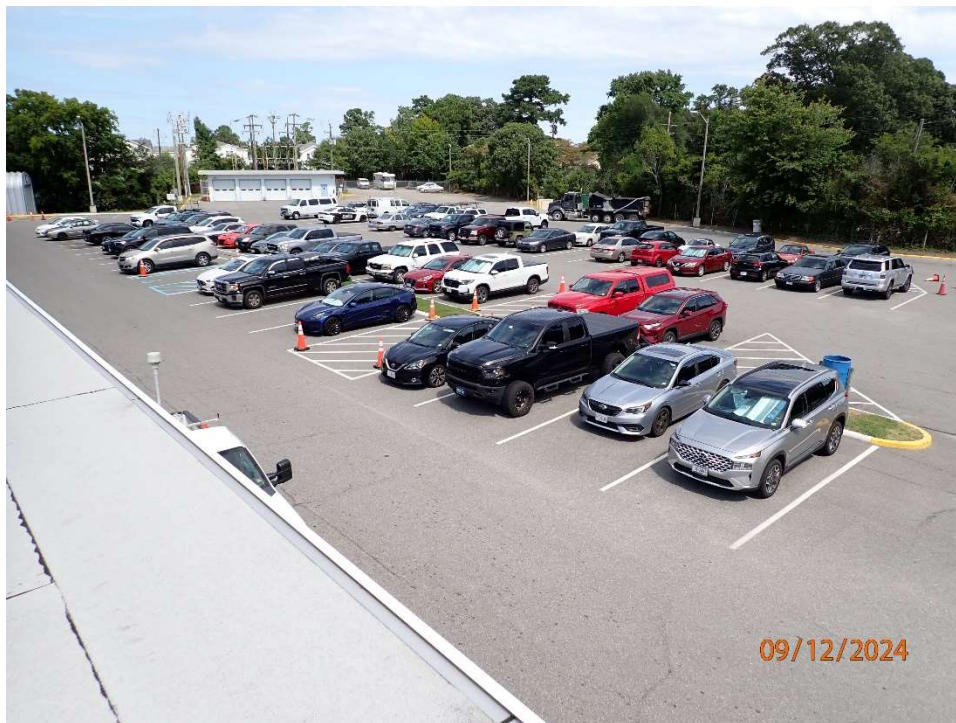
Photo 123: South Toll Plaza Parking Lot; Pavement has isolated alligator cracking up to 1/8" wide; however, overall, in good condition.

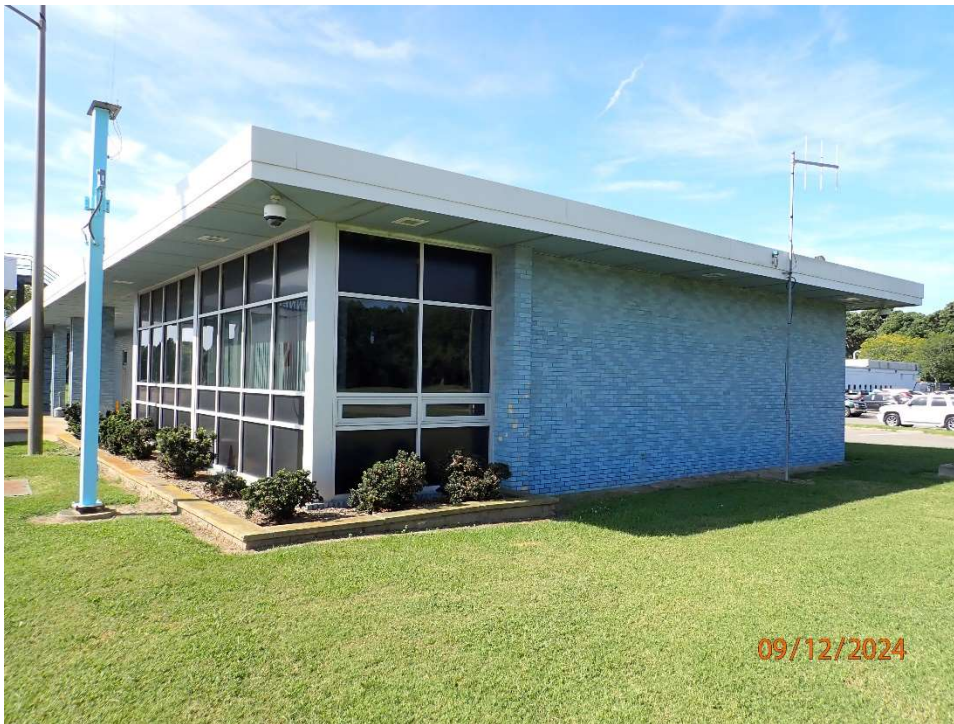
Photo 124: North Toll Plaza, Toll Office Building

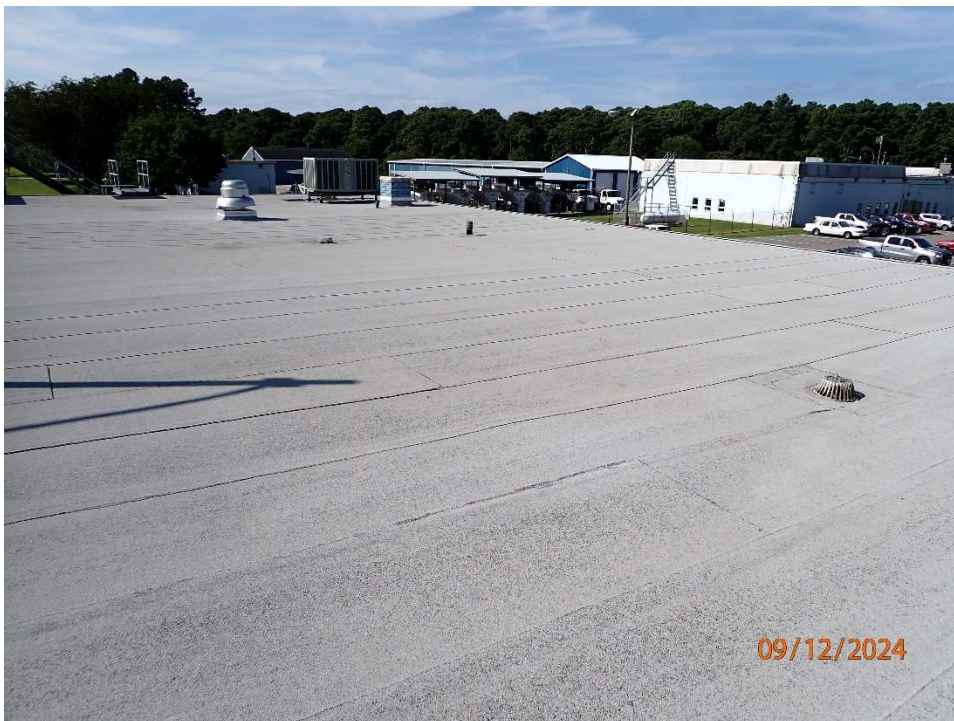
Photo 125: North Toll Plaza, Toll Office Building roof in good condition.

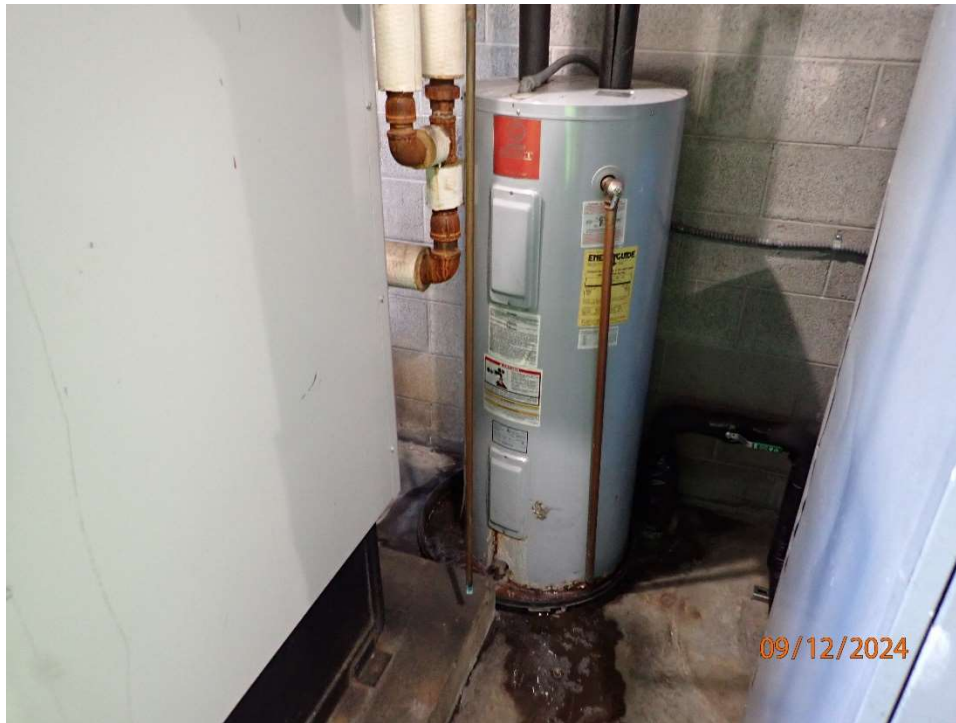
Photo 126 North Toll Plaza, Toll Office Building with water heater with minor leak.

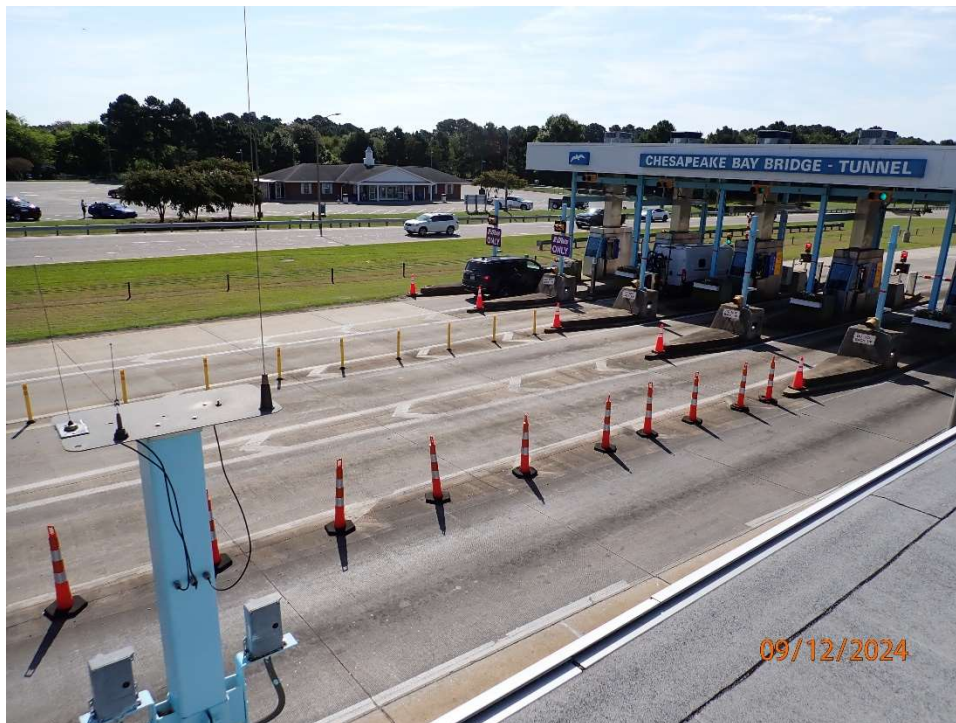
Photo 127: North Toll Plaza, Toll Booth and Canopy with roadway approach in good condition.

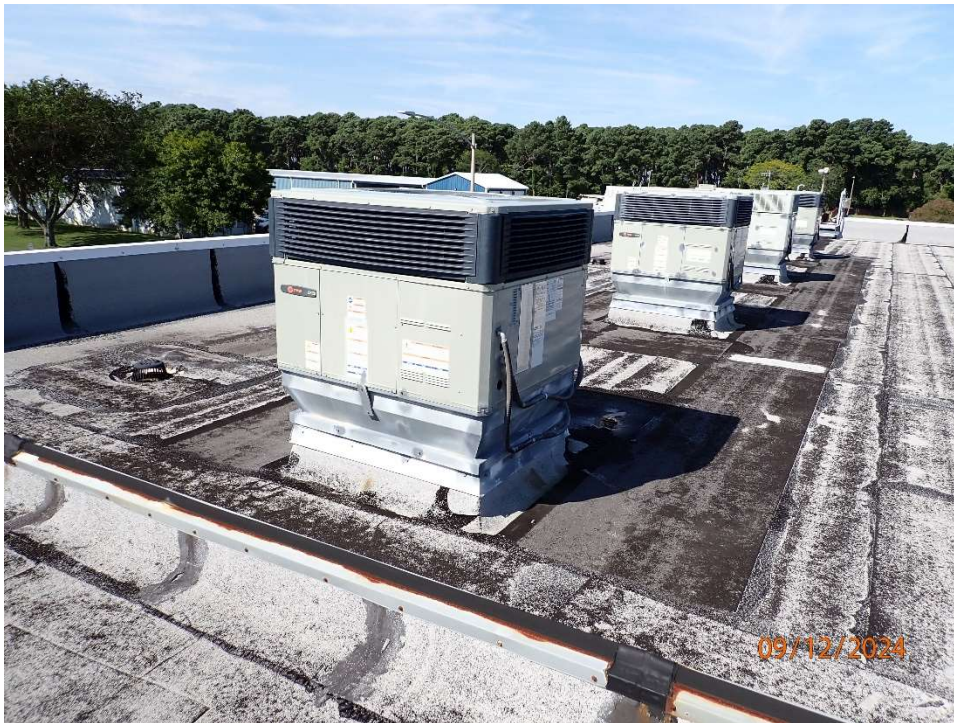
Photo 128: North Toll Plaza, Toll Booth and Canopy with roof in good condition.

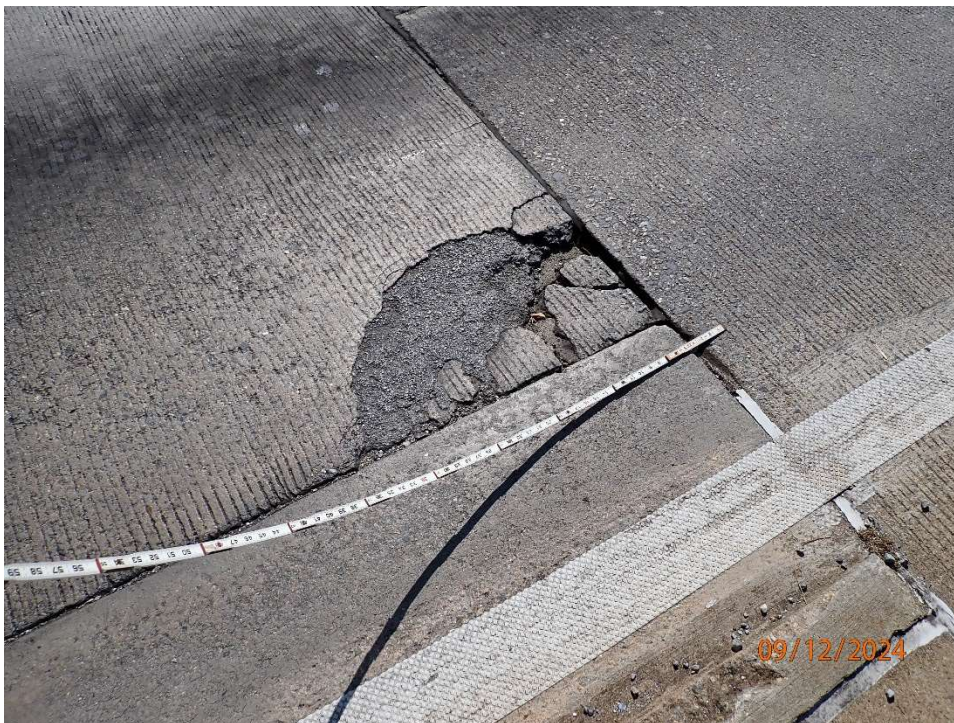
Photo 129: North Toll Plaza, Toll Booth and Canopy, isolated pothole 18" diameter x 2" deep.

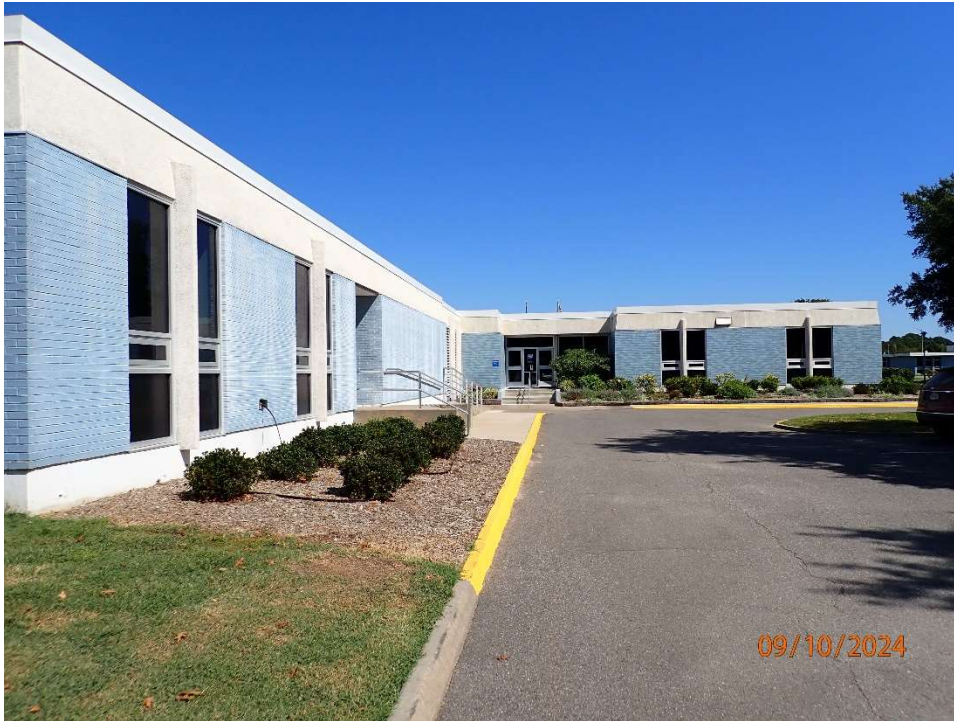
Photo 130: North Toll Plaza, Administration Building in good condition.

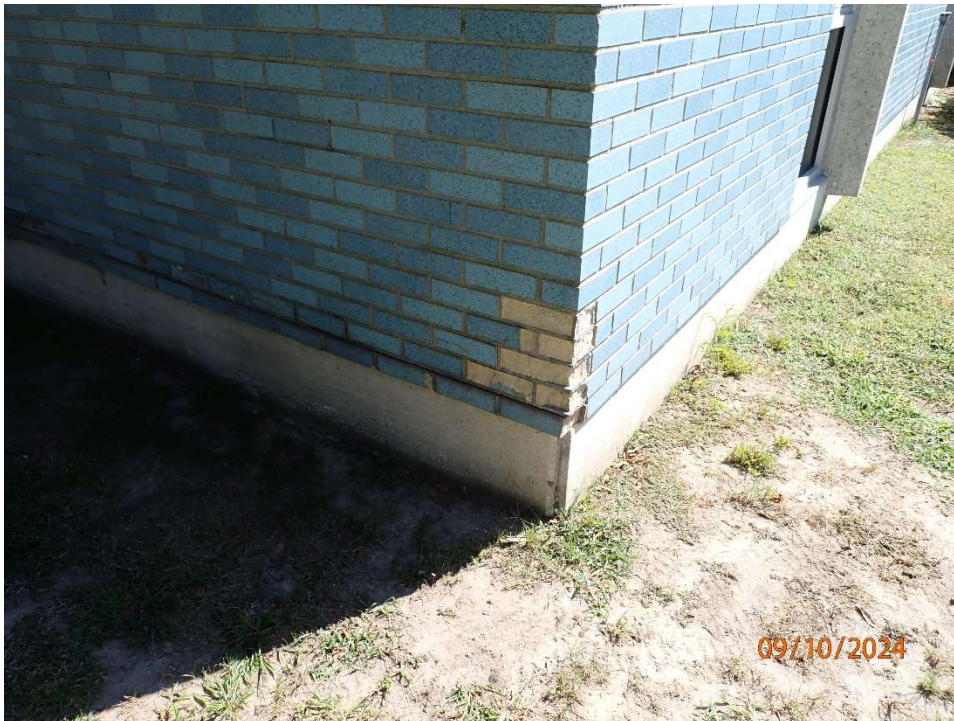
Photo 131: North Toll Plaza, Administration Building brick with minor deterioration at isolated locations. Overall, in good condition.

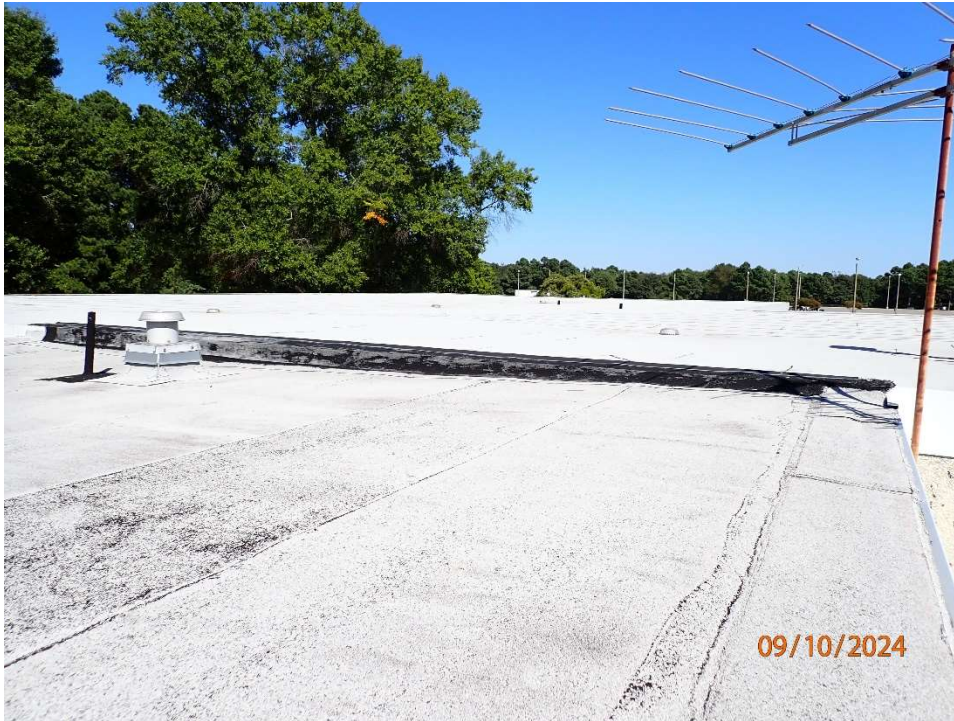
Photo 132: North Toll Plaza, Administration Building roof in good condition.

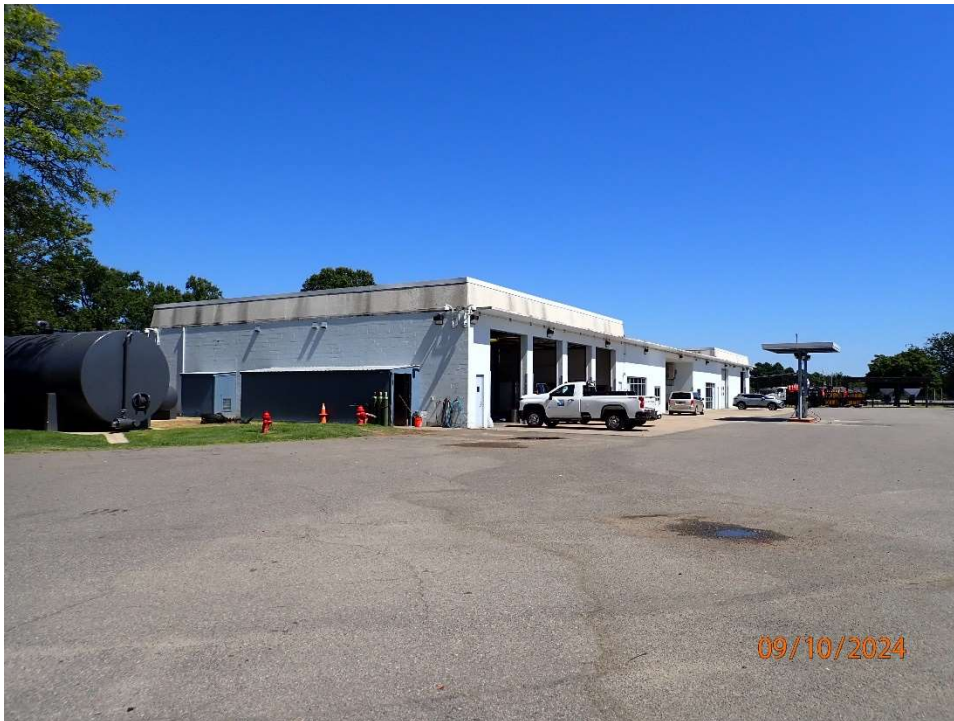
Photo 133: North Toll Plaza, Maintenance Building in overall in good condition.

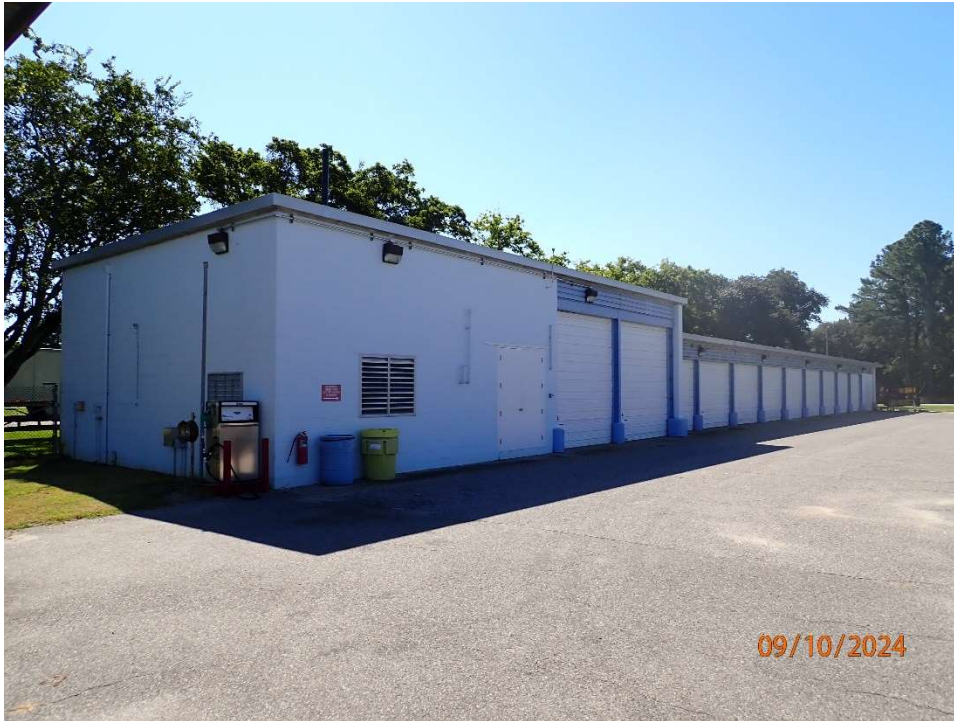
Photo 134: North Toll Plaza, Garage & Generator Building in overall in good condition.

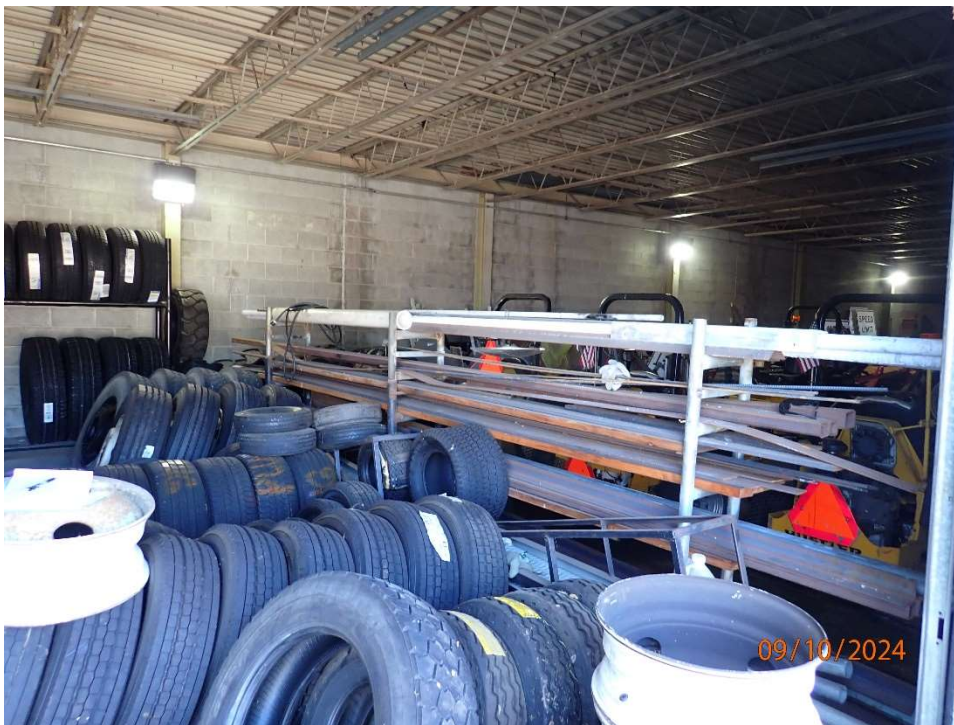
Photo 135: North Toll Plaza, Garage & Generator Building with interior in good condition with signs of minor leakage on backwall.

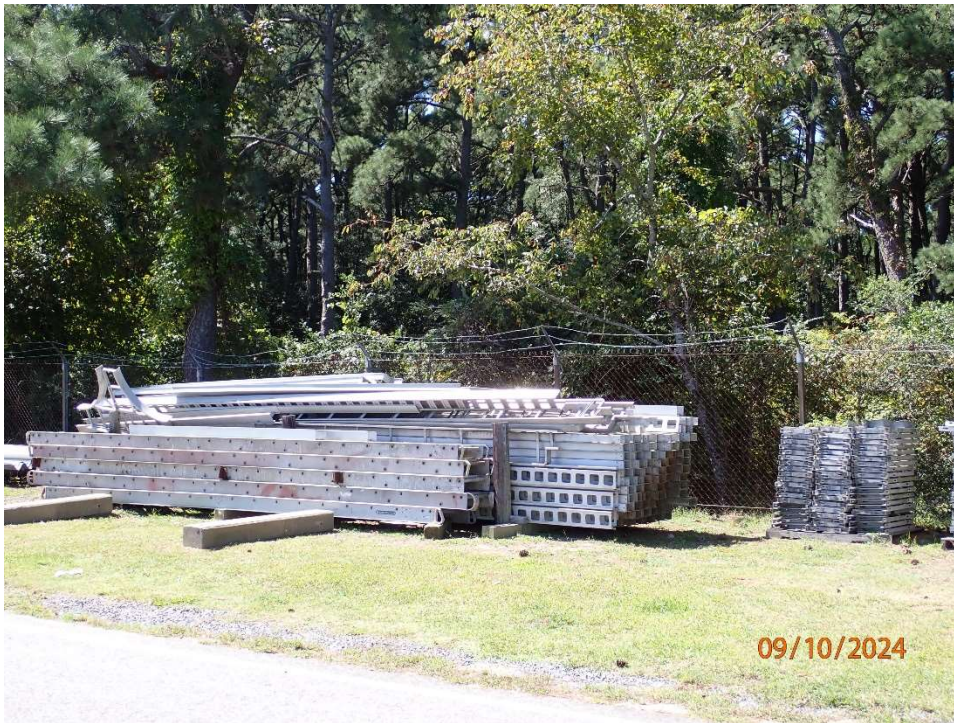
Photo 136: North Toll Plaza, Fence is in good condition with several post top for 3-wire barb off at isolated locations.
