moffatt & nichol
Creative People, Practical Solutions.®

FY2025 Annual Inspection and Underwater Inspection

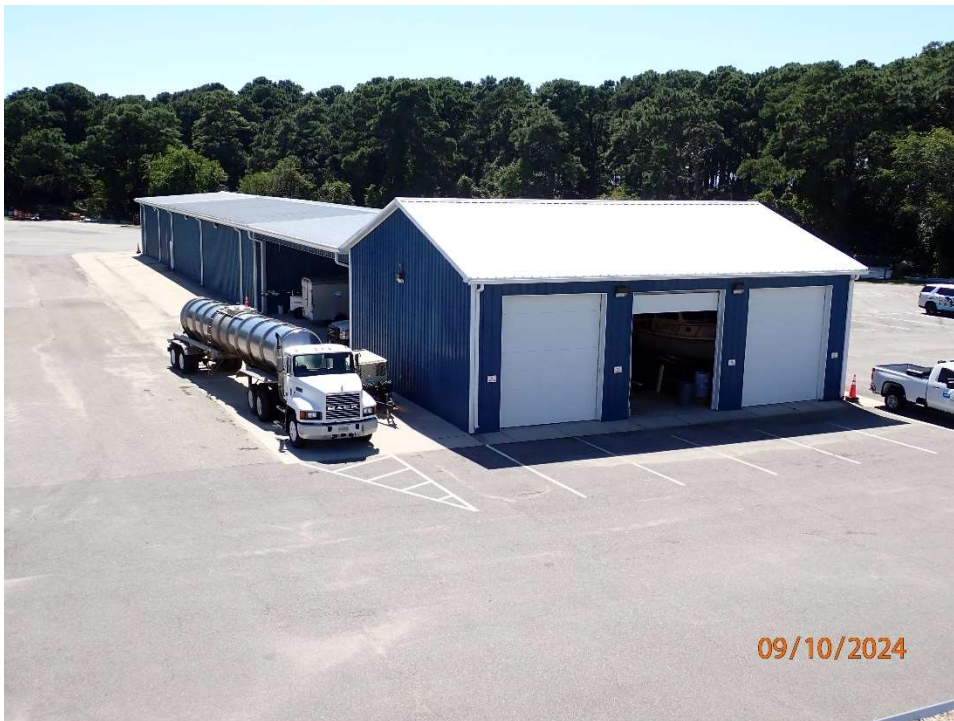
Photo 137: North Toll Plaza, Equipment Storage Building in very good condition. Minor damage noted to Bay 2 trim on north storage structure.

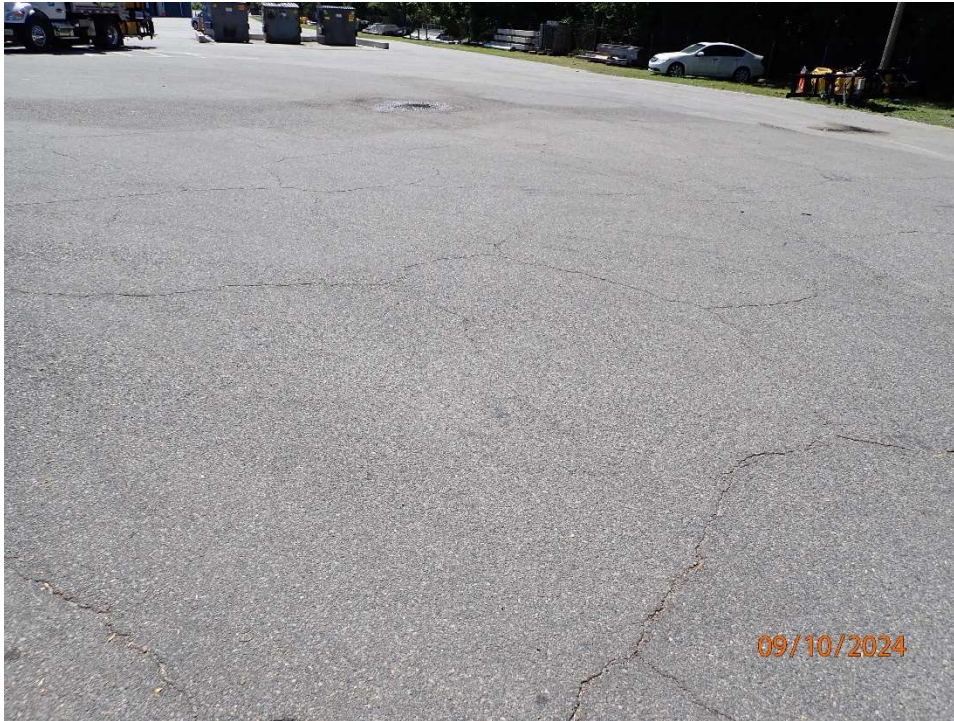
Photo 138: North Toll Plaza, Storage Yard and Parking in good condition with alligator cracking throughout up to ¼" wide. Isolated low areas with ponding water.

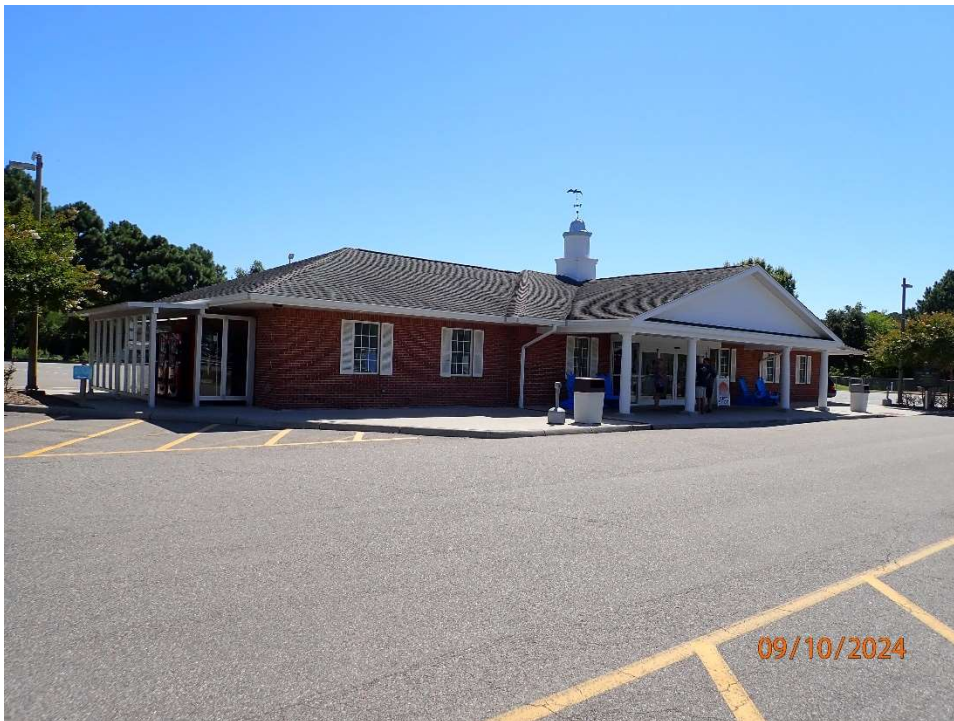
Photo 139: North Toll Plaza, Rest Room Facility in good condition with alligator cracking noted throughout the parking lot.
